Monmouthshire County Council

Pwll Ddu

Inspection Report

Project no. ED/000817

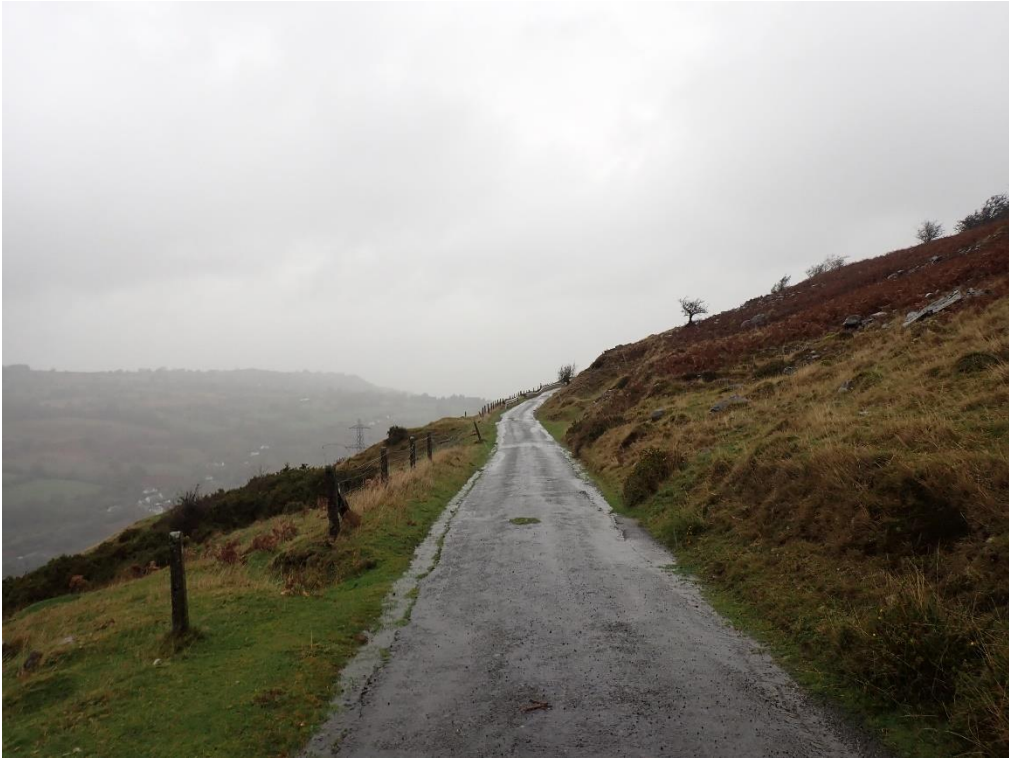
A chainage line was established on the site with chainage 0.0m set outside the area of immediate concern on a concrete fence post ^[1] at the southern (uphill) end of the section.

Plate 1: Chainage 0.0m at fence post.

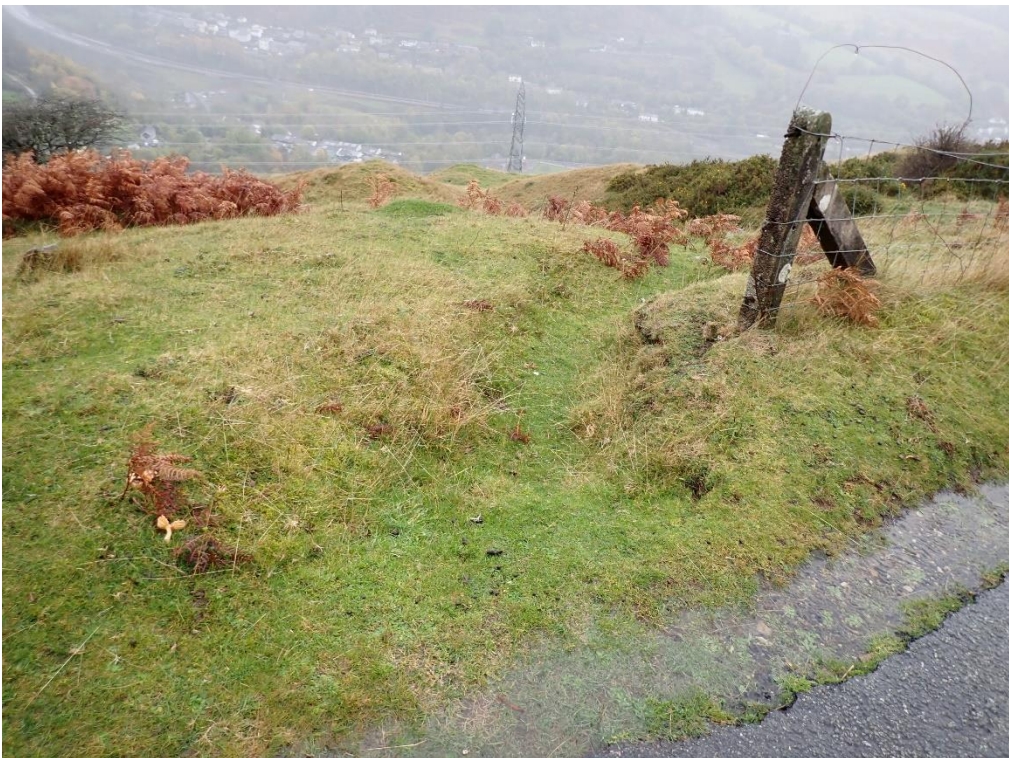
A small grip ^[2] (informal shallow drainage channel) was identified at this location, generally to the south of the main area of concern where the quarry face and road interact.

No change was noted in this area during the inspection.

Plate 2: Chainage 6m. Grip in verge

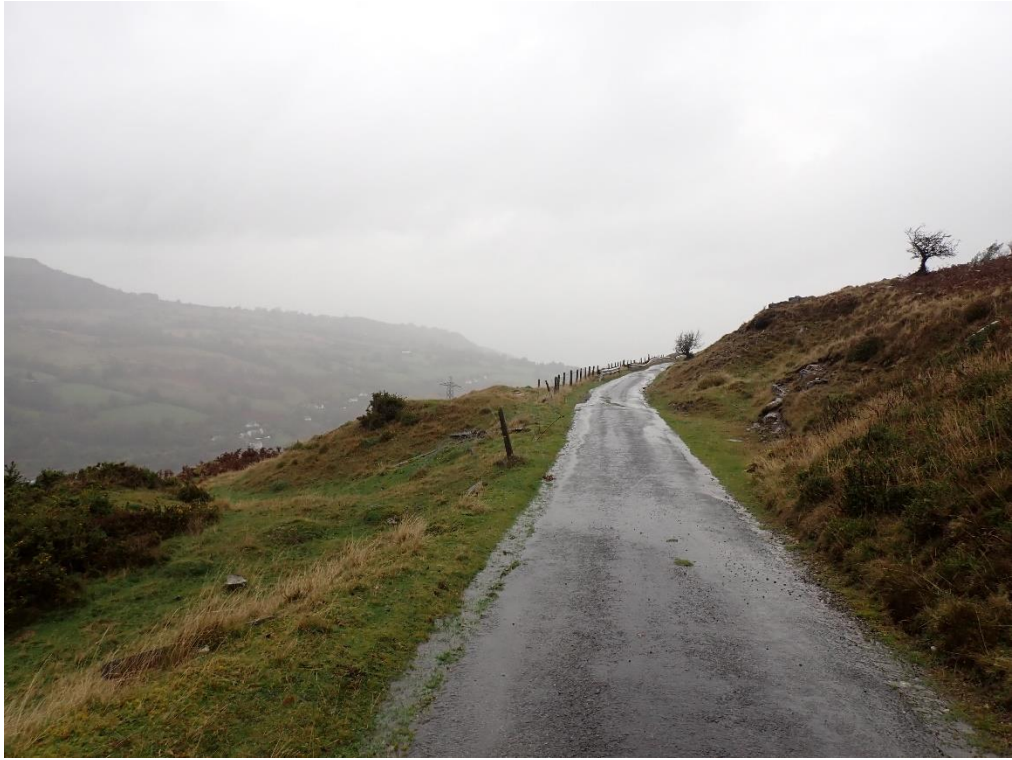
A local low point ^[3] is present at this location and a series of grips ^[4] were present leading surface water from the road and down towards the quarry face (located away from the road edge).

Plate 3 Chainage 32m. Local low point in carriageway - shallow grips in verge

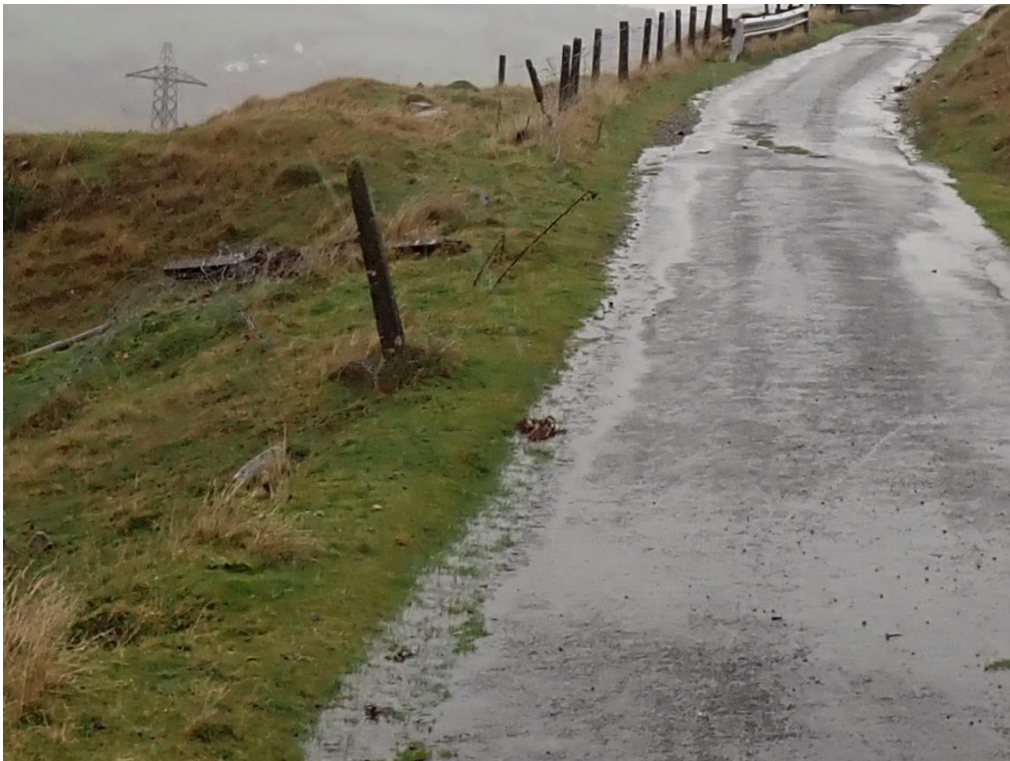
Plate 4 Chainage 32m. Local low point in carriageway - shallow grips in verge

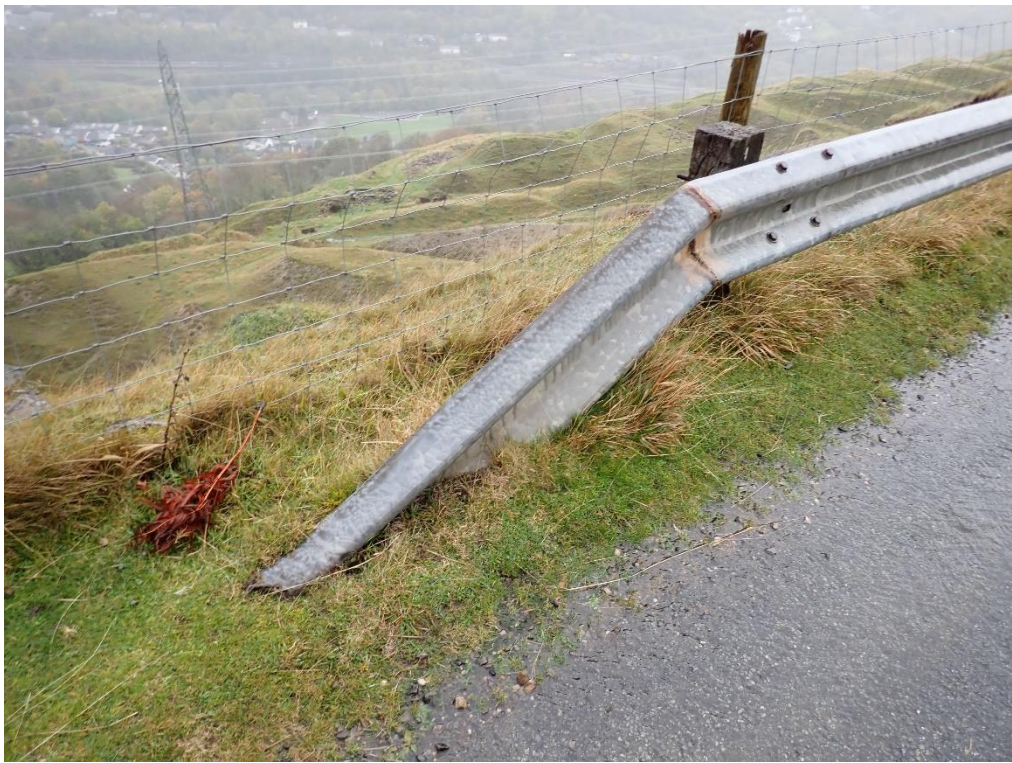
The rock face / crest of slope moves closer to the carriageway edge at this point and an old failing vehicle restraint system (VRS) starts. The VRS comprises horizontal metal “Armco” barrier mounted to wooden posts ^[5]. No change was noted during the inspection.

The existing barrier is sub-standard and supported by rotting wooden posts. Visually the VRS condition is so poor it is unlikely to provide any resistance to a vehicle impact.

Plate 5: Chainage 64m Start of VRS

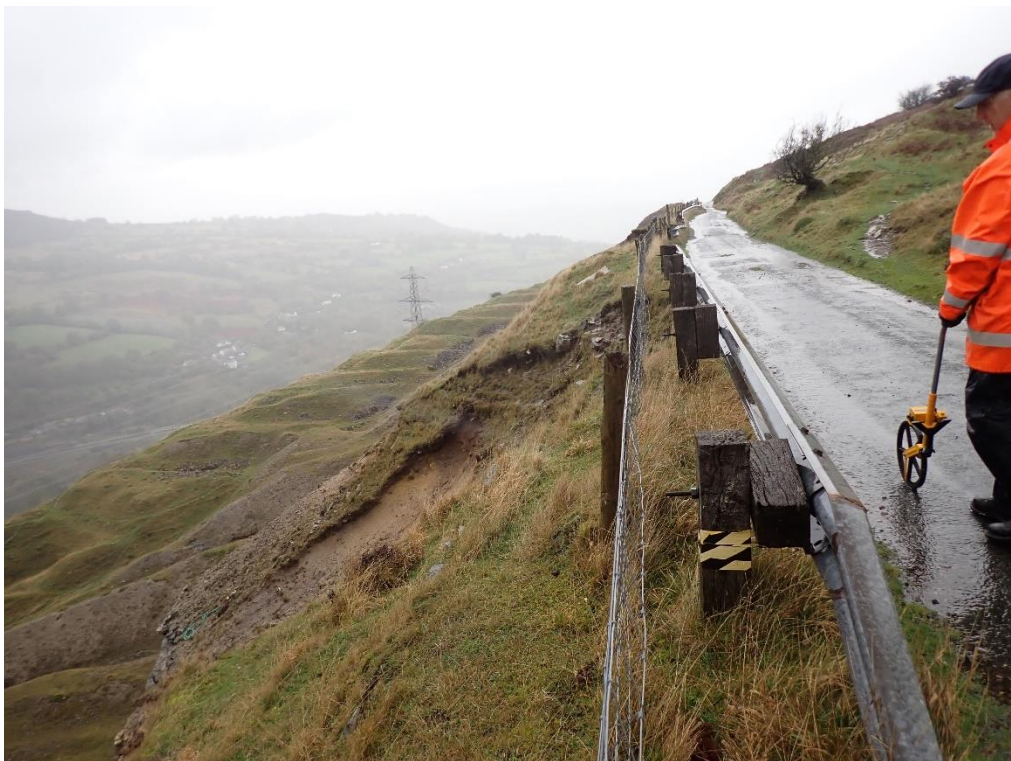
The rock face / crest of slope moves within 0.5m of the back of the VRS ^[6&7]. The slope below has recently and historically failed with minor slipping of shallow surface debris since the previous monitoring visit ^[7 & 8].

Plate 6: Chainage 69m The rock face / crest of slope moves within 0.5m of the back of the VRS

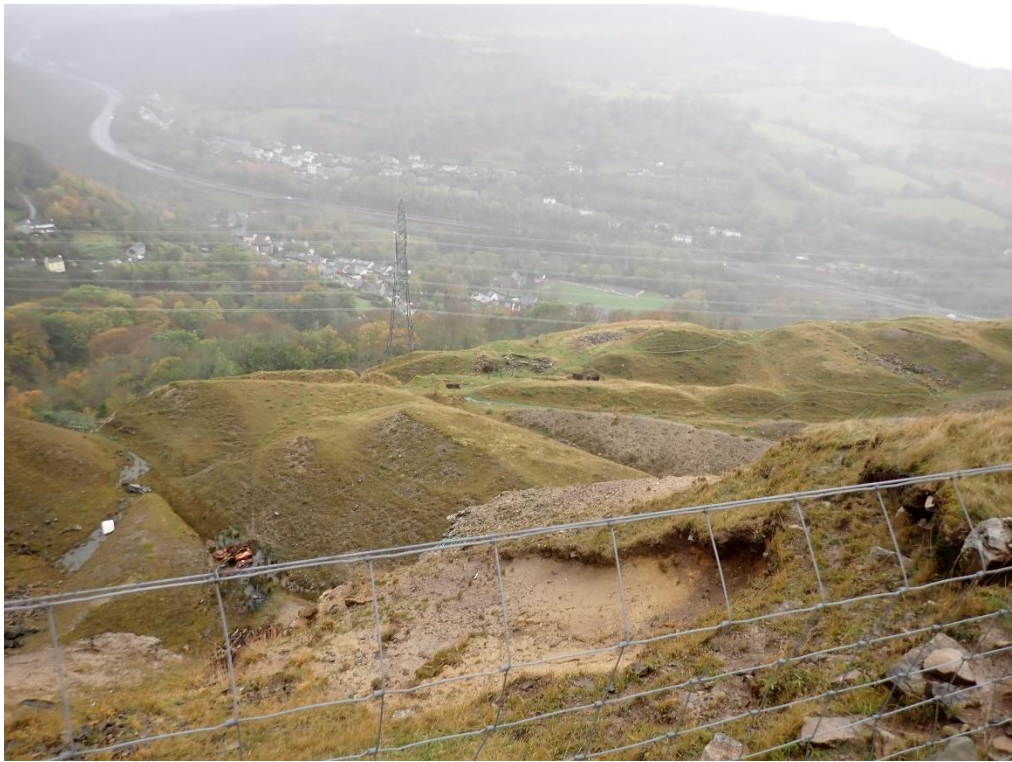
Plate 7: Chainage 69 to 79, The rock face / crest of slope moves within 0.5m of the back of the highway with surface slips on slope.

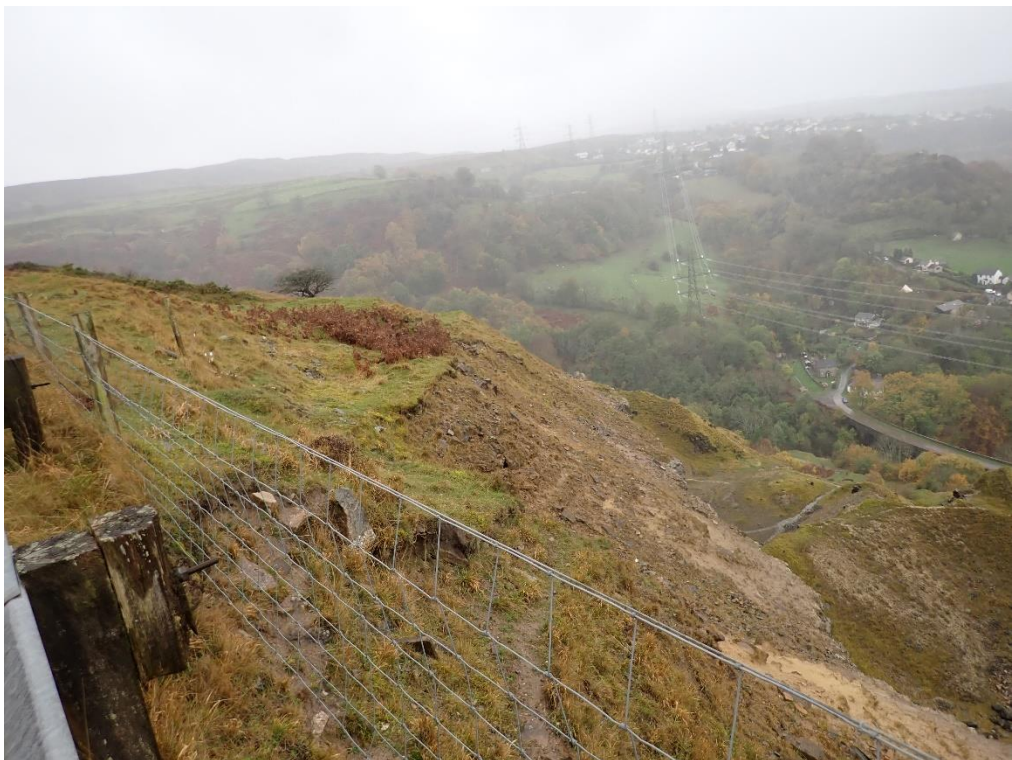
This section of VRS is visibly leaning towards the road, the supporting posts are in poor condition. Stockproof fencing in this area is suspended in fresh air with no posts present ^[8] (No change).

Plate 8: Chainage 69 to 79, The rock face / crest of slope moves within 0.5m of the back of the highway with surface slips on slope, leaning VRS, and stock fence with no supporting posts.

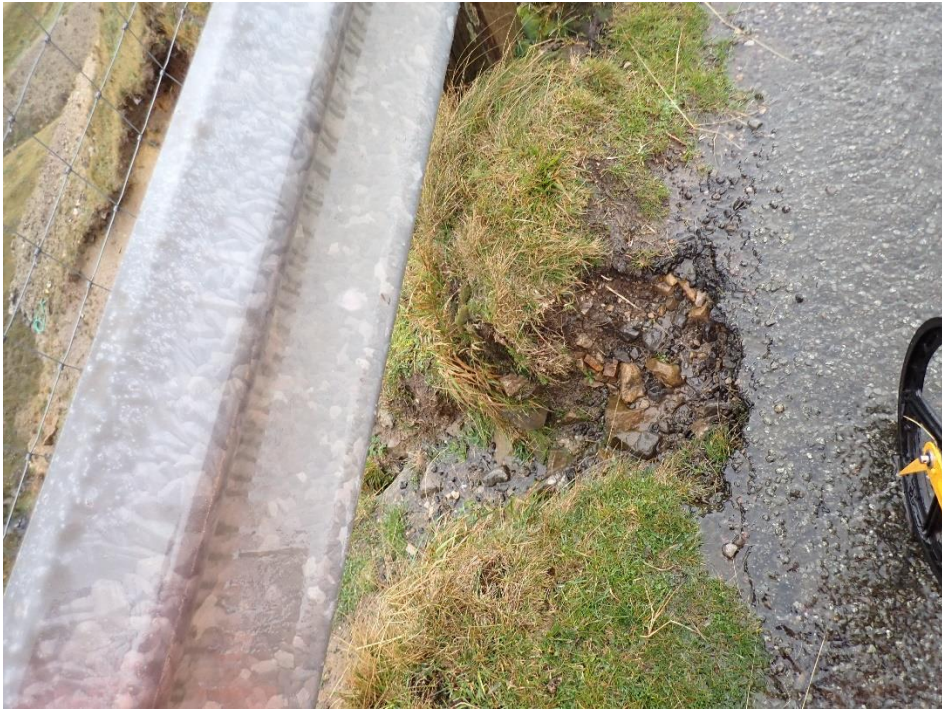
Drainage grip through narrow verge over edge of the slope. Slope crest is present within 400mm of the edge of the highway ^[9].

Plate 9: Chainage 74.5m Grip in verge.

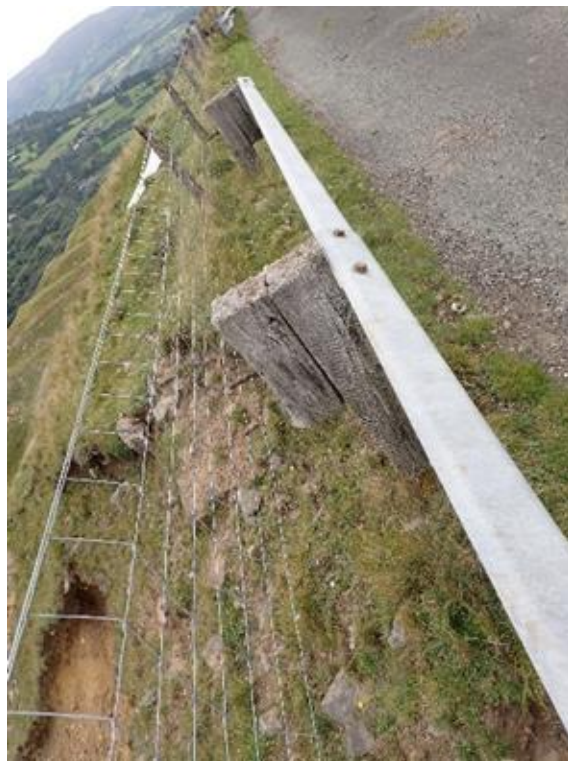
End of VRS section. Slope crest moves away from the road edge ^[10].

Plate 10: Chainage 79.0m. End of VRS section (historic photo)

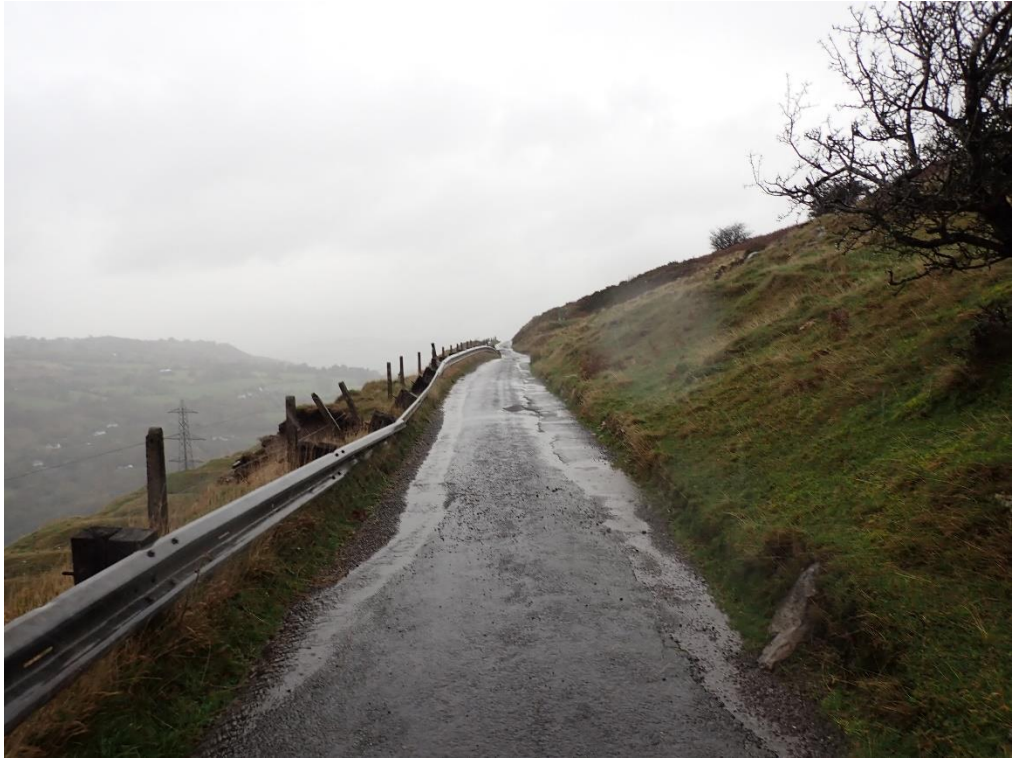
VRS section starts and is in poor condition throughout comprising a horizontal metal "Armco" barrier mounted to wooden posts, these are in poor condition allowing the barrier to rotate forwards towards the road.^[11]

Plate 11: Chainage 90m, VRS section starts.

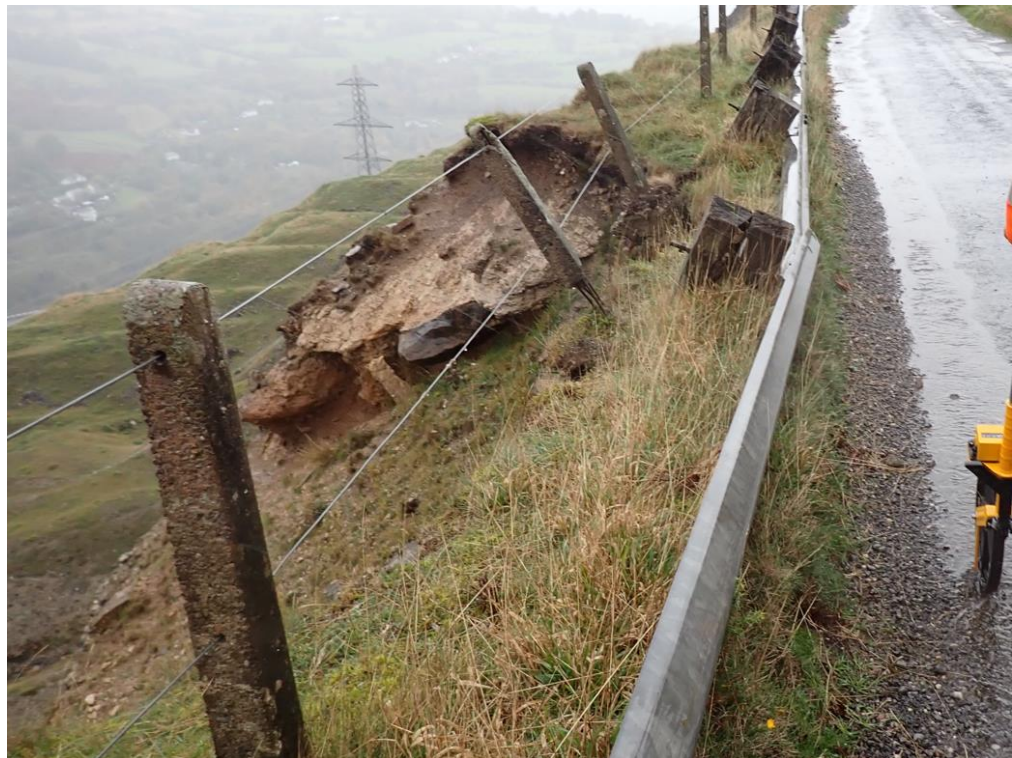
Crest of slope moves very close to the edge of the road at between chainage 97.0 and 104.0m (within 0.5m). A shallow slip is present on the slope in this vicinity. The VRS has also failed and rotated forwards towards the road, the slip has taken the footings downslope.

A concrete post and wire fence is present behind the VRS ^[12 & 13]. During the inspection two fence post foundations (previously 1 No) were found to have failed and was being supported by the fence wire ^[14].

Plate 12: Chainage 97.0m to 112.0m, crest of slope close to road edge, slip in slope below, rotated VRS and fence post.

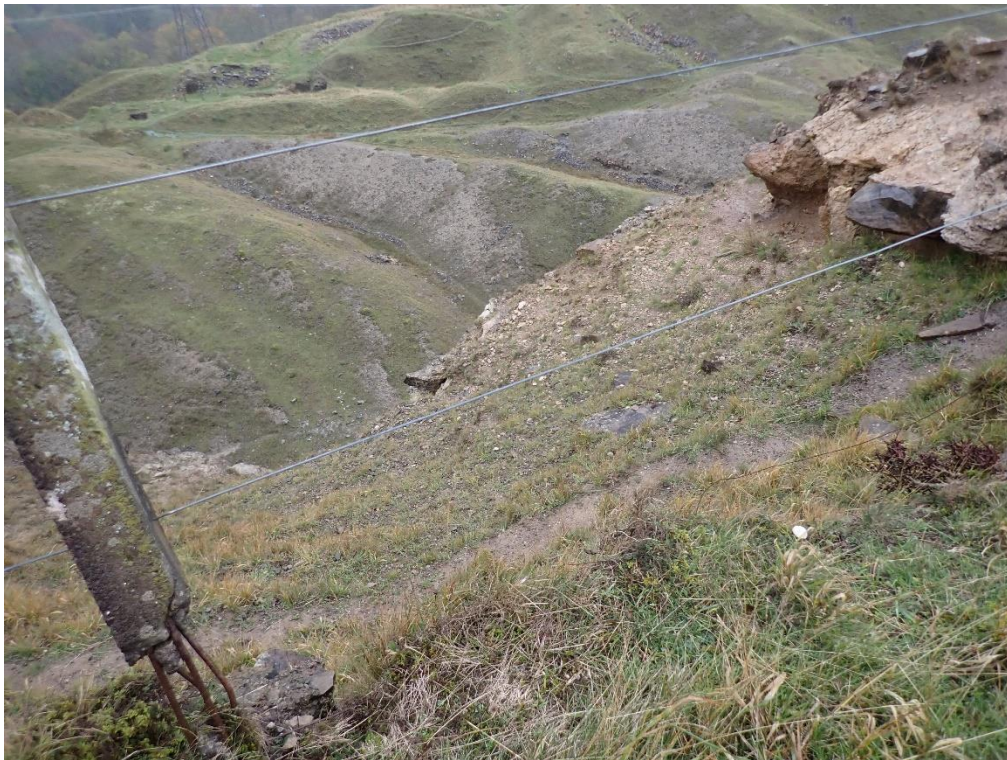
Plate 13: Chainage 97m, slip bowl below the road above quarry face with unsupported post

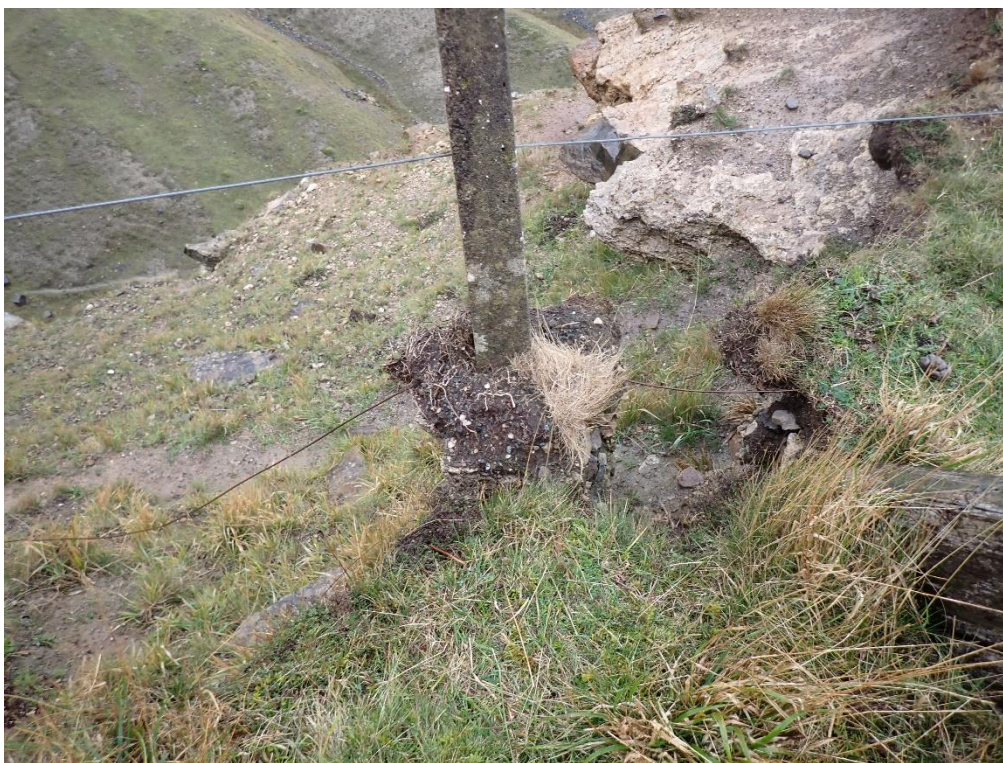
Plate 14: Chainage 100, failed fence post foundation.

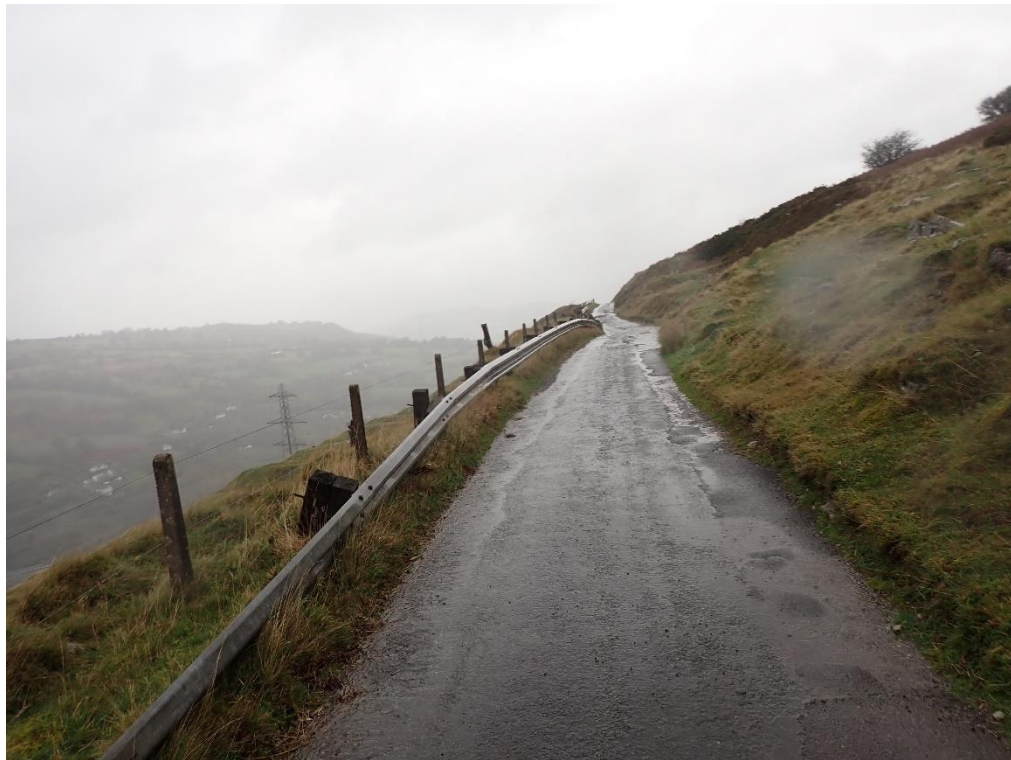
Crest of slope moves away from road, VRS remains tilted over ^[15].

Plate 15: Chainage 104 to 112m, failed tilting VRS.

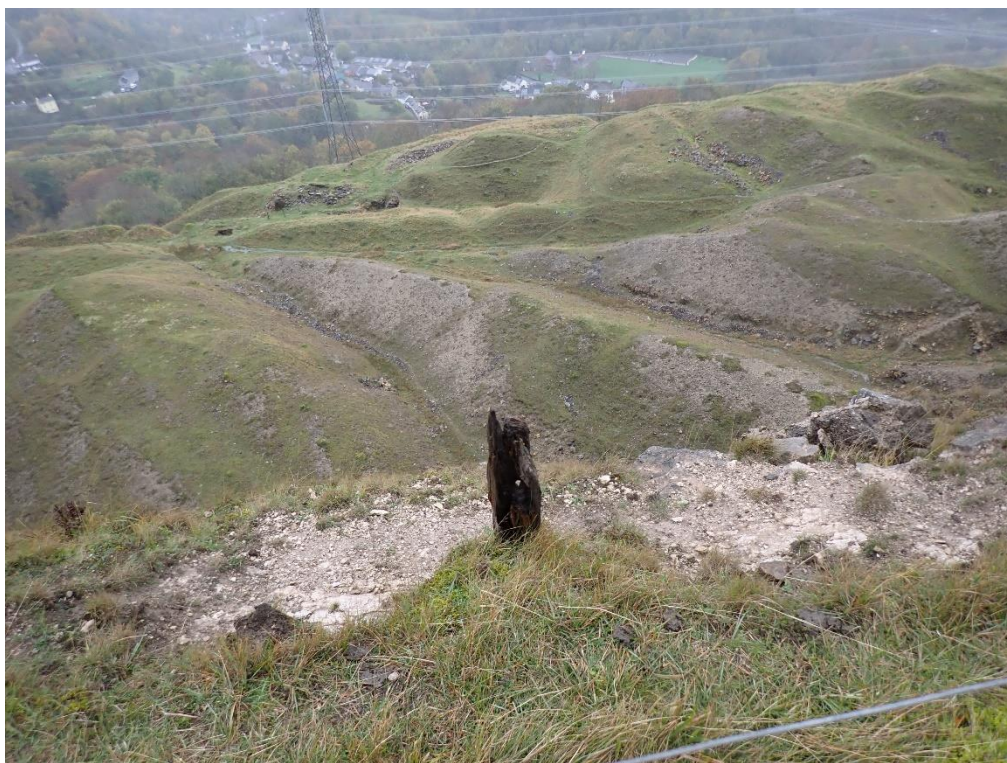
Surface slip on slope below road ^[16 & 17].

Plate 16: Chainage 135m, slip on slope below road close to carriageway.

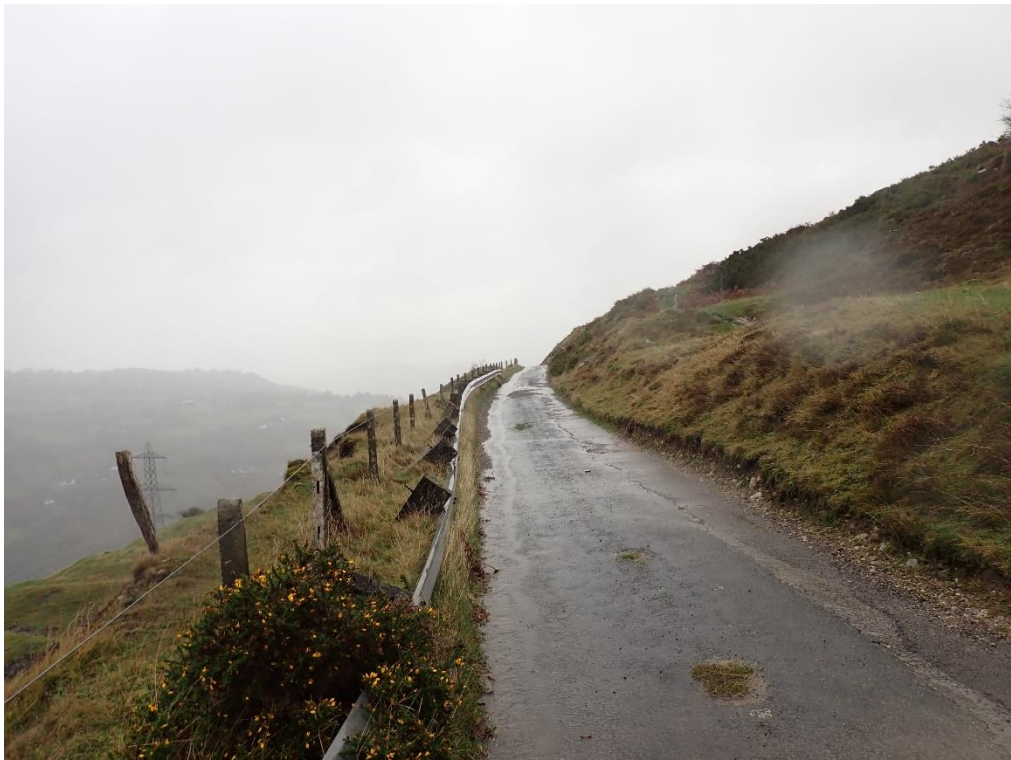
VRS is leaning forward into the road with failing (slipped) slope downhill ^[17].

Plate 17: Chainage 141m, slip on slope below road close to carriageway. Note VRS leaning forwards

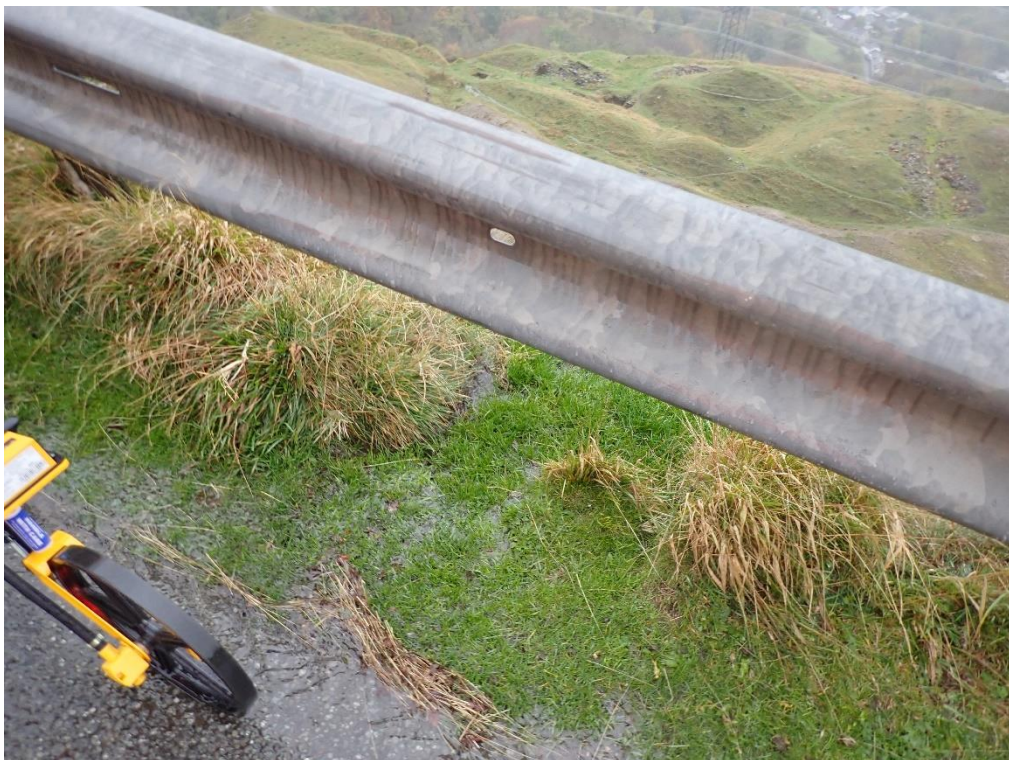
Low point in road, water draining off the road onto the failed slope below via a grip ^[18].

Plate 18: Chainage 139m, Low point in road, water draining off the road onto the failed slope below via a grip.

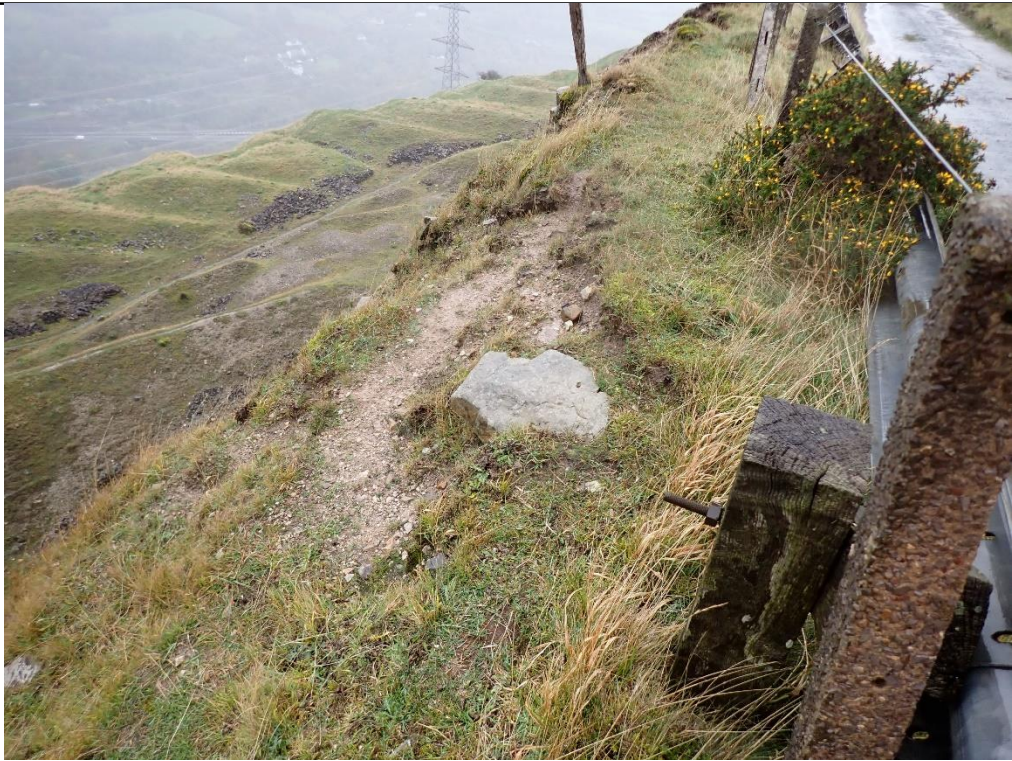
Crest failure 1.5m from edge of carriageway ^[19]. VRS remains leaning forwards ^[20] and returns to vertical at CH 160.0m.

Plate 19: Chainage 150m, slip on slope 1.5m off highway

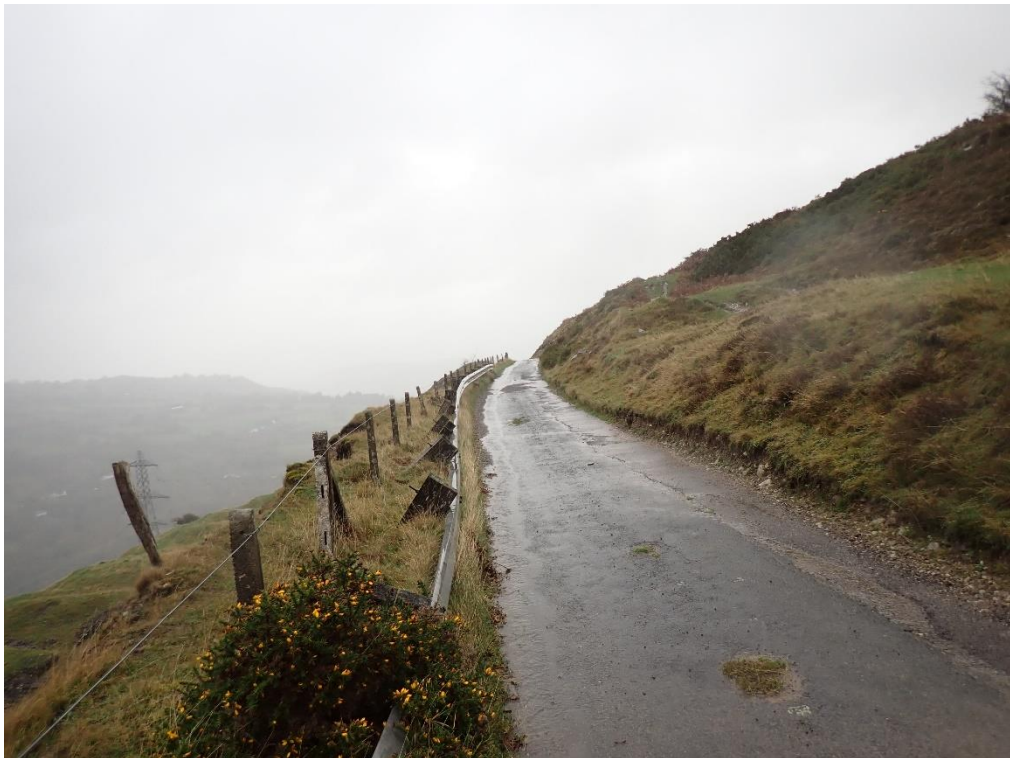
Plate 20: Chainage 150m, leaning VRS

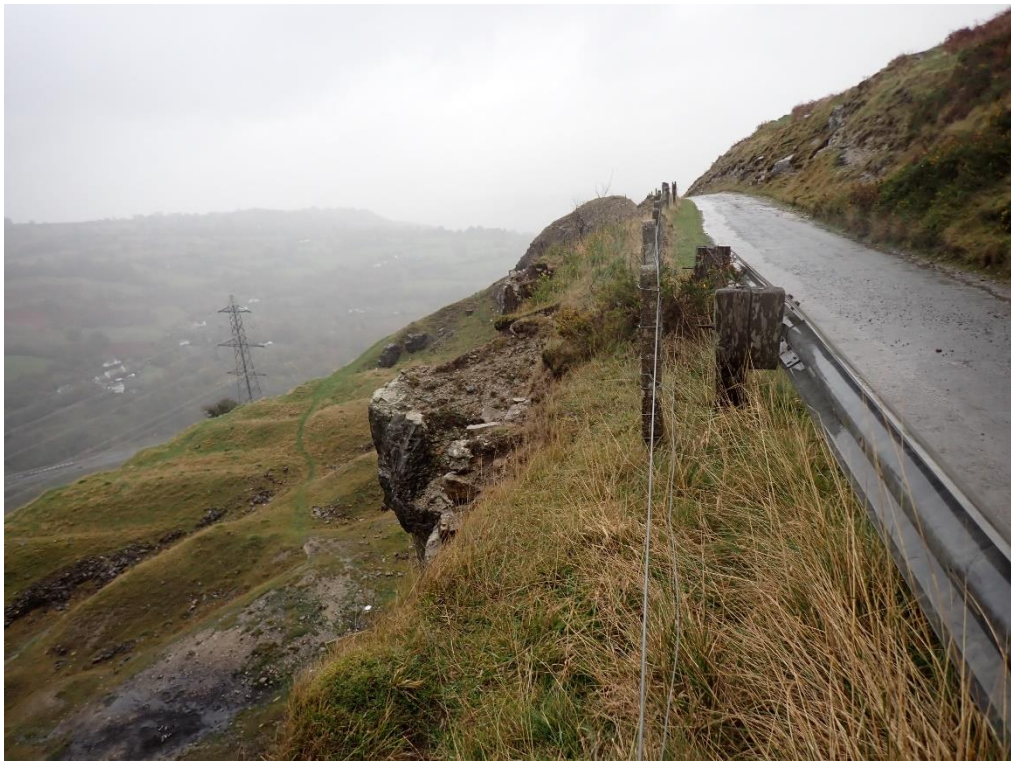
Edge of rockface with local crest failure approximately 0.5m from back of VRS ^[21].

The VRS ends at CH183.

Plate 21: Chainage 179m, crest of slope / rock face close to edge of road. Note the end of the VRS at CH183.

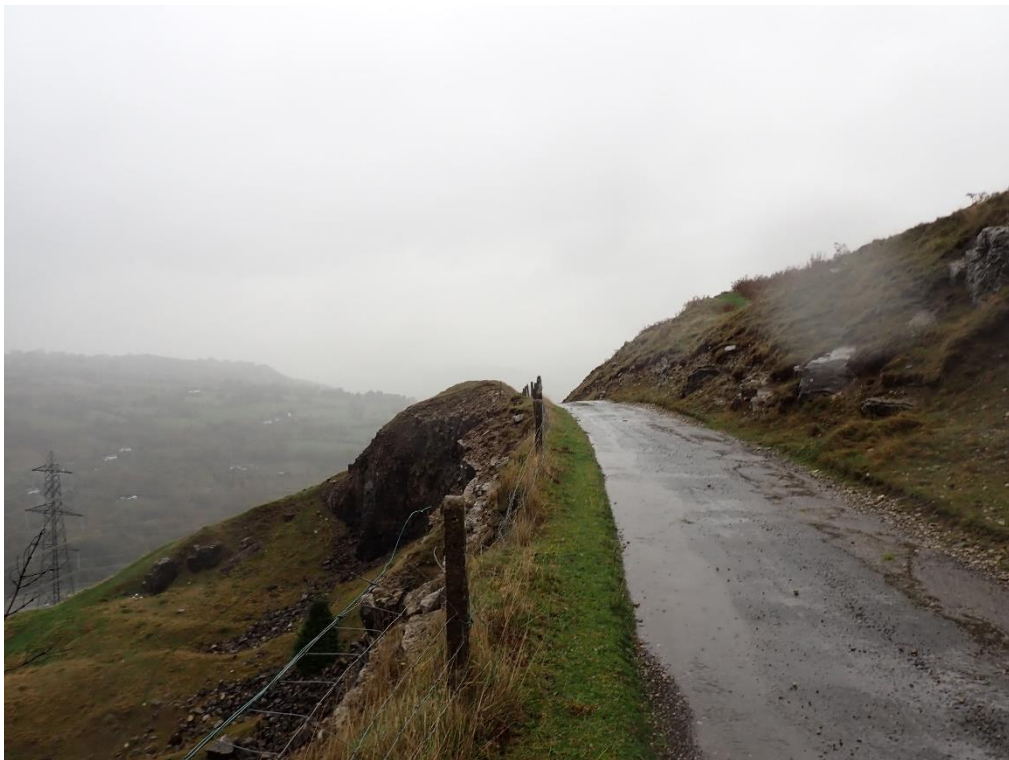
In this section the vertical quarry face is very close to the edge of the carriageway separated only by a narrow verge and a dilapidated fence ^[22]. High risk section.

Plate 22: Chainage 199m, crest of slope / rock face close to edge of road. Note the poor quality of the fence.

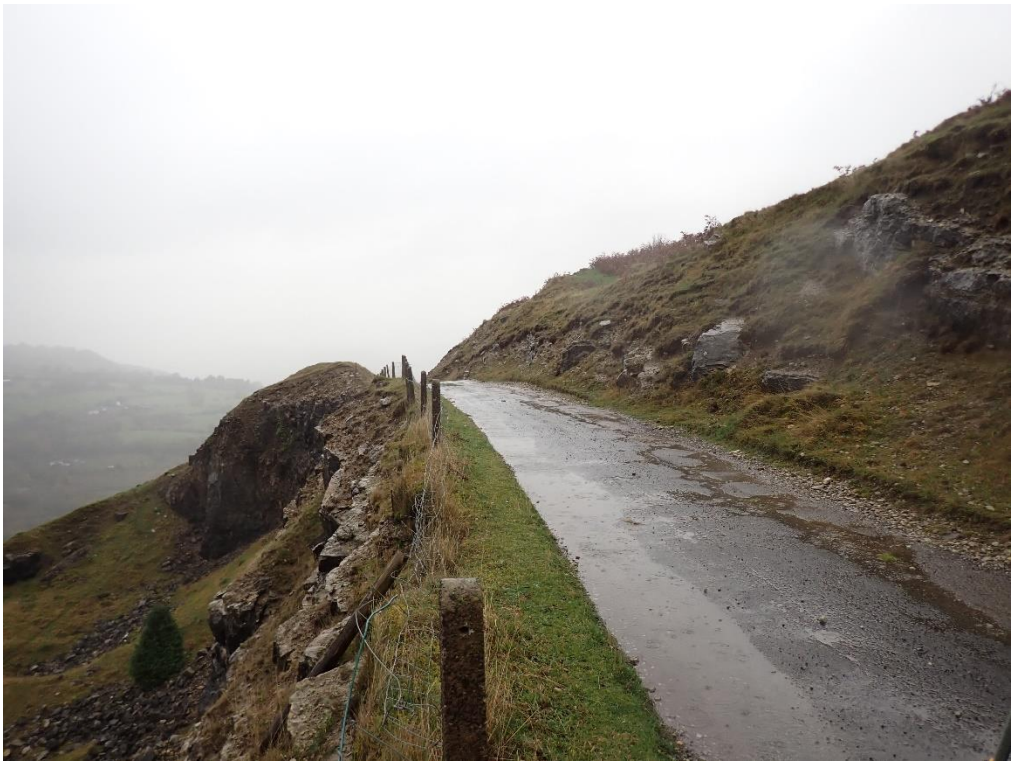
Fence down (fence post failed over crest) no fall protection to edge ^[23 & 24].

Plate 23: Chainage 202.0m, Failed section of fence

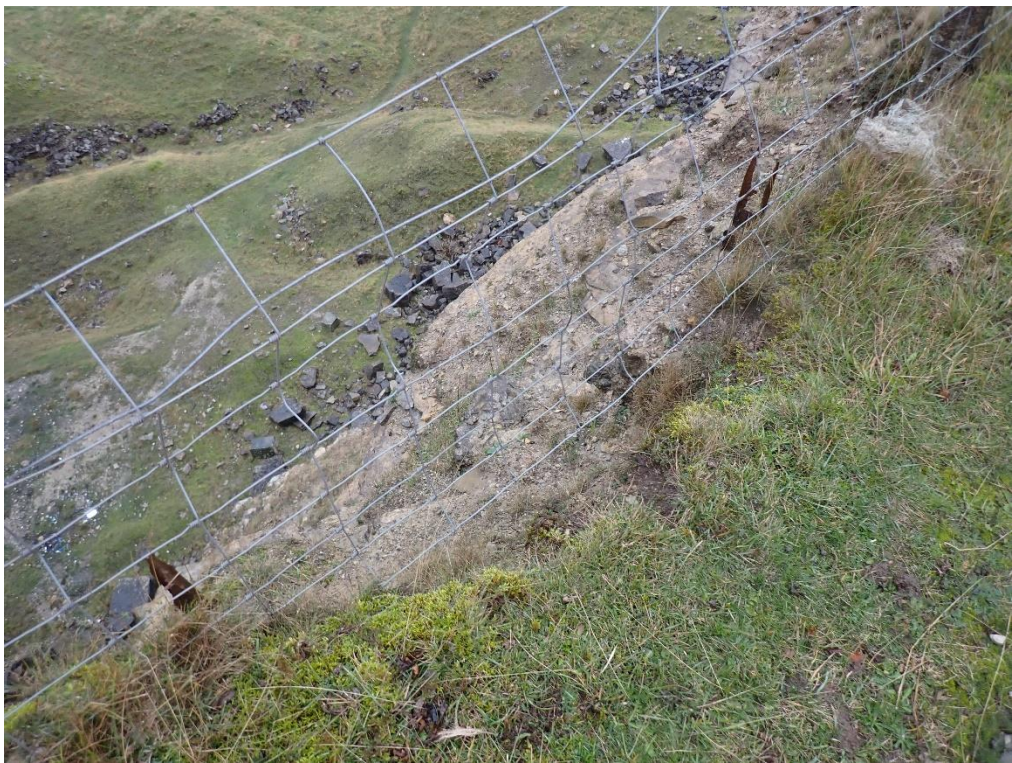
Fence hanging with no post to support due to crest failure ^[24].

Plate 24: Chainage 215.0m, Section of fence with no support due to crest failure

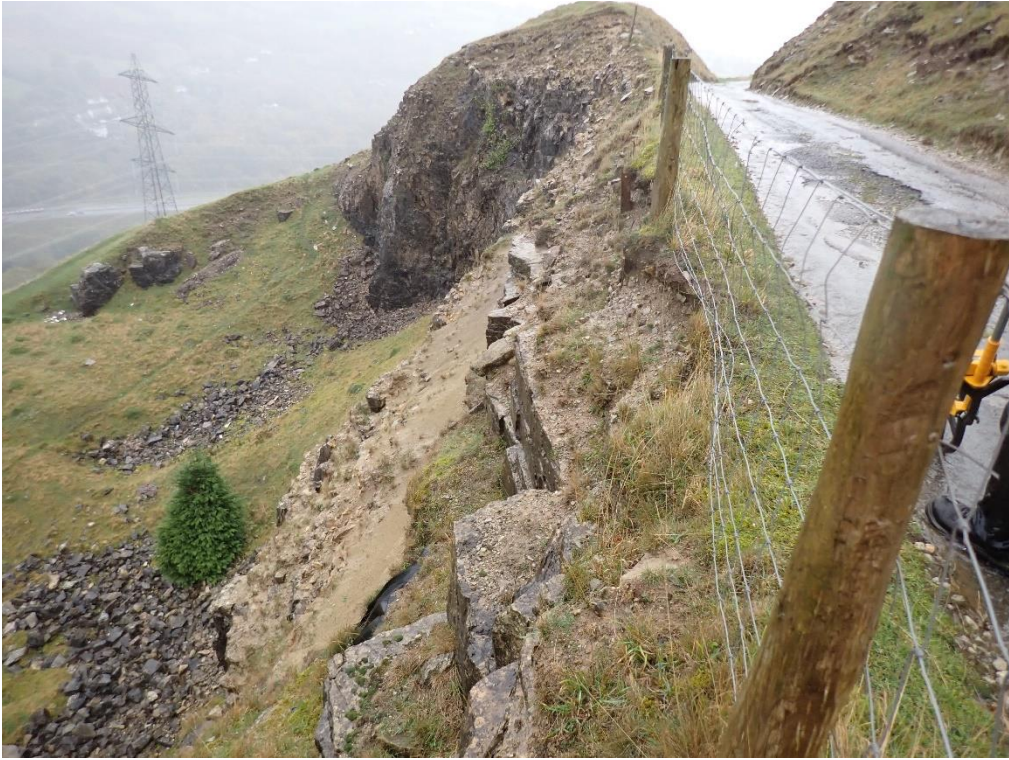
Fence hanging with no post to support due to crest failure ^[25 & 30].

Plate 25: Chainage 228.0m to 250, Section of fence with no support due to crest failure

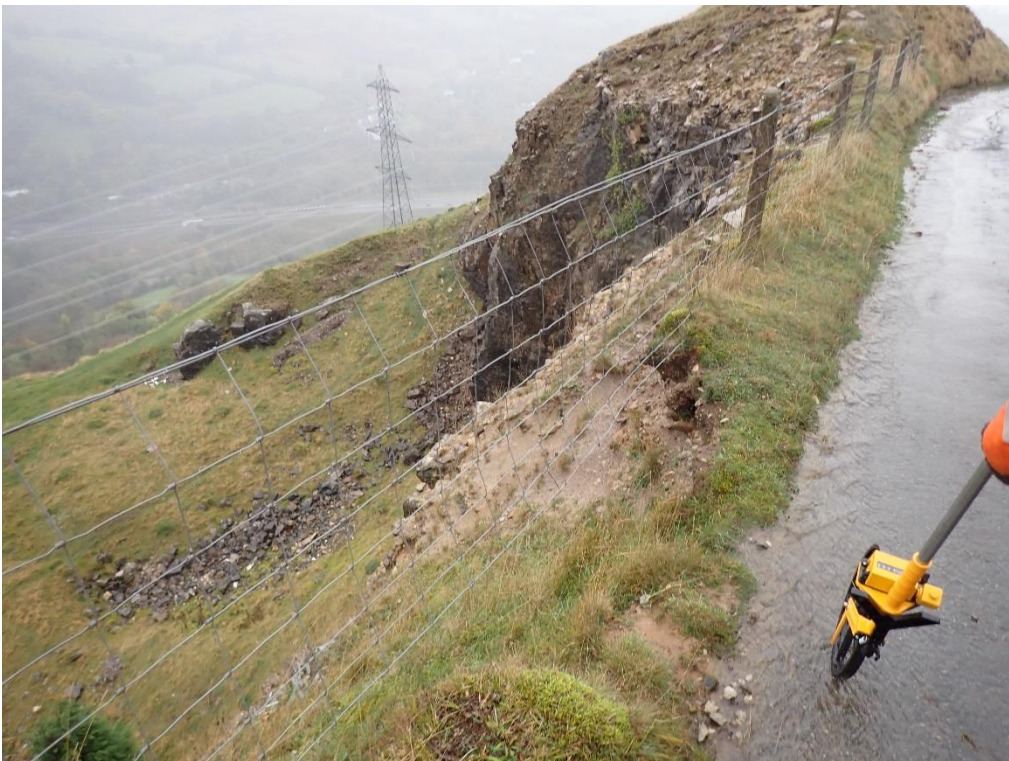
Drainage grip is present at 243.0m.

Plate 26: Chainage 243, Section of fence with no support due to crest failure with grip through verge.

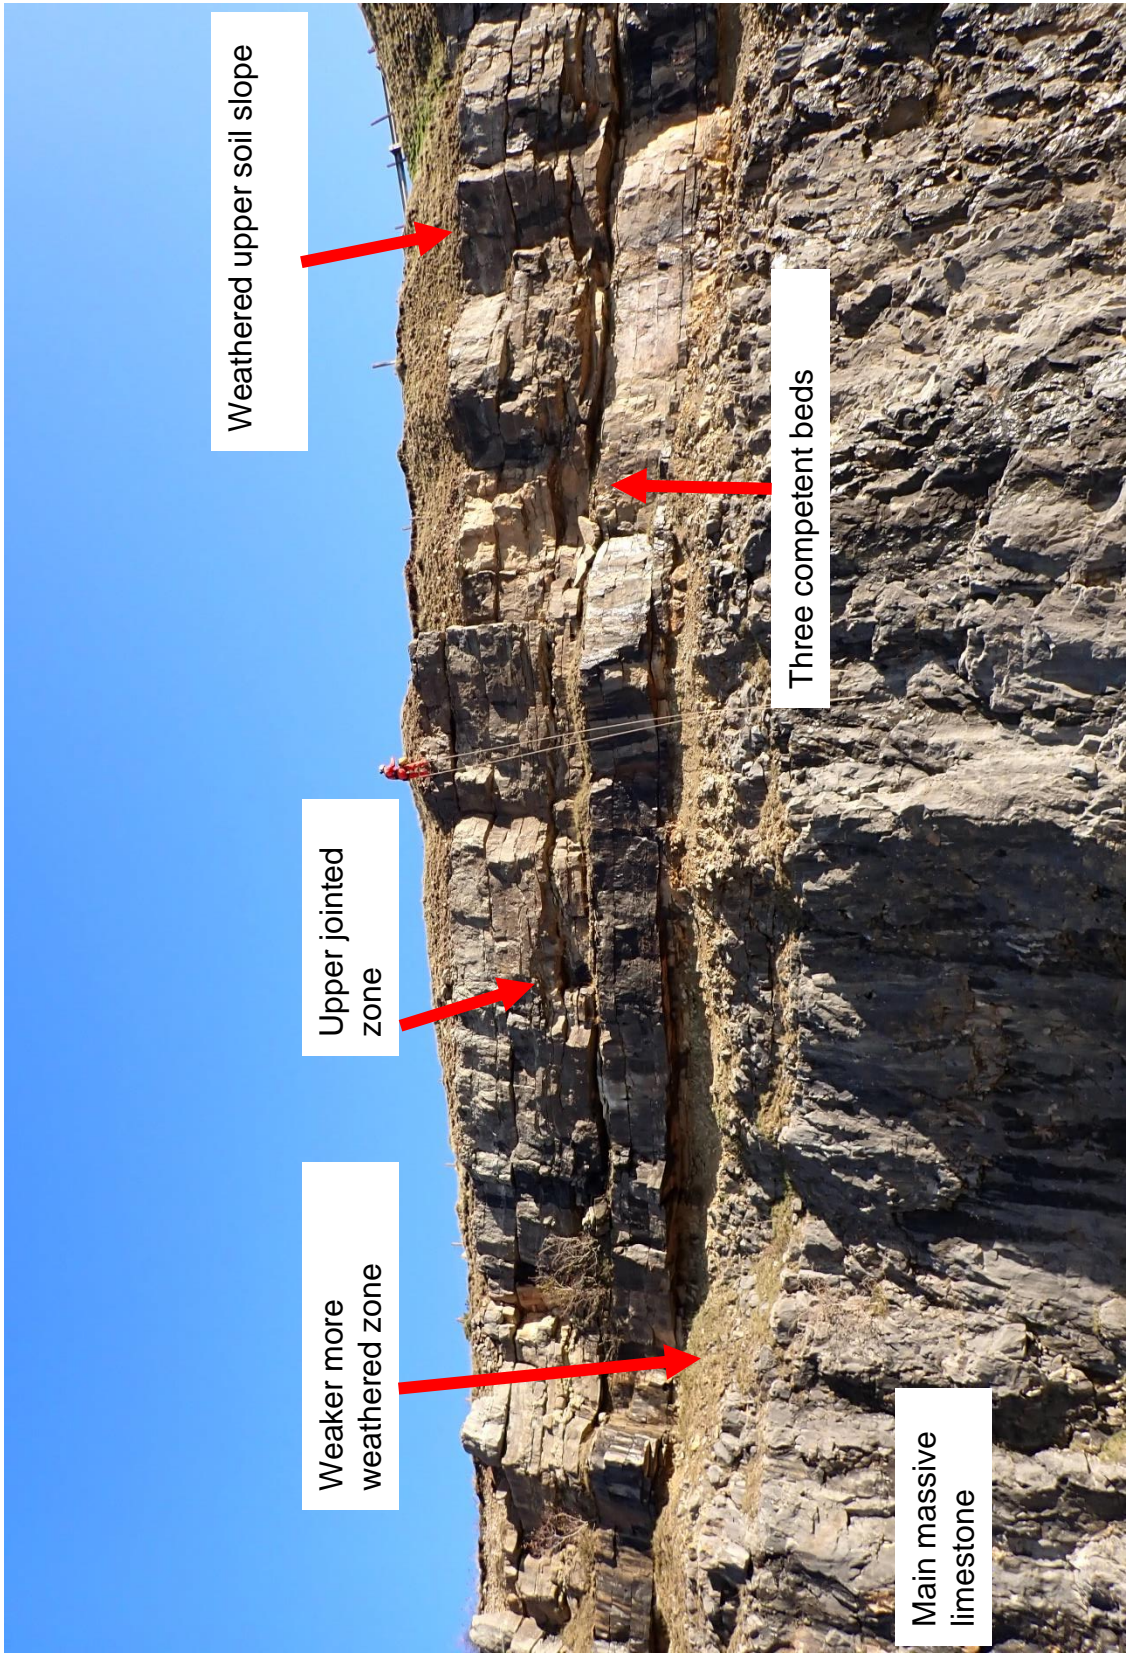
The quarry face can generally be split into three sections which are generally traceable across the quarry face with an apparent dip towards the south, these are indicated on Plate 27.

Plate 27: Main strata present in quarry face..
