Monmouthshire County Council

Pwll Ddu

Inspection Report

Project no. ED/000817

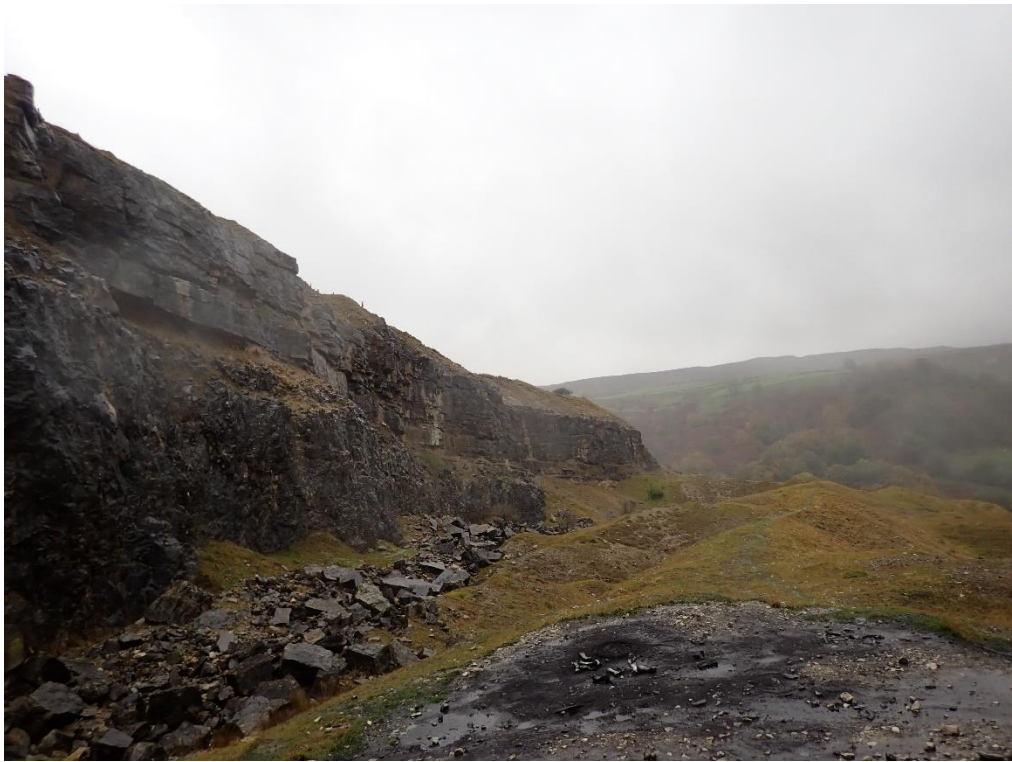
The inspection located a number of areas where the differences in weathering and staining of the rock face suggests fresh rockfalls and erosion of surface soil from the “Weaker more weathered zone” have occurred since the last inspection ^[28 to 30].

Plate 28: General view of quarry face.

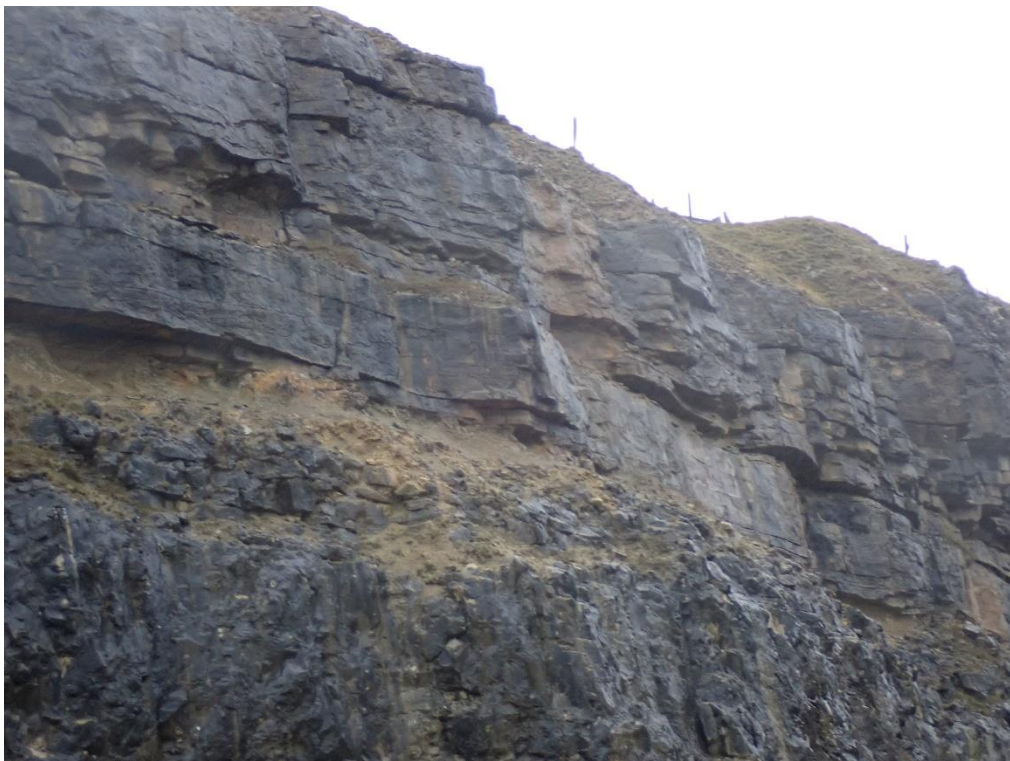
Plate 29: Weathering / erosion of the weaker material undercutting the upper section of the face.

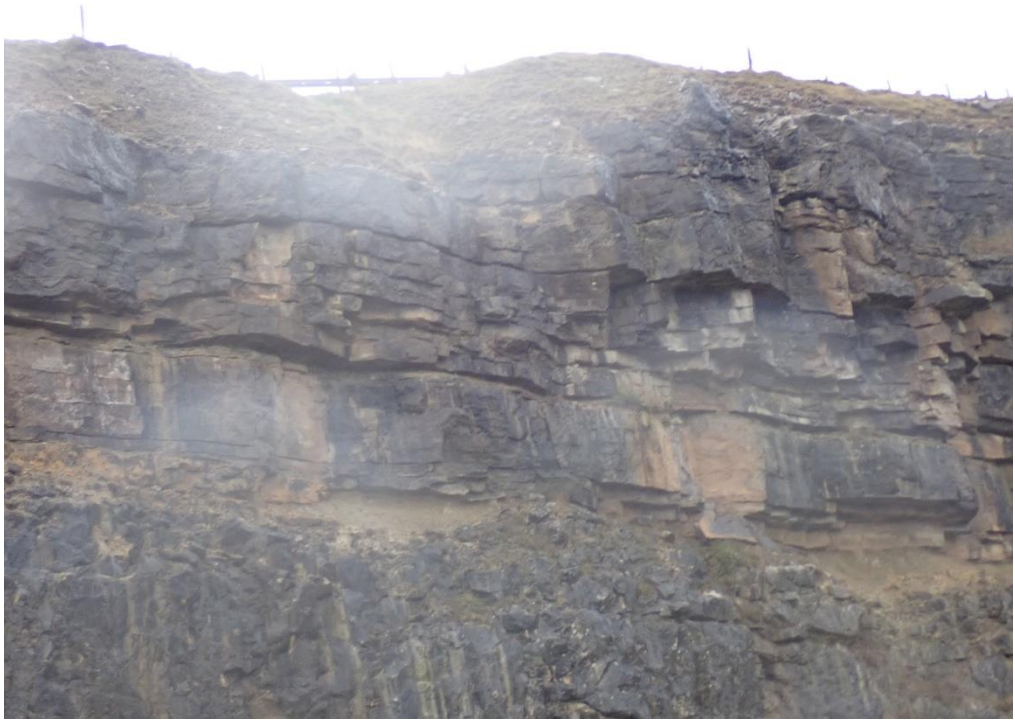
Plate 30: upper rock section with rockfall debris on ledge of weaker materials (recent rockfall).
