Evidential Report Edition 3i:

Definitive Map Modification Order

TO ADD ROUTE, A TO G, FOOTPATHS 83 AND 84 CALDICOT TO THE DEFINITIVE MAP AND STATEMENT

The Seawall

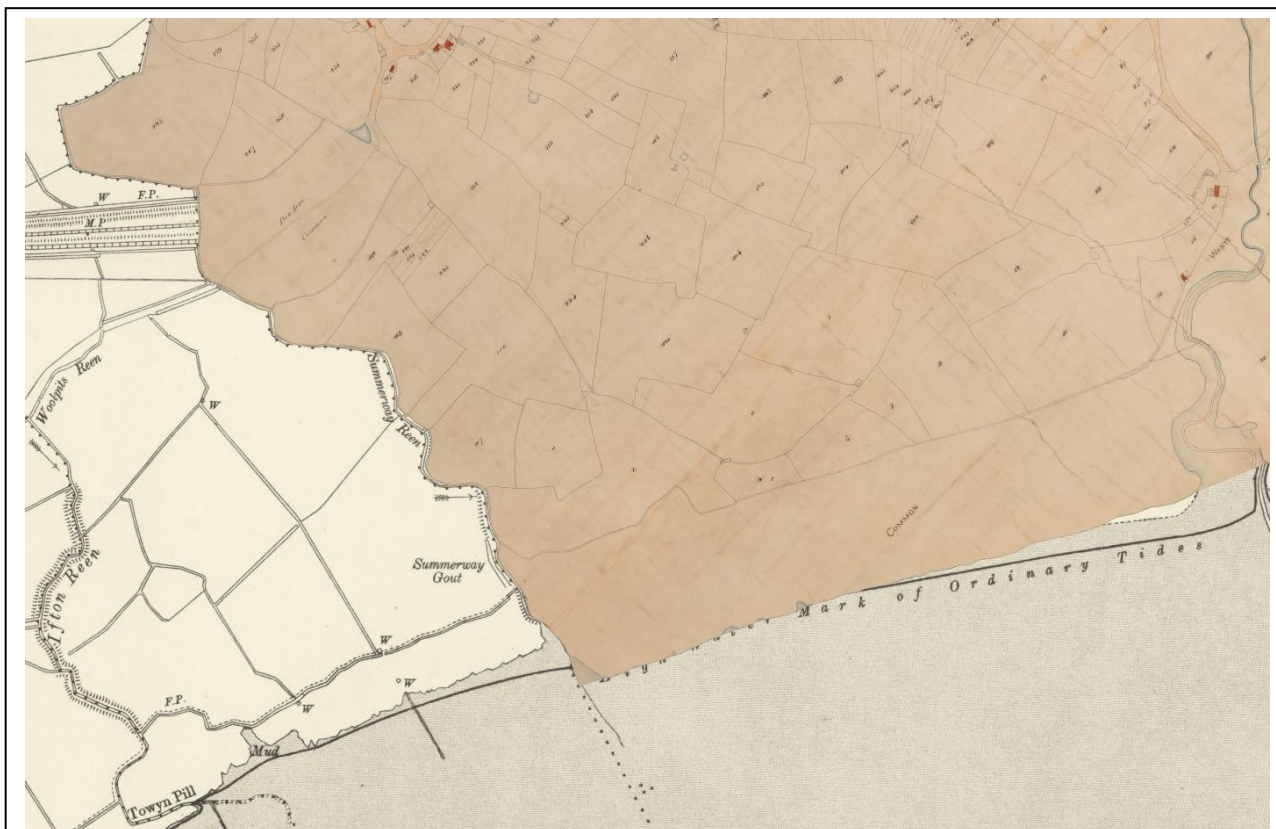
Fig. 6.5: (1902 OS map on the left, no tithe map available) | 1843 Tithe Map Caldicot on the right: not to scale. NLW-online

6.7. The 1843 Tithe Map for Caldicot (Fig. 6.5) held by the National Library Wales, online view, suggests the alignment for FP 6 Caldicot. There are roads shaded brown and rivers shaded blue on the 1843 Tithe Map. However, other maps need to be studied together with this one to best interpret the depiction of the feature along the northern boundary of the area marked “Common”. The double parallel lines mark a similar alignment for the road, previously observed on the 1830s maps, but it is not shaded in the conventional way for roads. However, the 1858 Tithe Map (Fig.6.7) does show this feature shaded blue for the depiction of drains.

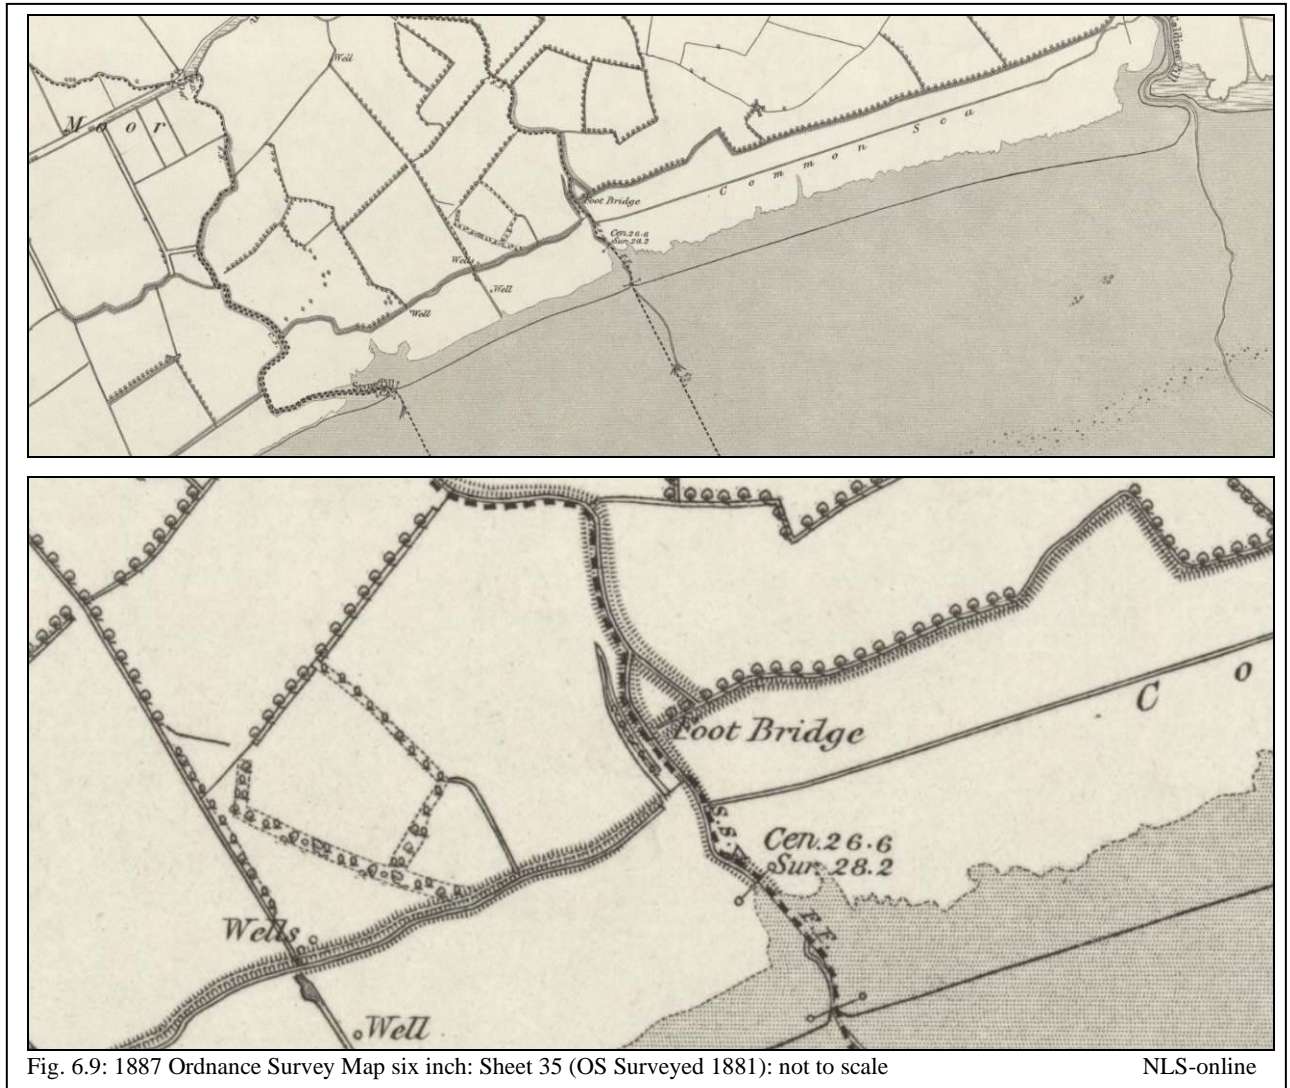
Fig. 6.9: 1887 Ordnance Survey Map six inch: Sheet 35 (OS Surveyed 1881): not to scale

6.12. The 1887 Ordnance Survey Map, Sheet 35, (OS surveyed: 1881) (Fig. 6.9), shows the drains with black solid lines marked on the same alignments as depicted on the 1843 Caldicot Tithe Map and the 1858 Caldicot Parish (Copied Tithe) Map. Parallel to this is also marked a raised feature illustrated by short black triangles along with the words “Foot Bridge” suggesting that the raised feature has a footpath along it.

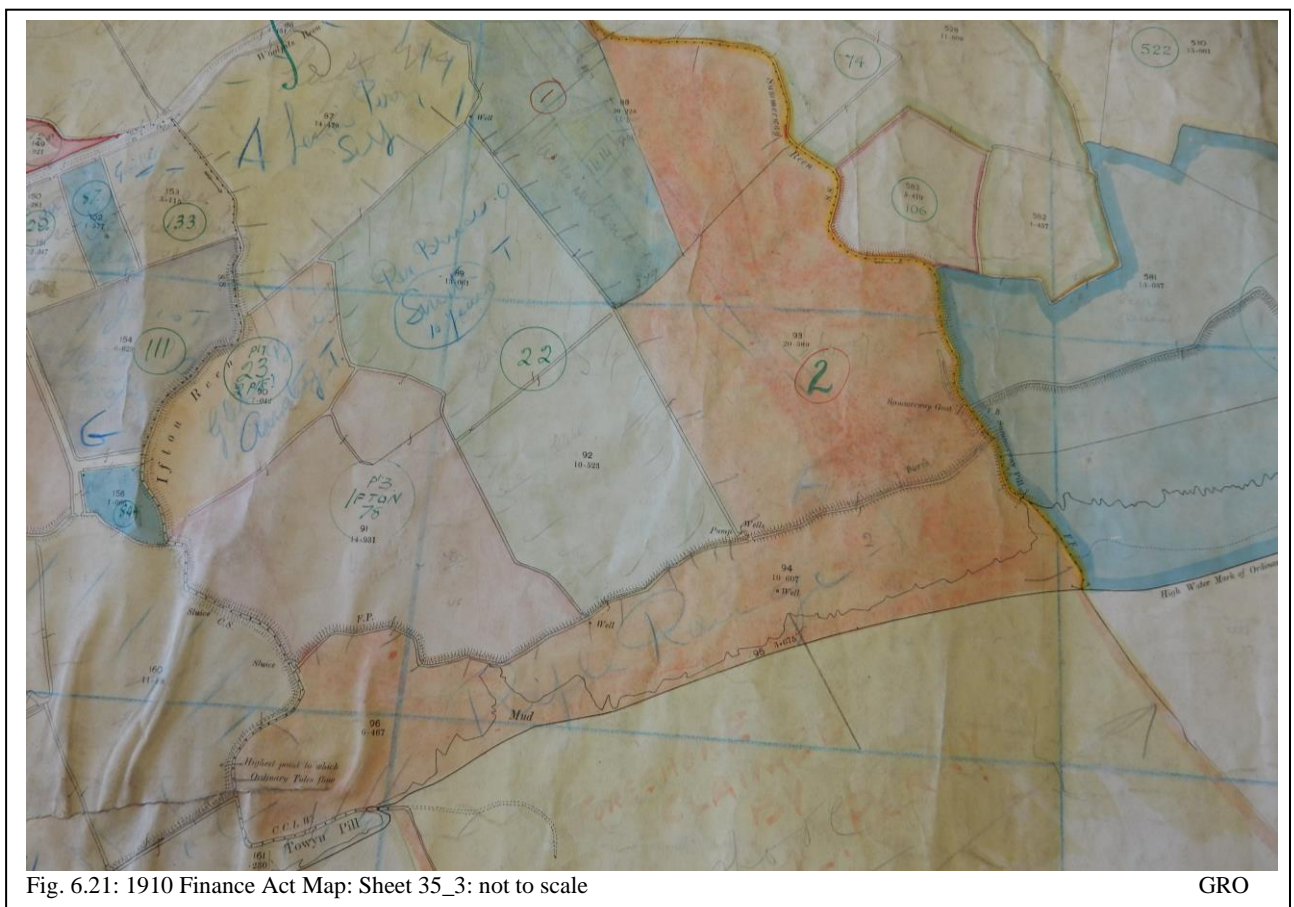
- 6.31. The 1910 Finance Act Map, working sheet 35.3 (Fig. 6.21) does not show the Route in question as 'uncoloured' or 'white out'. This means that when this map is taken together with all the historical information investigated it is reasonable to determine that there are no public vehicular or equestrian rights.

- 6.32. The 1910 Finance Act map working sheet 35.3 has the words "Butts" and "Rifle Range" marked in pencil across the plot numbered 2. This indicates the location of the Rifle Range in 1909-1910 which precedes the start of the First World War in 1914.
- 6.33. The base map for the 1910 Finance Act map is the 1901 Ordnance Survey Map (Fig. 6.12) and this shows the alignment of a footpath along with the symbols for footpaths "F.P." and footbridge "F.B.".
- 6.34. The Finance Act Register that references the plot numbers on the accompanying map has not been found at the Gwent Record Office for the community of "St Brides - Ifton Parish"

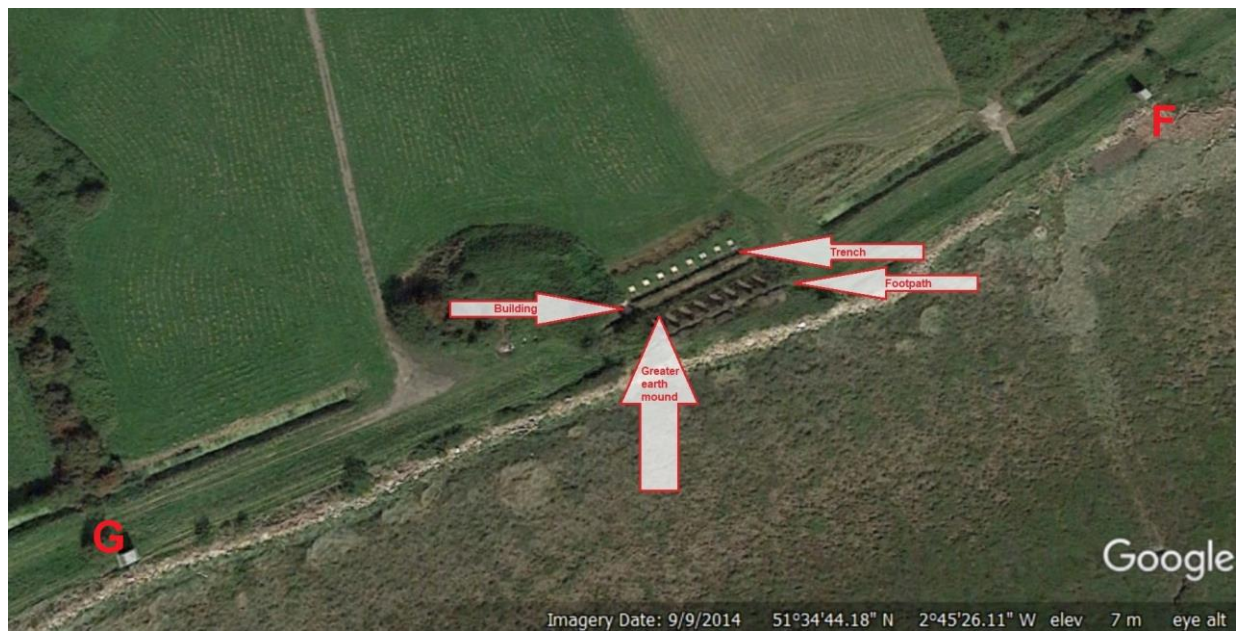
Photograph B:

9.23. The 2014 aerial photograph B has been marked up to show a building at the east end of the targets, a trench, the greater earth mound, and the used footpath that on this photograph has a dark line probably caused by the height of the vegetation on the seaward side.
