## Pwyllgor Trwyddedu a Rheleiddio

Item No	Item	Pages
1.	Ymddiheuriadau am absenoldeb.	
2.	Datganiadau o Fuddiant.	
3.	Deddf Bywyd Gwyllt a Chefn Gwlad 1981 – Adran 53 Gorchymyn Addasu Llwybrau Map Diffiniol, A i G, Llwybrau Troed 83 a 84 Cil-y-coed – Mur y Môr.	1 - 148

1.	Introduction: Background
2.	Legal Basis3 - 5
3.	Land registry6
4.	Objections7
5.	Pre-Order Consultation
6.	Evidence – Historical Maps
7.	Definitive Map and Statement
8.	Historical maintenance
9.	Aerial Photographs
10.	Site Photographs
11.	User Evidence
12.	Summary
13.	Conclusion
14.	Recommendation

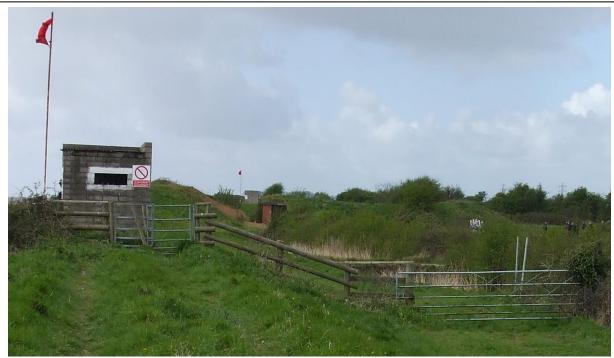
Photo A: Sentry box: Point F: 2008

It is noted that sentry boxes are situated at the east and west boundaries of both Rifle Ranges. In connection with this section of the Route, A to G, the sentry boxes for Severnside Rifle Range have lookouts both directed seawards and overlooking the alignment of the Route that is along the crest of the sea wall. (Fig. 5.1). Furthermore, the sign directed to the walking public is on the wall of the sentry box that is facing any on-coming walkers beyond a kissing gate. Alternatively, the sign is not on the wall that is facing out to sea (Fig. 5.1: Photograph A).

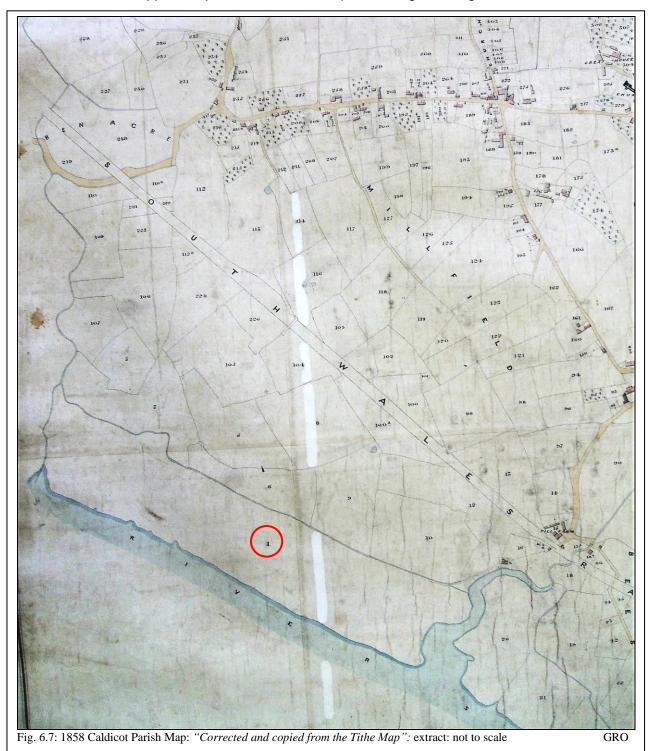
- 6.10. The "Map of Caldicot Parish, Monmouthshire, 1858. Corrected and copied from the Tithe map by J P Williams" (Fig. 6.7), shows clearly the roads shaded brown and highlights in blue the parallel lines bounding the northern side of the area referred to as "Common" marked with the number 1 (circled in red on Fig. 6.7). The Common land has been previously recorded on all historical maps examined so far. When this map is compared with the 1830s maps it shows that there are now no roads in the area and the drains are marked by parallel lines and shaded blue.
- 6.11. The combination of both the Tithe maps for Caldicot joined with no tithe map for Rogiet reduces the support for public vehicular or equestrian rights along or near the seawall.

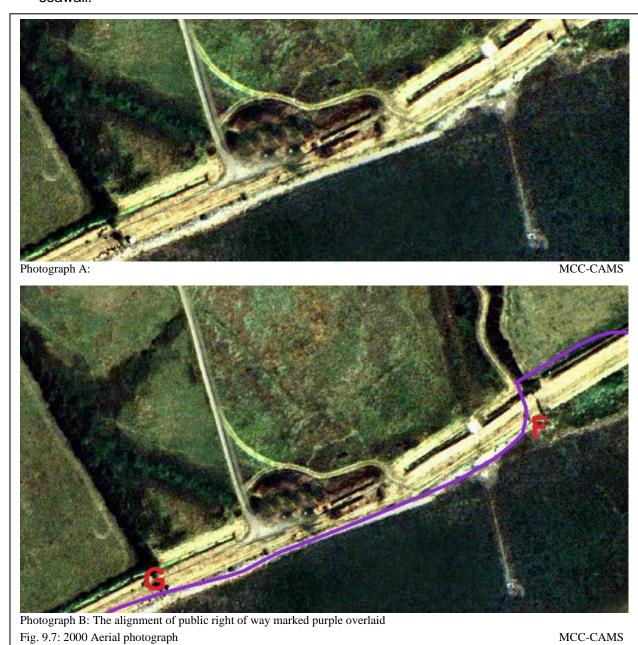
9.11. The 2000 aerial photograph B shows the alignment of the registered public right of way marked by a purple line. The clarity of this photograph is not good. However, the registered alignment is in part unavailable due to historic works altering the sea defences in the area.

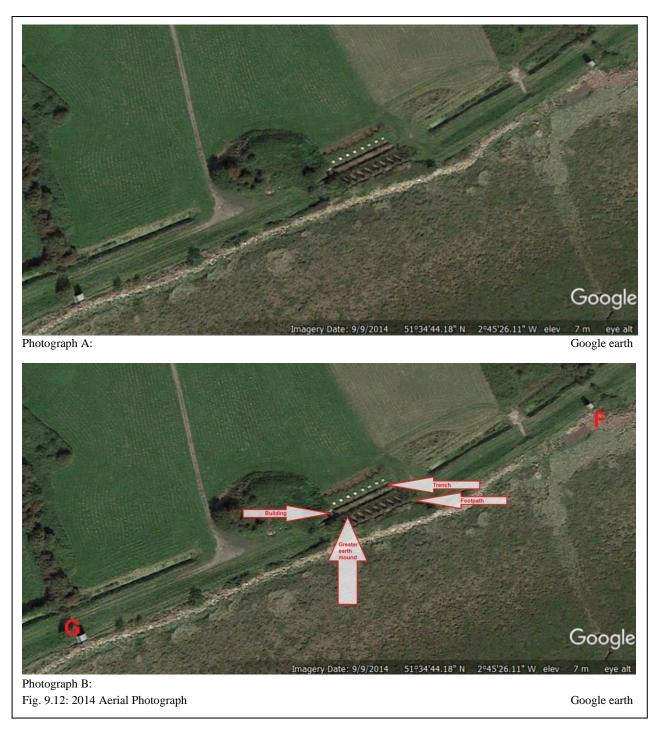
9.24. The 2014 aerial photograph B has been marked up to show a building at the east end of the targets, a trench, the greater earth mound and the used footpath that on this photograph has a dark line probably caused by the height of the vegetation on the sea ward side.

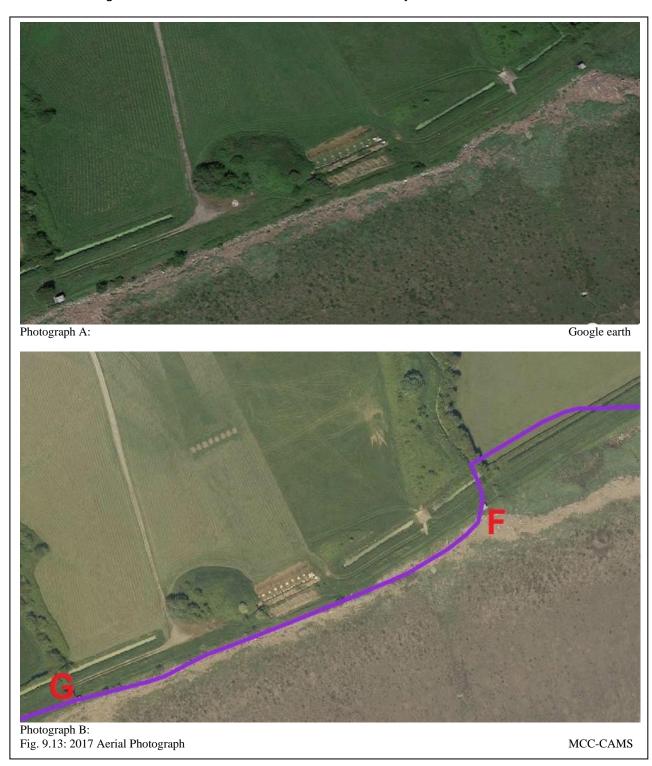
9.26. The 2017 aerial photograph B has the alignment of the registered public right of way marked by a purple line overlaid. This alignment is passing over land coloured brown indicating that it is in an area that is regularly affected by the sea tides.

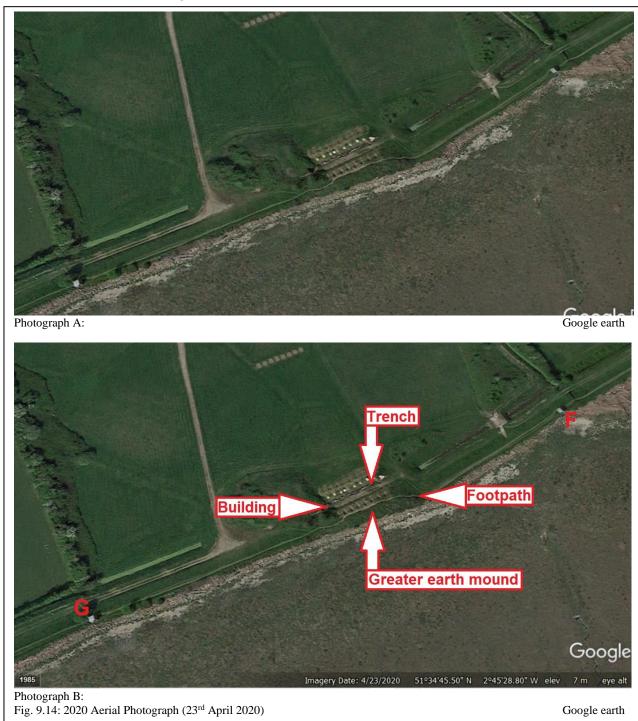
9.27. The 2020 aerial photograph (Fig. 9.14) again has less shadow. This photograph shows the more pronounced and narrow worn lines that indicate the walked alignment of the Route between points F and G the location of the sentry boxes. This worn line is also clearly shown to ascend the greater earth mound.

9.28. The 2020 aerial photograph B is labelled to show the location of the used footpath where it ascends the greater earth mound, the trench and the building. This aerial photograph shows that there has been regular use of the footpath on the crest of the seawall.
