Monmouthshire HWRC Compliance and Health & Safety Review

A high-level review of the HWRC network across Monmouthshire, with recommendations on measures that could be adopted to improve health & safety and permit compliance.

Document reference (please use this reference when citing WRAP's work):
[WRAP, 2019, Monmouthshire HWRC Compliance and H&S Review, Prepared by Eunomia Research & Consulting Ltd.]

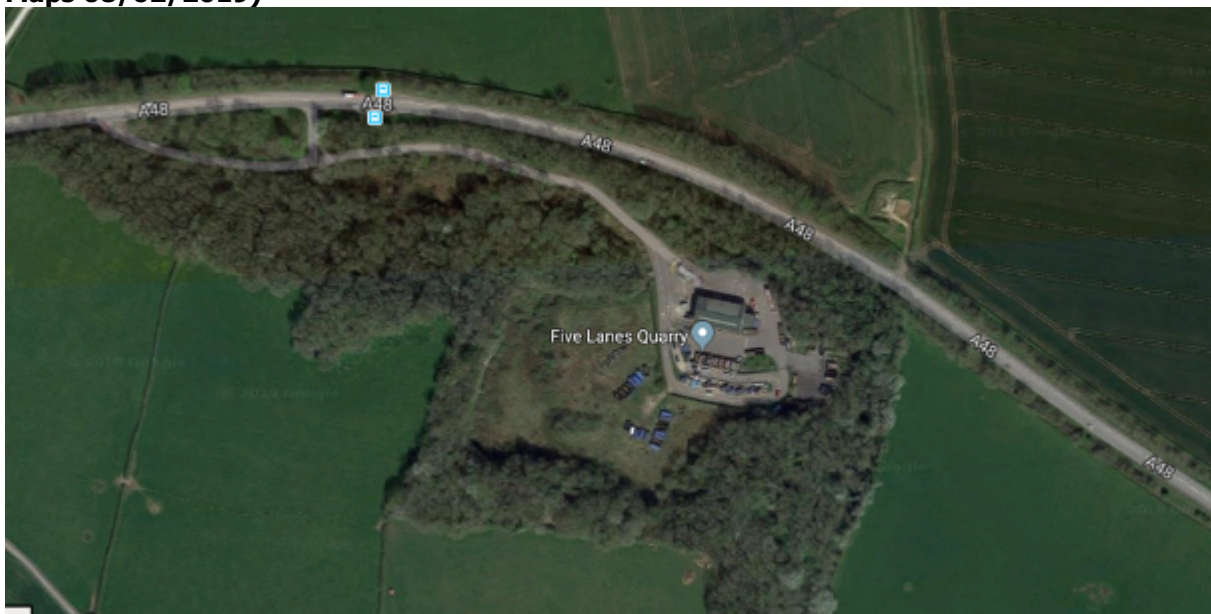
Figure 2: Overview of Five Lane HWRC and WTS Site showing site access road (Google Maps 08/02/2019)

The HWRC has good access from the highway (A48), Figure 2 shows the site and its access road in relation to the A48. Access is via a dedicated private gated access road which also serves the WTS (Figure 3). The access road is shared between traffic using the HWRC (cars, trailers and light vans) and that using the WTS (HGVs). During the time of the site assessment the site was quiet with no traffic queuing to enter the site. However, it is understood that at times when the HWRC is most busy site staff are deployed to manage HWRC user traffic on the access road to enable traffic to access the site safely. The access road is sufficiently long that traffic accessing the site has not queued onto the A48.

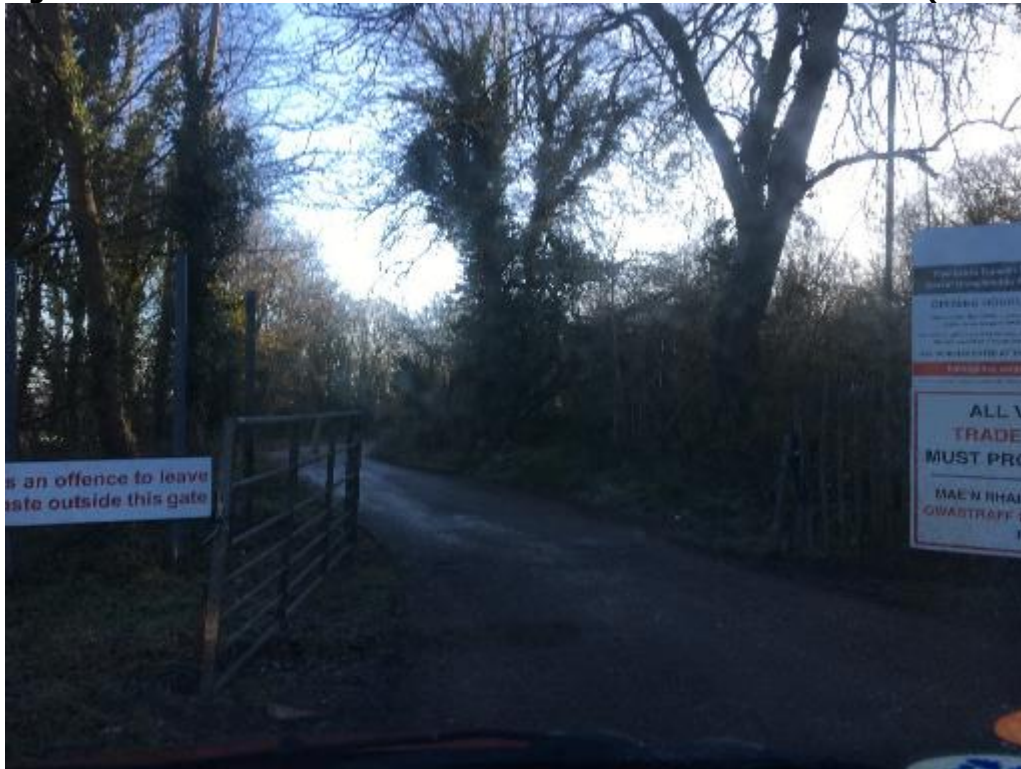
Figure 3: Five Lanes Site Entrance Gate and Site Information Boards (E.How 31/02/2019)

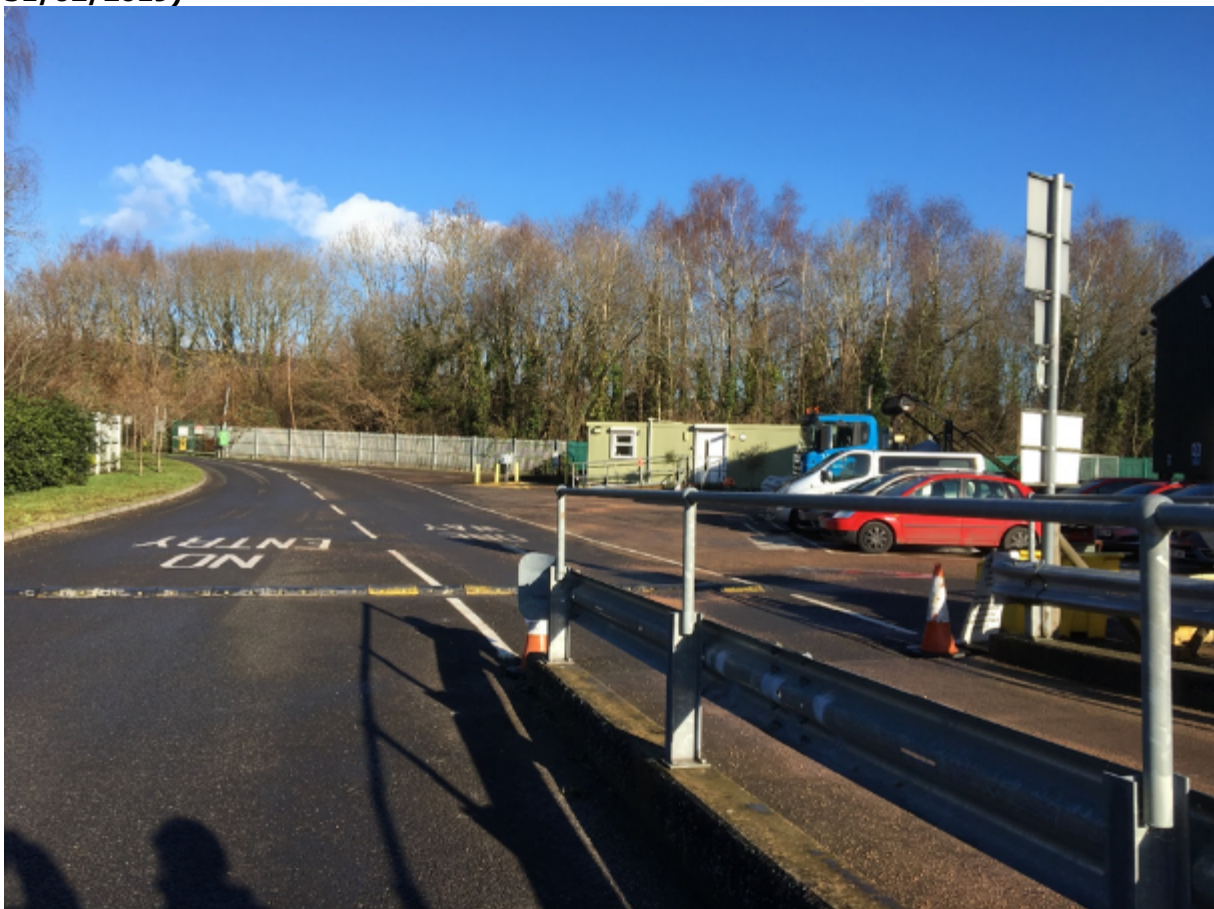
HWRC and WTS traffic enter the site via a share access then separate by the site office and weighbridge with WTS traffic continuing to the left of the building across the weighbridge and HWRC traffic passing to the right-hand side of the building, past the staff parking area and HWRC Yard Area before continuing up a access ramp to the HWRC Public Area. Figure 5 shows the main site entrance (left of the picture), the site office (green cabin), staff parking and entry/exit roads to/from the HWRC Public Area from the bottom of the access ramp to the HWRC Public Area.

Figure 5: Main site entrance, site office, staff parking and HWRC entry/exit (E. How 31/02/2019)

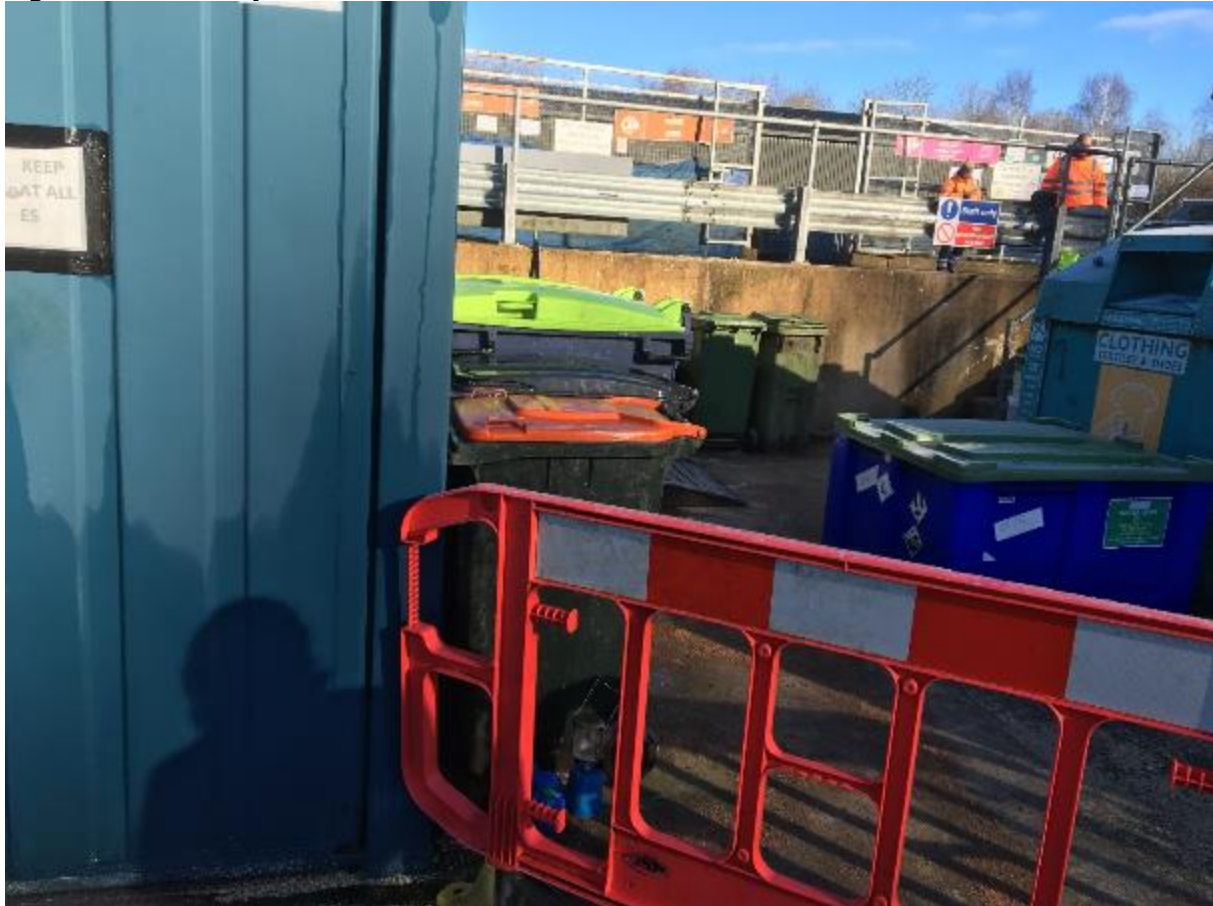
Figure 6: Staff Only Area

A designated crossing point is provided for to enable access to a small cordoned off area of the lower part of the site which is accessed via a flight of concrete steps. This area is marked by suitable signage as Staff Only. Site staff take smaller items such as waste oils, batteries and textiles from site users and separate them into appropriate containers within this area (Figure 6). This area of the site is cordoned off using movable plastic barriers along its lower boundary to prevent users from accessing the area themselves however the cordon is not sufficient to prevent users accessing the area.

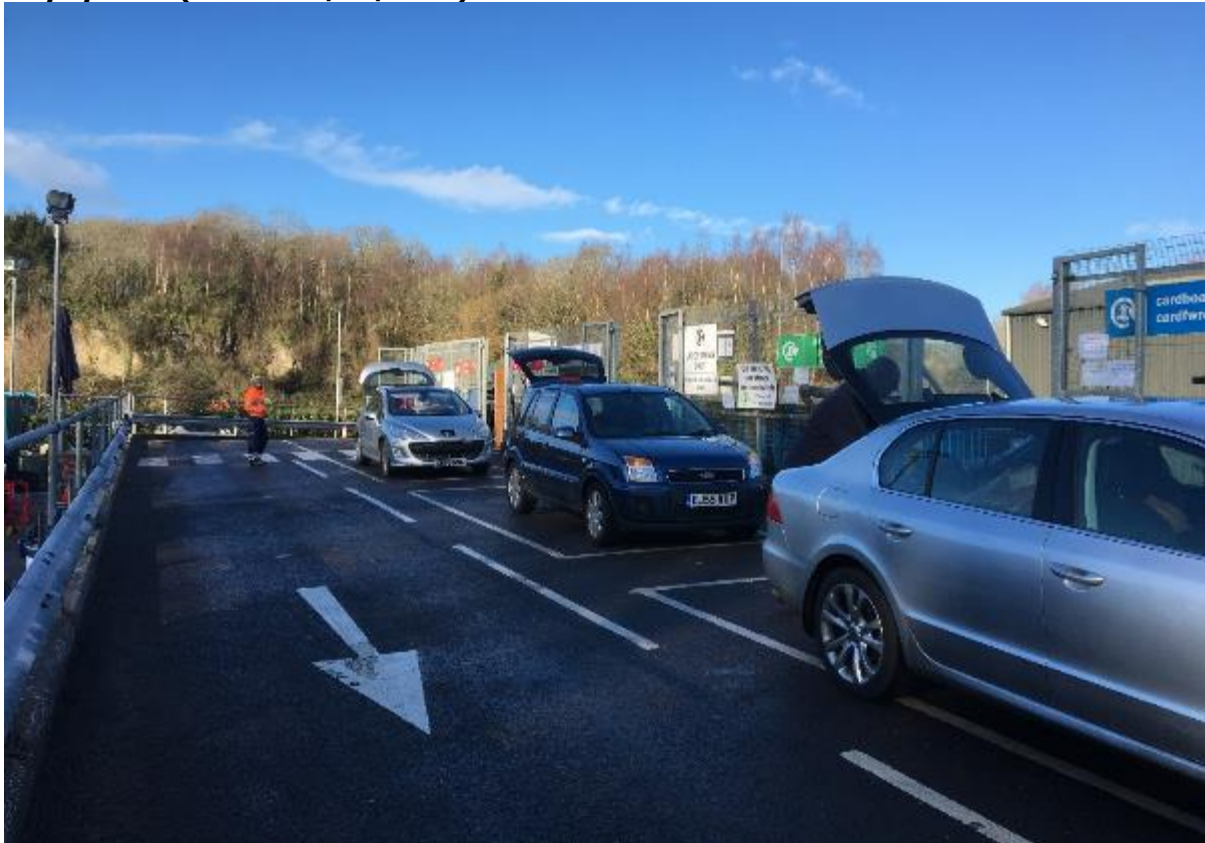
Designated parallel parking bays of sufficient length are provided on both the raised (Figure 7) and lower sections (Figure 8) of the site to enable users to park and unload their materials into the designated containers. The use of parallel parking bays reduces the need for site users to reverse their vehicles as they travel around the site.

Figure 7: Raised Section of The HWRC Public Area showing parallel parking bays and one way system. (E. How 31/02/2019)

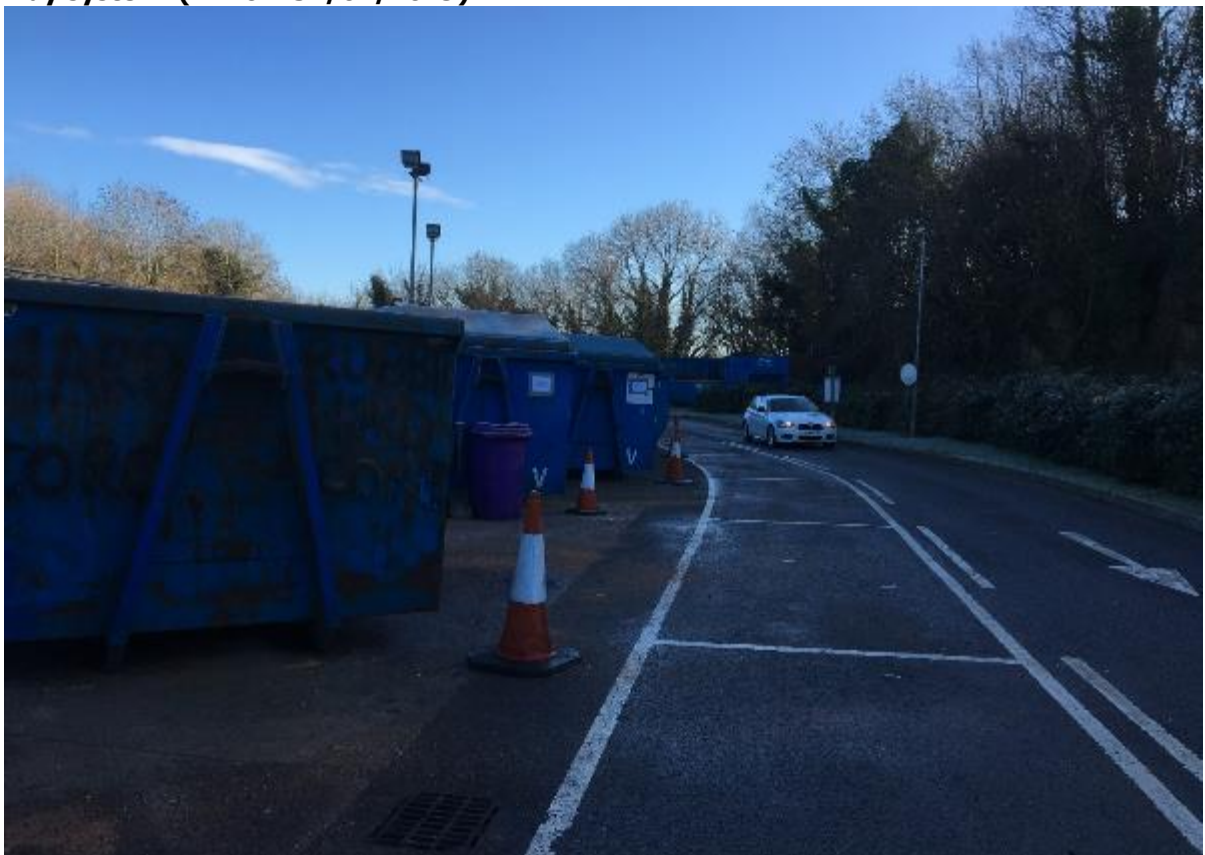
Figure 8: Lower Section of The HWRC Public Area showing parallel parking bays and one way system. (E. How 31/02/2019)

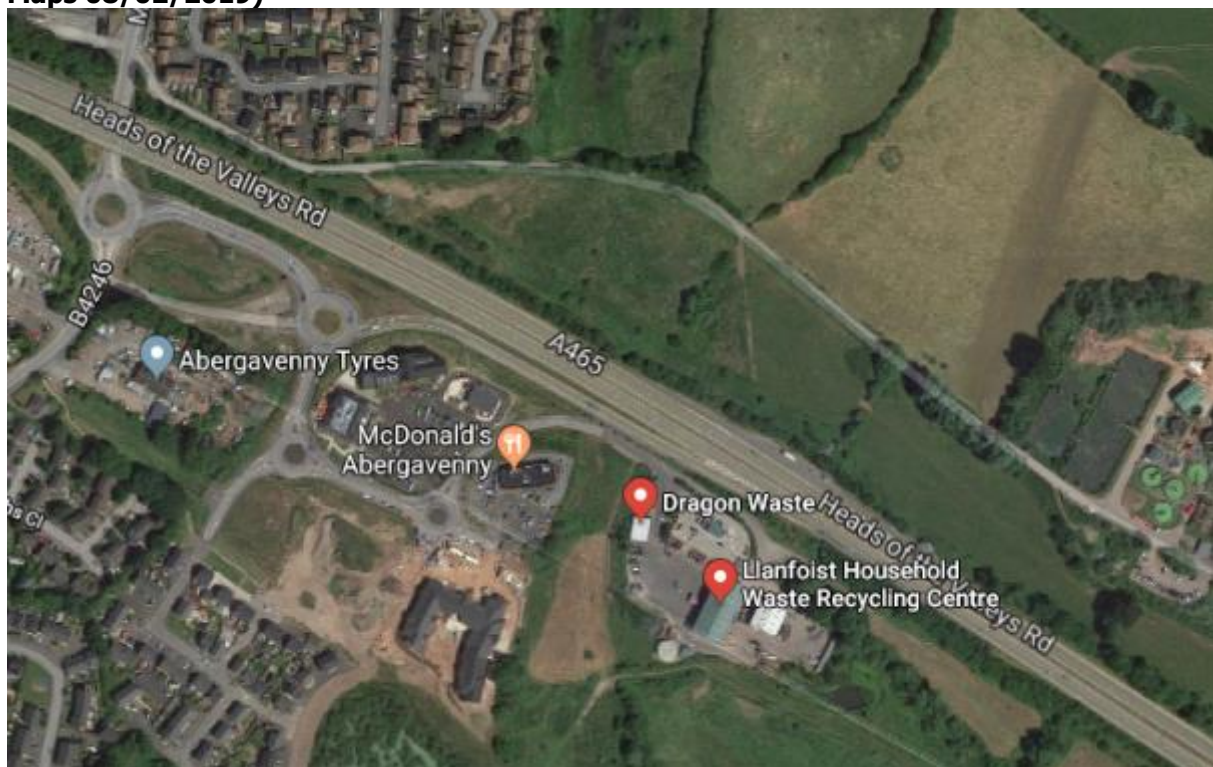
During the time of the site assessment the site was quiet with no traffic queuing to enter the site. It is understood that the access road is sufficiently long that traffic accessing the site has not queued beyond the roundabout by the adjacent McDonalds outlet and certainly not as far at the Heads of the Valleys Road.

Figure 9: Overview of Llanfoist HWRC and WTS Site showing site access road (Google Maps 08/02/2019)

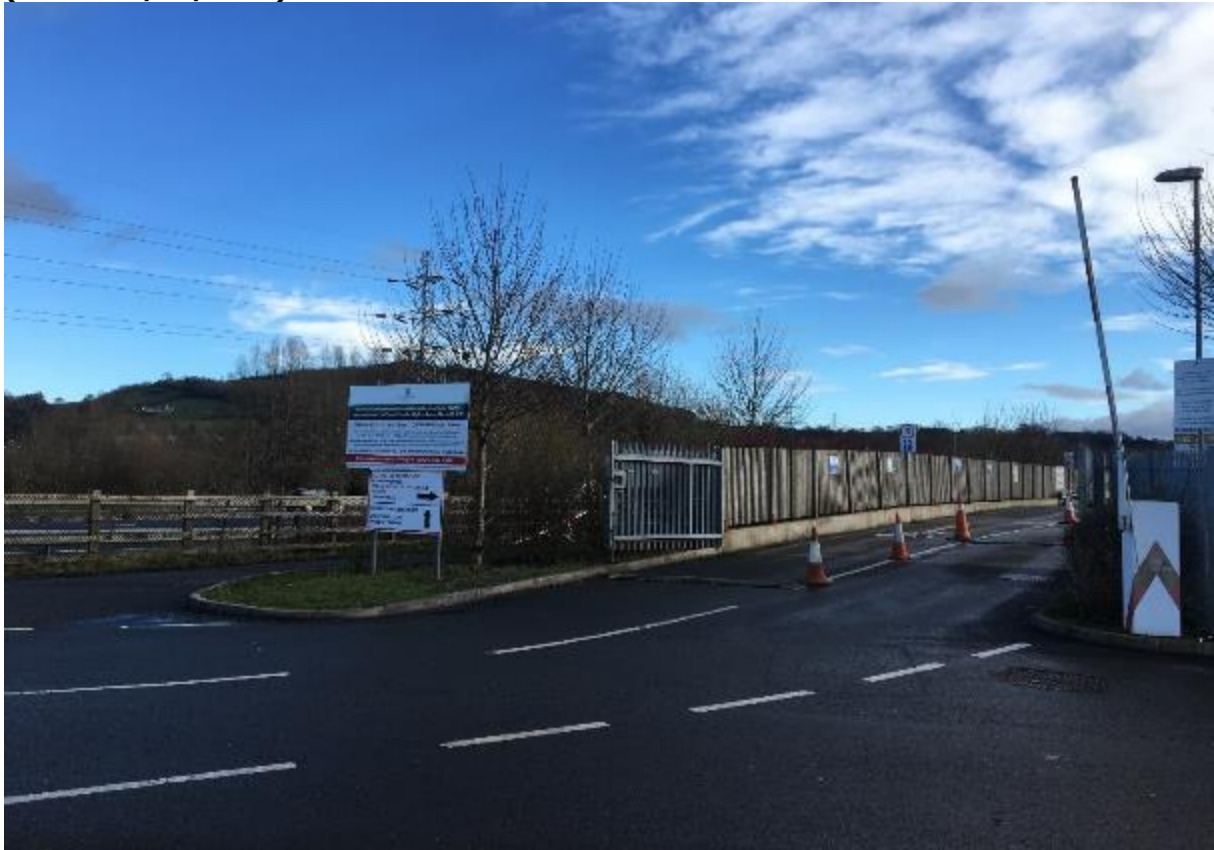
Figure 10: Llanfoist HWRC Public Entrance showing Site Sign and Traffic Information (E.How 31/02/2019)

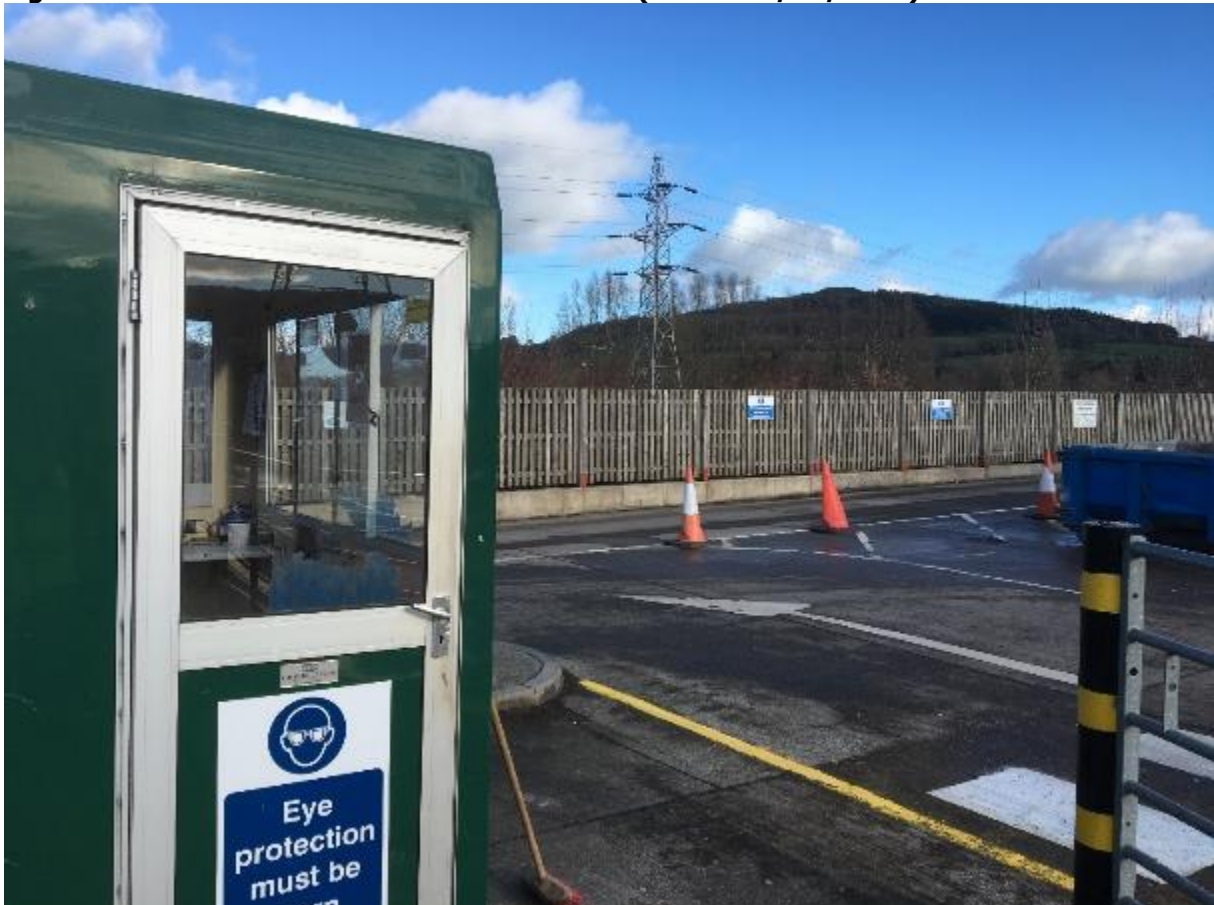
Figure 11: Public Exit from the Llanfoist HWRC (E.How 31/02/2019)

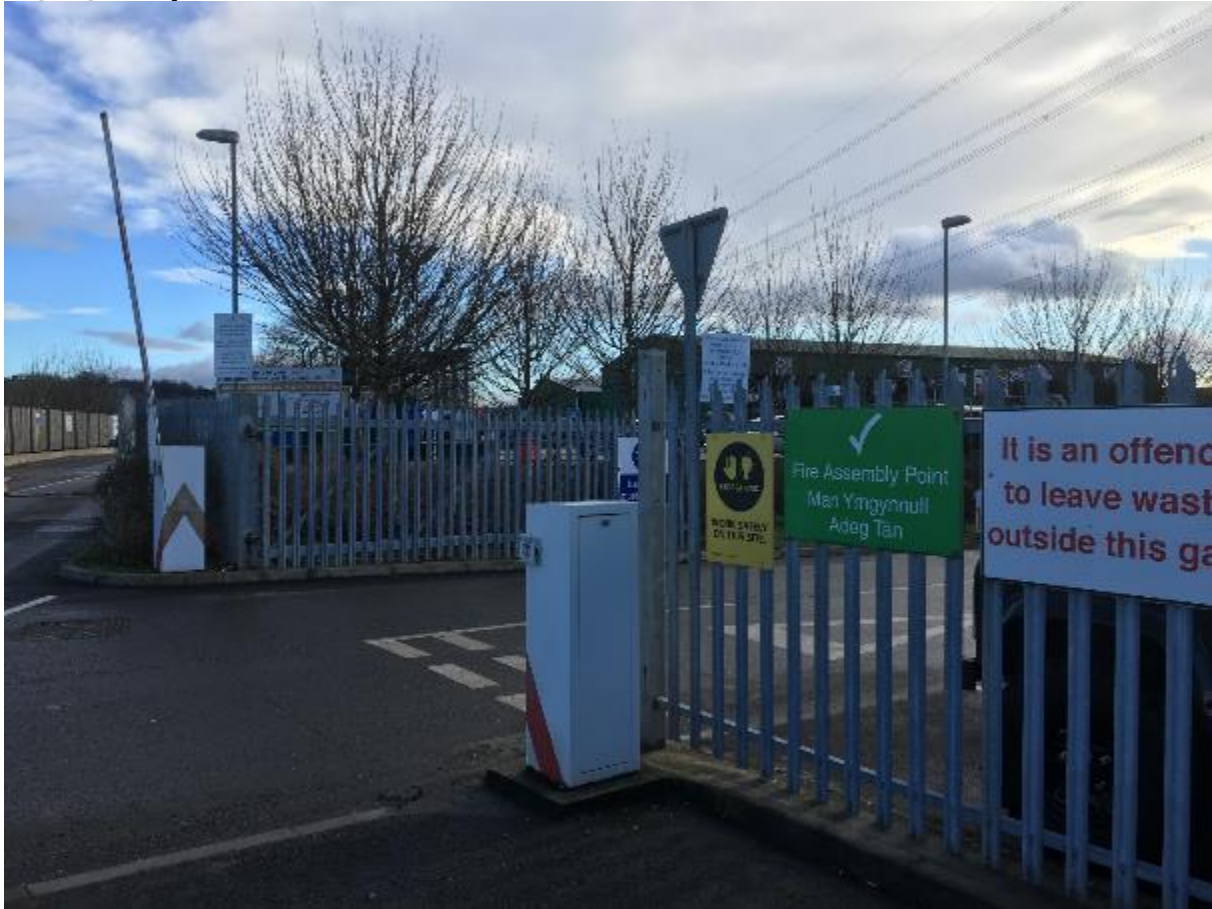
Figure 12: Separate Llanfoist WTS and HWRC Service Entrance / Exit (E.How 31/02/2019)

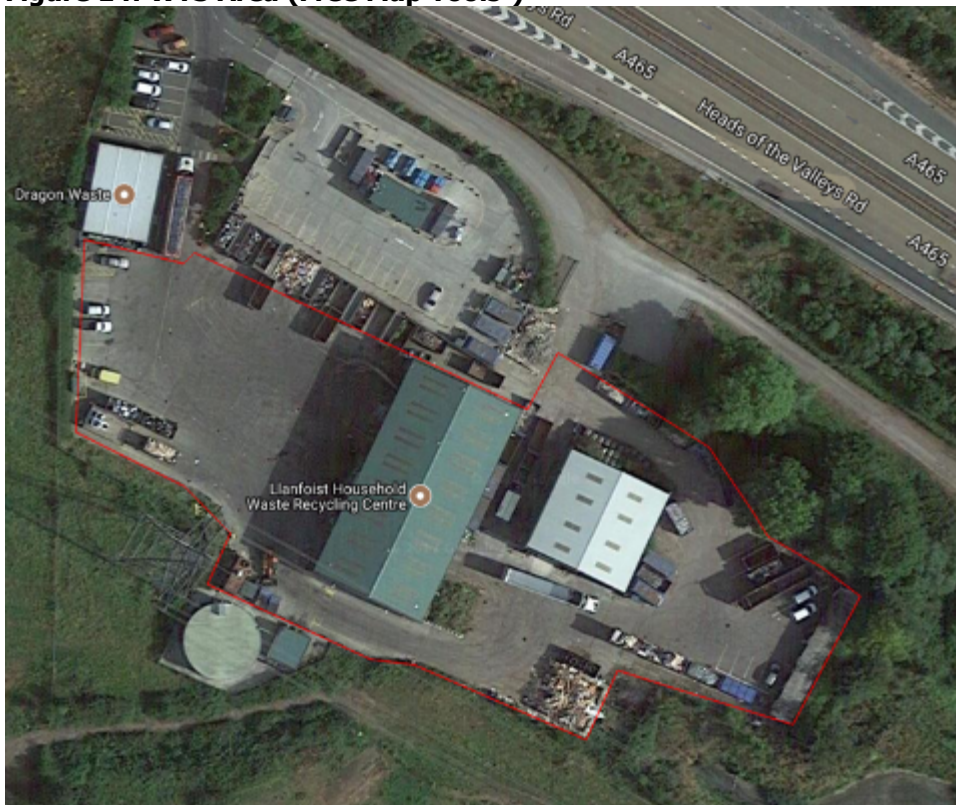
Figure 14: WTS Area (Free Map Tools³)

Figure 14 shows the site consists of an administration area which includes site office and weighbridge, public education centre buildings and staff parking in the north western portion of the site. The Household Waste Recycling Centre public area is located in the north-eastern portion of the site whilst the HWRC service area and WTS materials storage shed and container storage area is located within the red boundary line. The HWRC is of split level design.

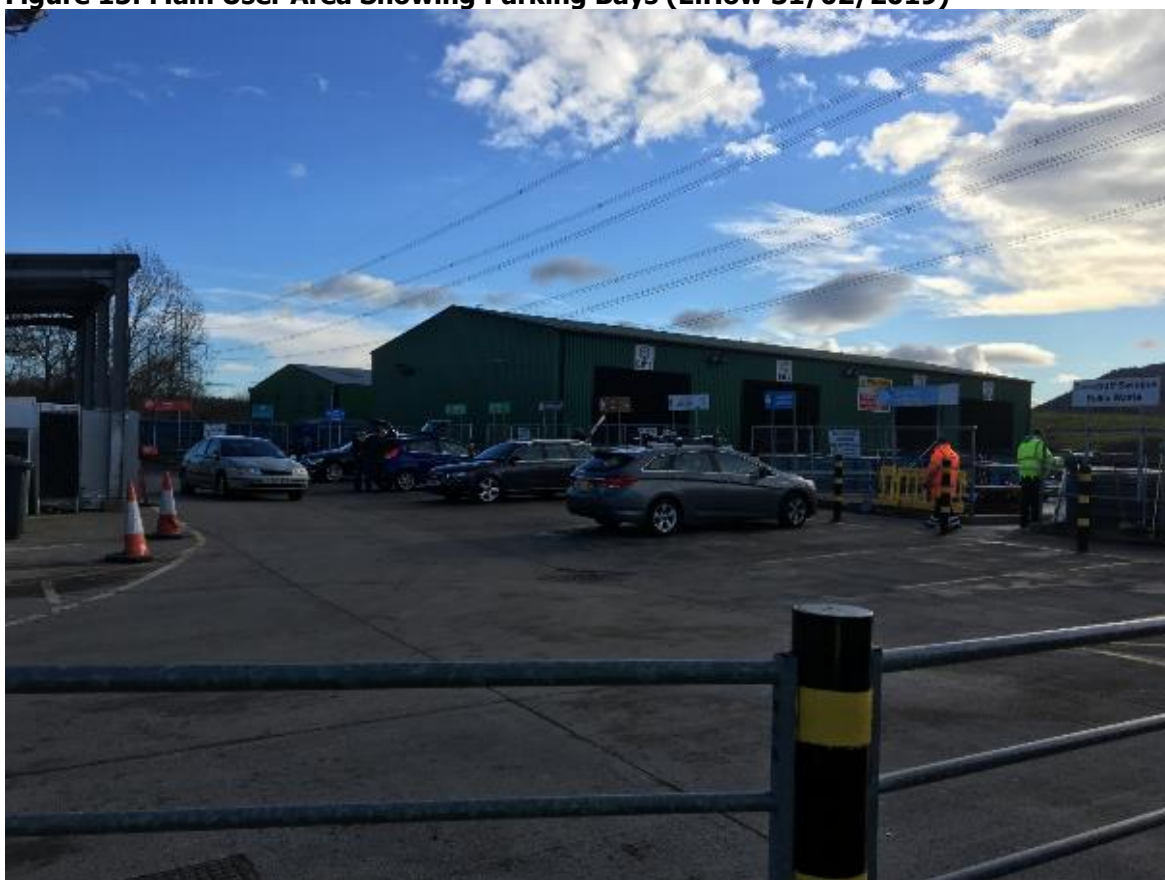
Figure 15: Main User Area Showing Parking Bays (E.How 31/02/2019)

Clear signage at the site entrance together with road markings including directional arrows and parking bays are provided. **The markings for the parking bays were worn in places and would benefit from being repainted.**

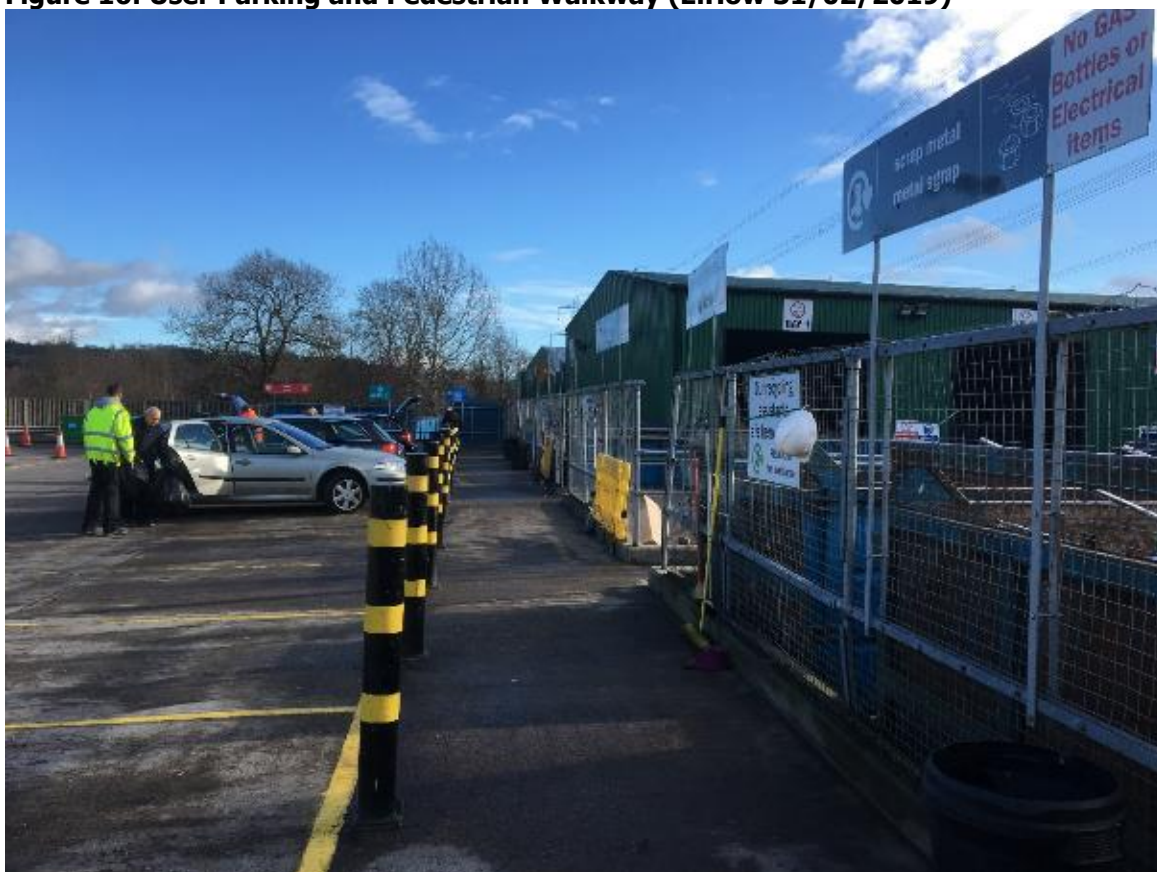
Figure 16: User Parking and Pedestrian Walkway (E.How 31/02/2019)

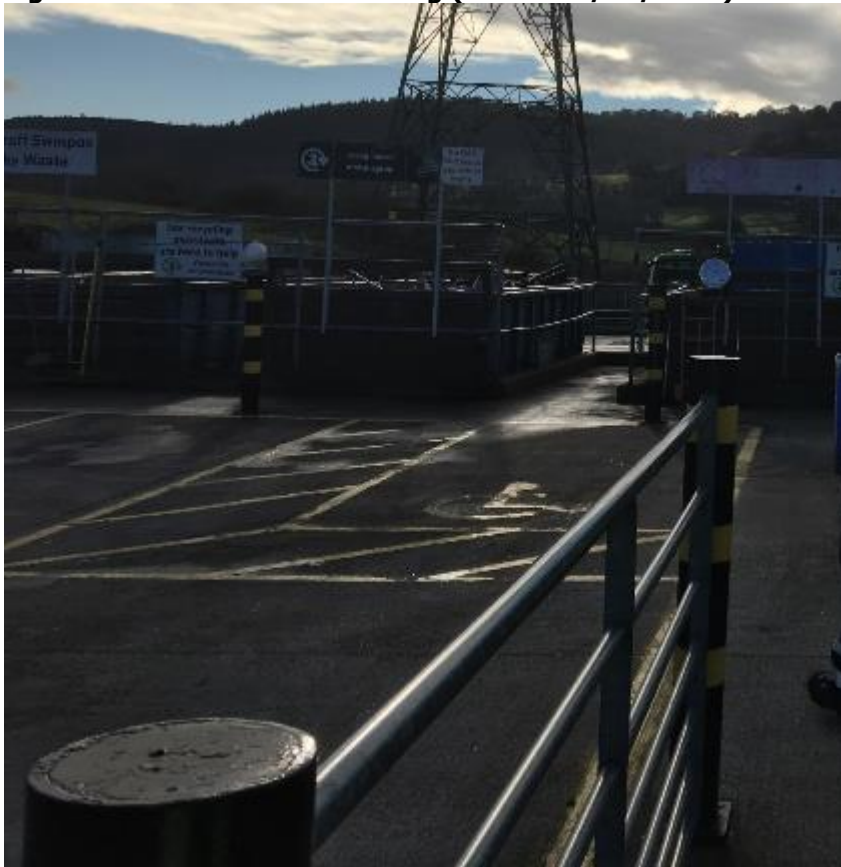
Figure 17: Disabled User Parking (E.How 31/02/2019)

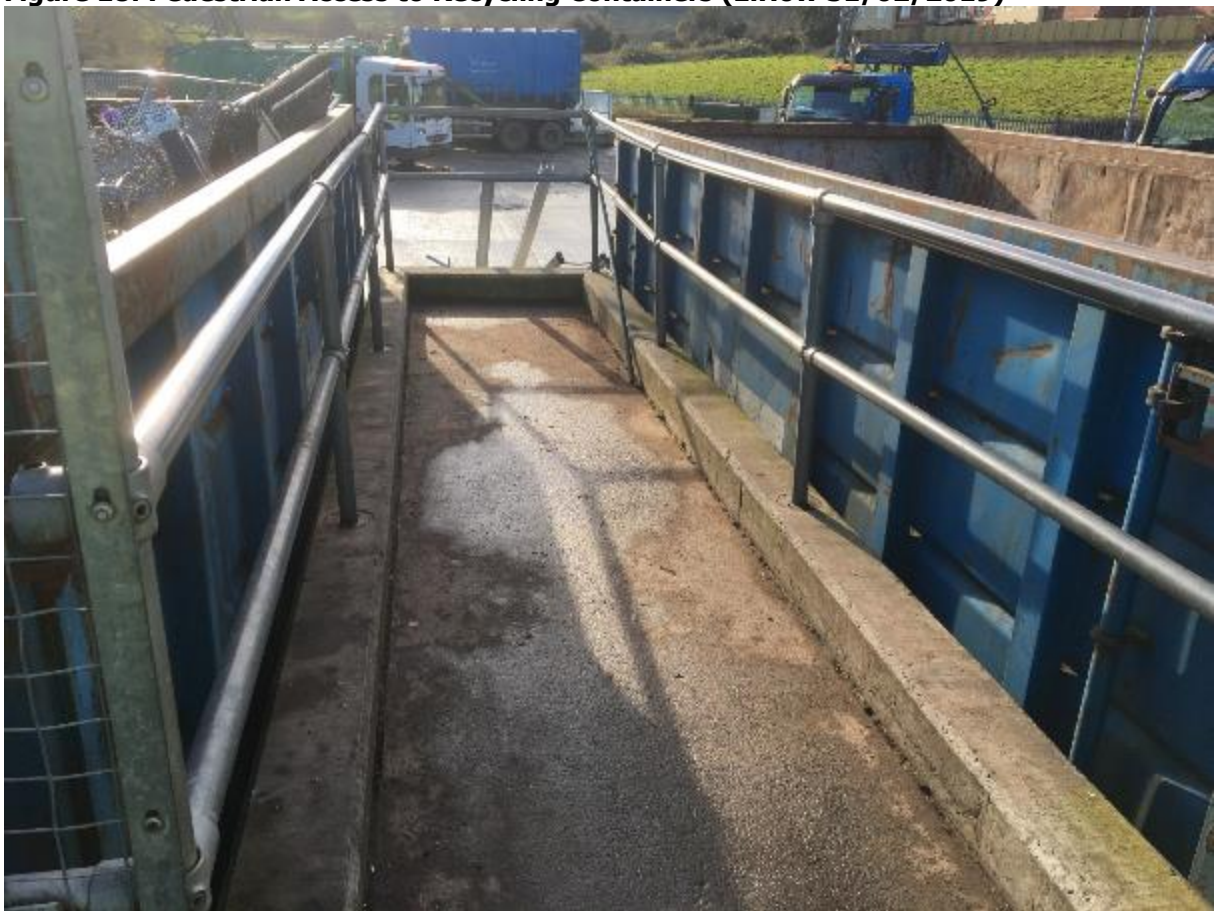
Figure 18: Pedestrian Access to Recycling Containers (E.How 31/02/2019)

The site would benefit from the use of lockable gates at the container access points as is in operation at the Five Lanes HWRC.

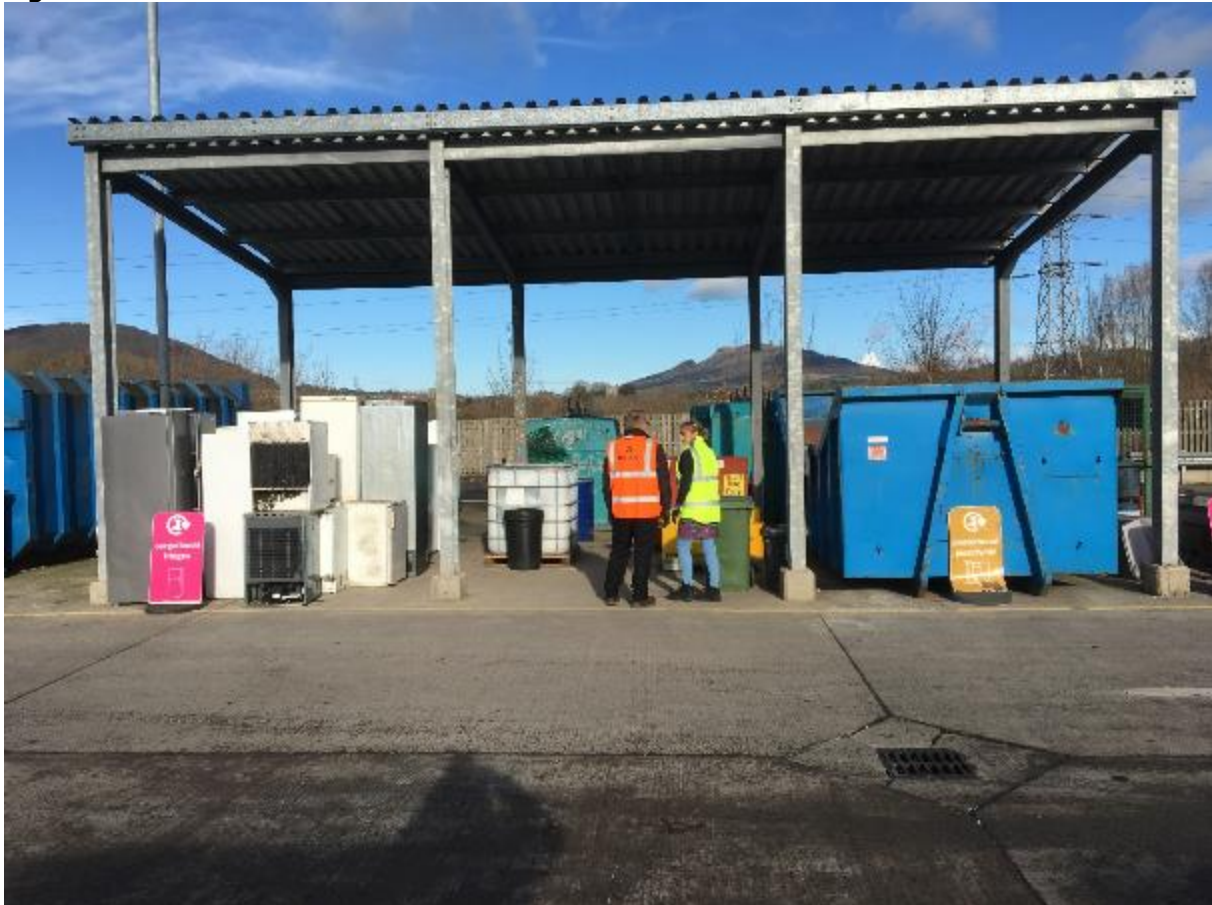
Figure 19: Central Covered Area

A central covered area is provided opposite the roll-on-roll-off containers for users to deposit a range of smaller materials such as textiles, batteries and also plasterboard and large WEEE (Figure 19). Currently there is no dedicated pedestrian route from the parking bays to this area and this combined with the need for users to either reverse in to or out of the parking bays increases the risk to pedestrian from reversing vehicles. **As already noted, consideration should be given to remarking the parking bays to enable parallel parking. Again, as previously noted, in considering this option the risks associated with lower user throughput including those associated with queuing traffic, users rushing and being less safe, should be considered.**

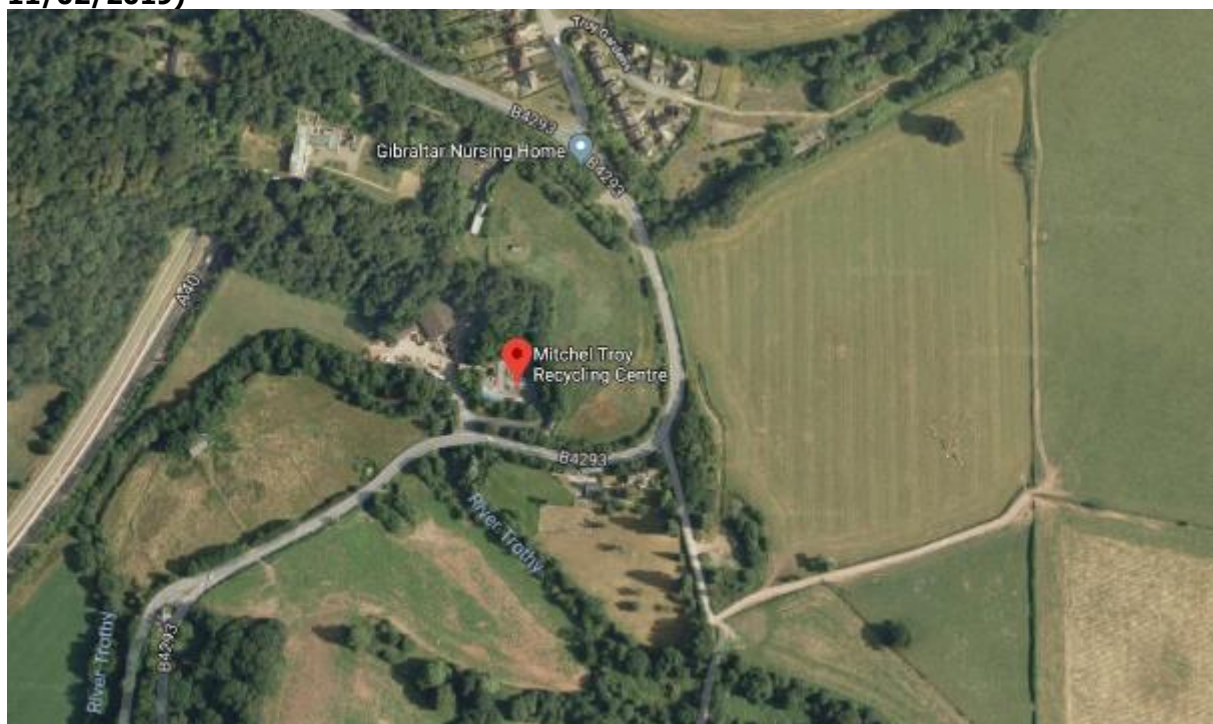
Figure 20: Overview of Mitchel Troy HWRC showing site access road (Google Maps 11/02/2019)

Figure 20 shows the site and its access road in relation to the surrounding road infrastructure.

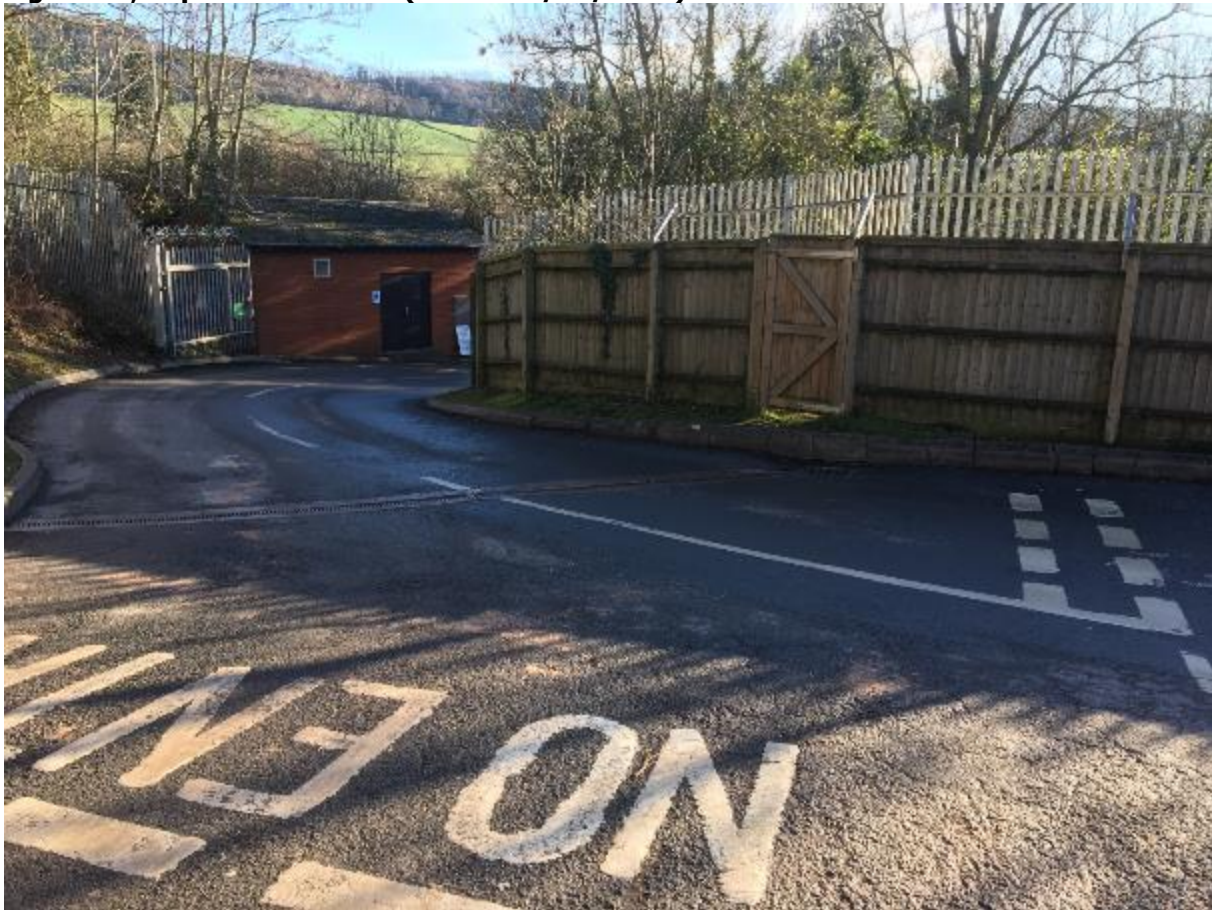
Figure 21 shows the top set of access gates to the site; a further set of gates are located at the beginning of the access road. These gates enable the site to be closed to users when site operations are being undertaken during opening hours.

Figure 21; Top Entrance Gate (E.How 31/01/2019)

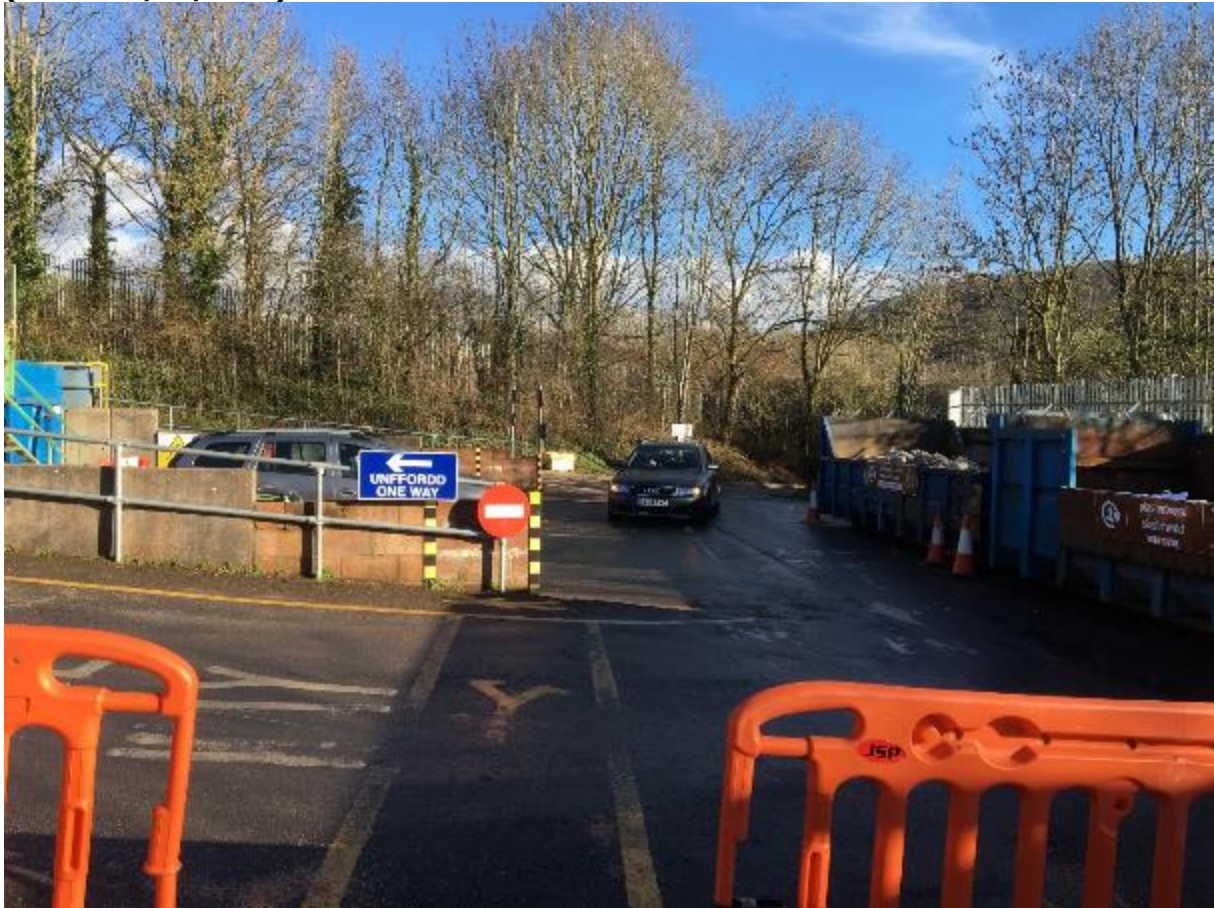
**Figure 23: User vehicles Parked in front of the Roller-Packer machine (to the right)
(E.How 31/01/2019)**

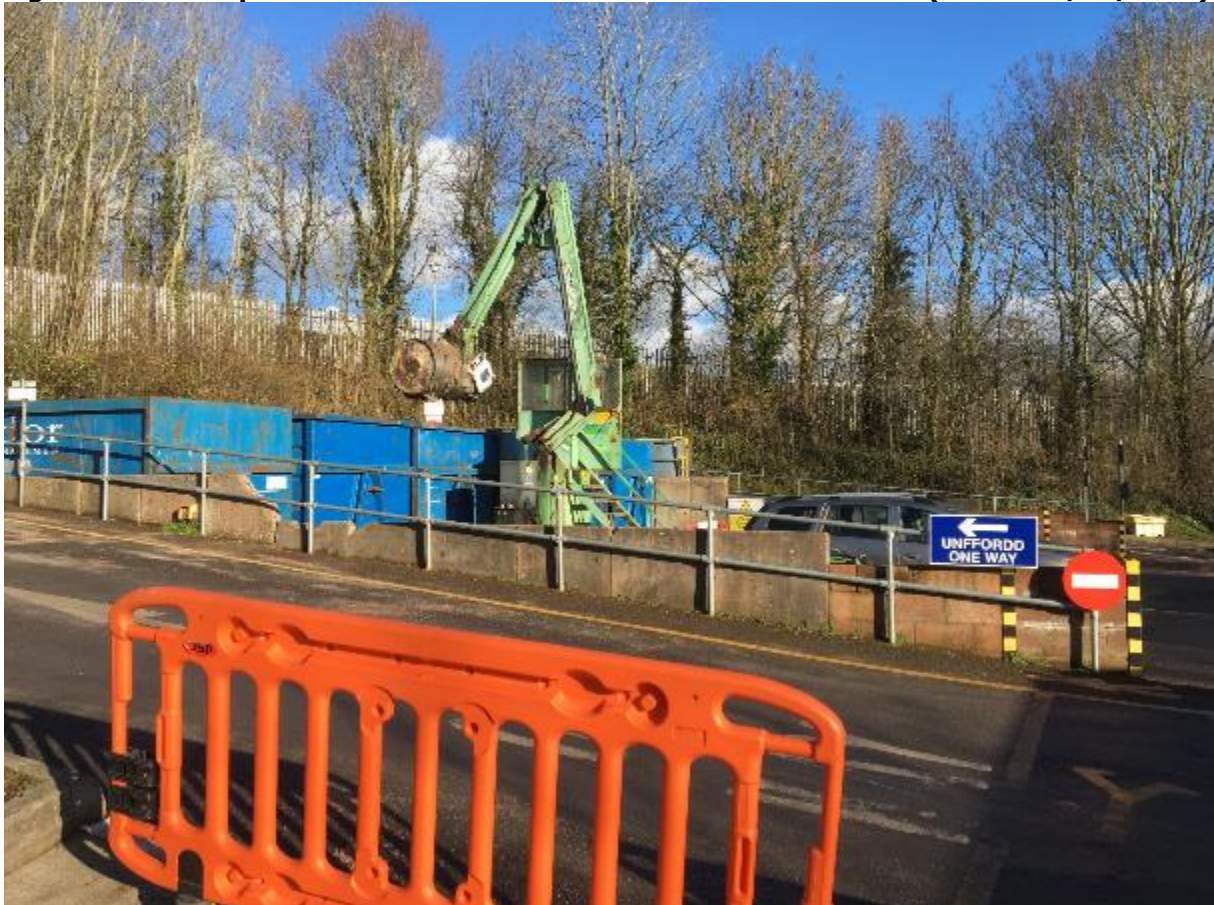
It is understood that the site is closed between four and five times per day at peak times for compaction to take place. This operation can take up to 45 minutes to complete as the roller-packer machine, which was installed in 1993, operates slowly. In addition, between three and four container changes per day can be required at peak times; taking between 25 and 30 minutes to complete each time. Where possible these two operations are undertaken at the same time to reduce down-time however there can still be a considerable amount of site down time during peak times. This causes frustration for users as the nature of the surrounding road infrastructure means that it is unsafe for traffic to queue leading to staff turning users away from the site. Downtime therefore needs to be minimised as much as possible.

Figure 24: Roller-packer Machine Located in the Centre Service Area (E.How 31/01/2019)

- The site would benefit from having compaction units on the general waste, cardboard, garden waste and wood containers and the relocation of the scrap-metal container to the current location of the garden waste container. Although an alternative option would be for a modern roller-packer machine to be installed that is capable of operating at a quicker speed there would still be down time associated with its use.
- In addition, the site would benefit from having the road markings refreshed especially at the lower section of the site where they are most worn.

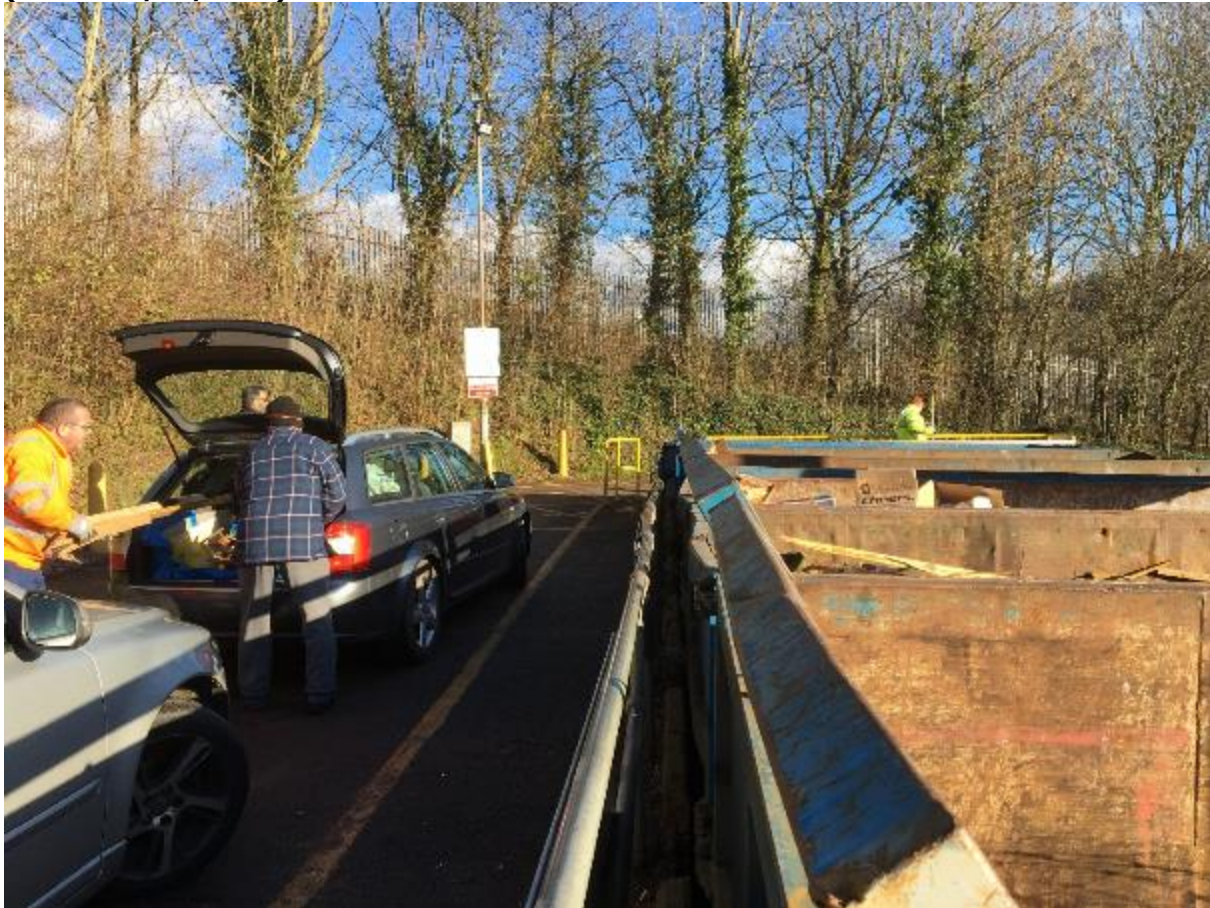
Figure 25: User Vehicles Parked in Parallel Bays and Dedicated Pedestrian Walkway (E.How 31/01/2019)
