Monmouthshire HWRC Compliance and Health & Safety Review

A high-level review of the HWRC network across Monmouthshire, with recommendations on measures that could be adopted to improve health & safety and permit compliance.

Document reference (please use this reference when citing WRAP's work):
[WRAP, 2019, Monmouthshire HWRC Compliance and H&S Review, Prepared by Eunomia Research & Consulting Ltd.]

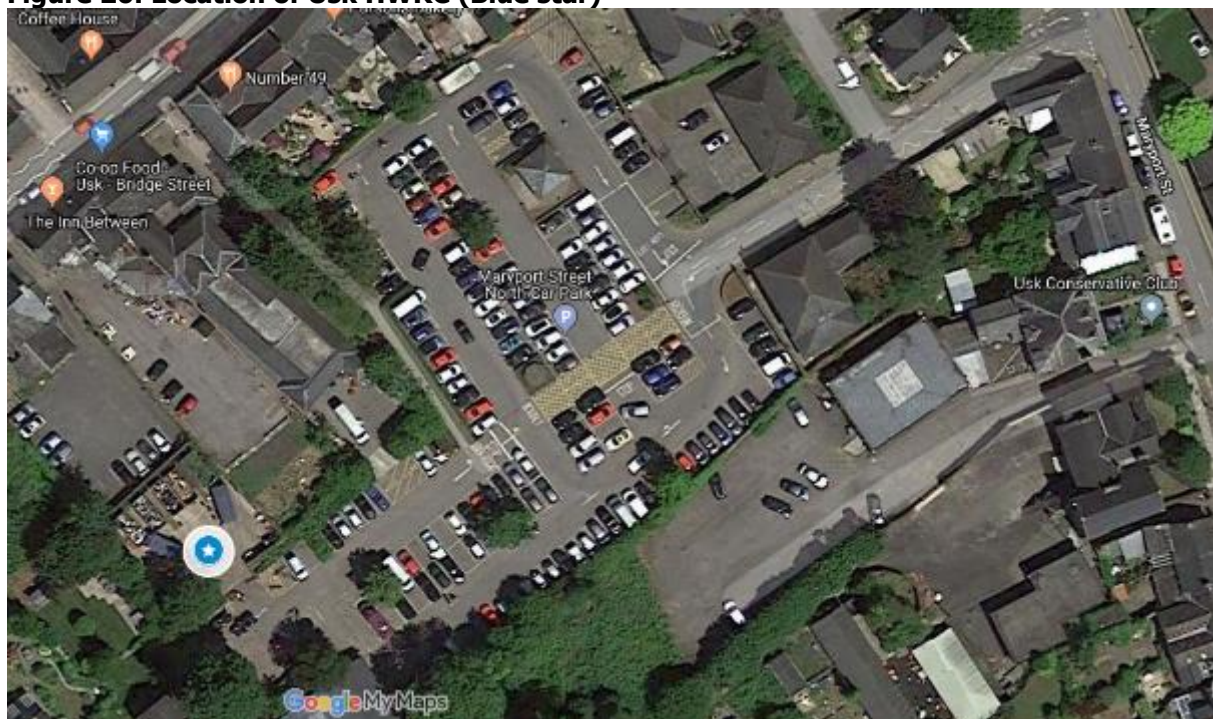
Figure 26 shows the site and its access road via the car-park in relation to the surrounding road infrastructure. The yellow area of hatching has been provided to enable HGVs servicing the site to leave through the car park using a more direct and safer route than following the car-park one-way system.

Figure 26: Location of Usk HWRC (Blue star)

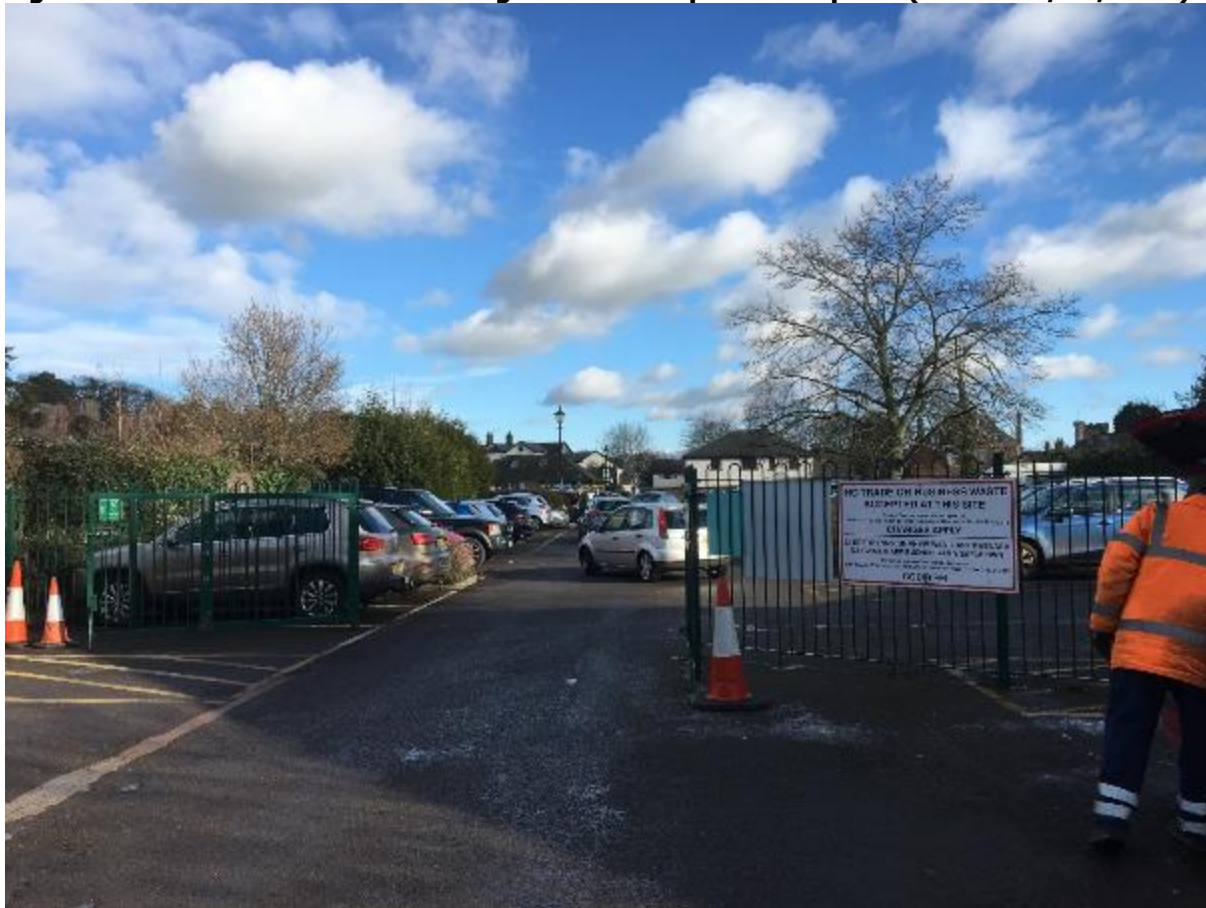
Figure 27: External Site Gates looking towards the public car-park. (E.How 31/01/2019)

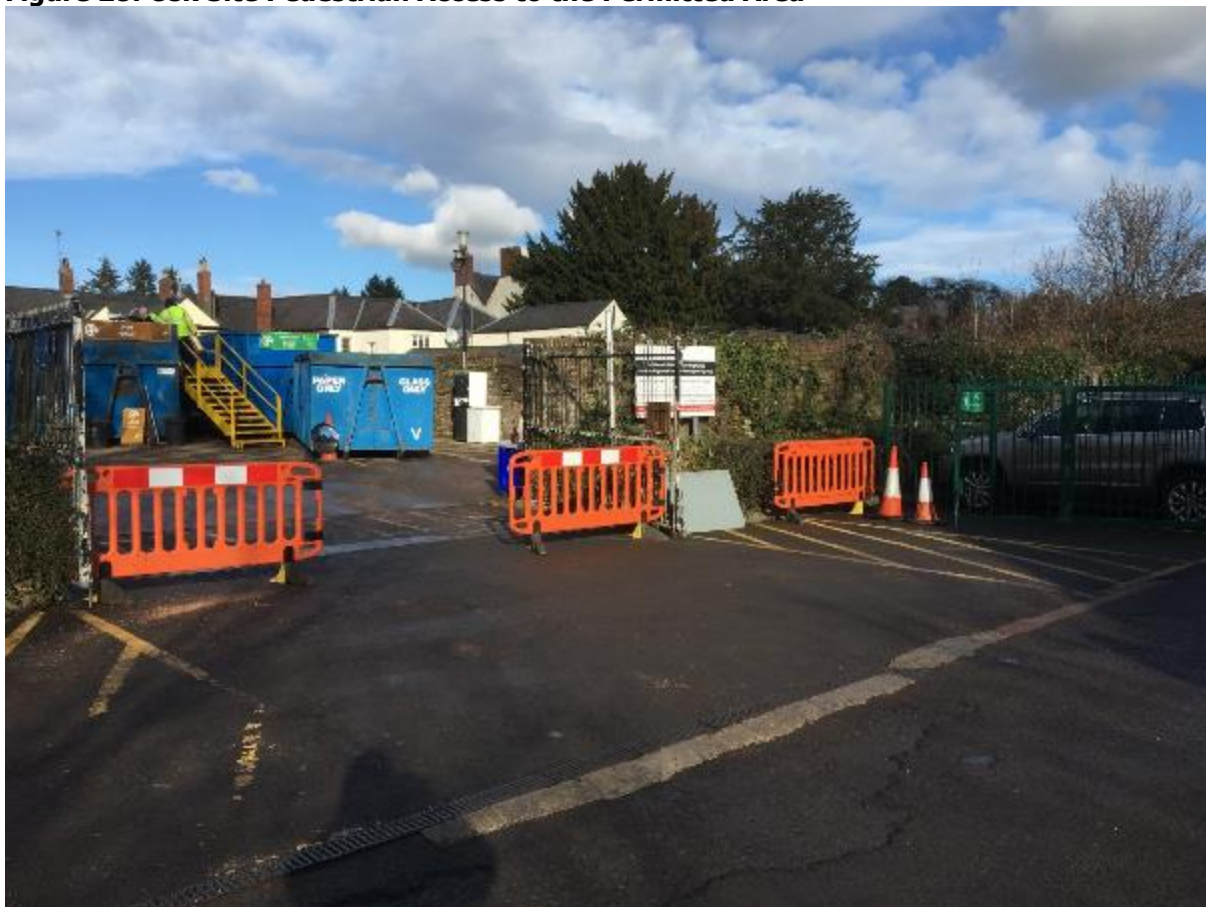
Figure 28 shows the original site entry/exit which is now a pedestrian access only.

Figure 28: Usk Site Pedestrian Access to the Permitted Area

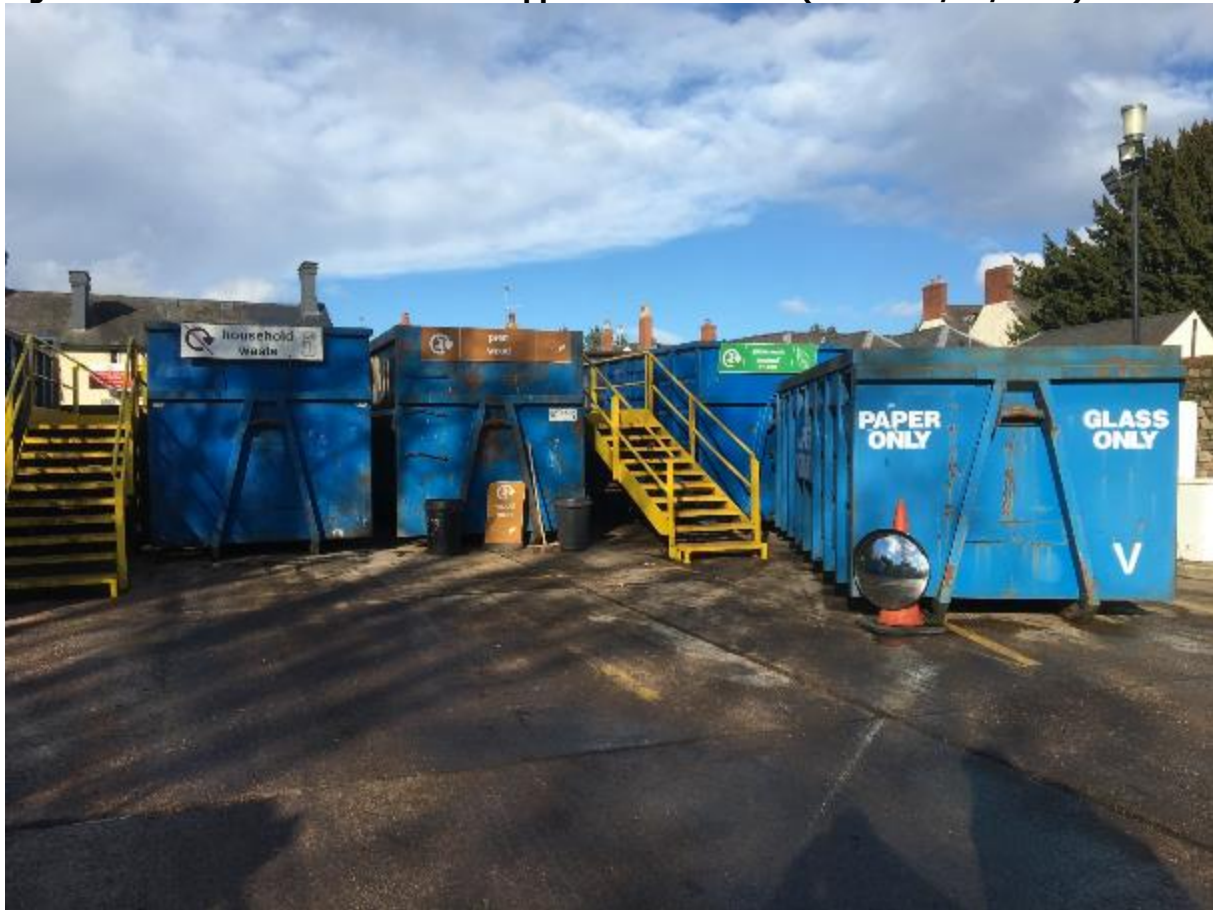
Figure 30: Containers Accessed via Stepped Metal Gantries (E.How 31/01/2019)

- The constraints of the site mean that it will not be possible to remove the stepped gantries if the site continues to use the current complement of containers and, deploying smaller containers that are accessible from ground level will necessitate an increase in the number of container changes required which increase the risks associated with HGV movements through the public car-park and users queuing. However, it is noted that 52% of waste deposited at the site is residual waste therefore by removing the option for users to deposit this material at the site the tonnage throughput and therefore the number of users will be reduced thus reducing the overall risks associated with the site.

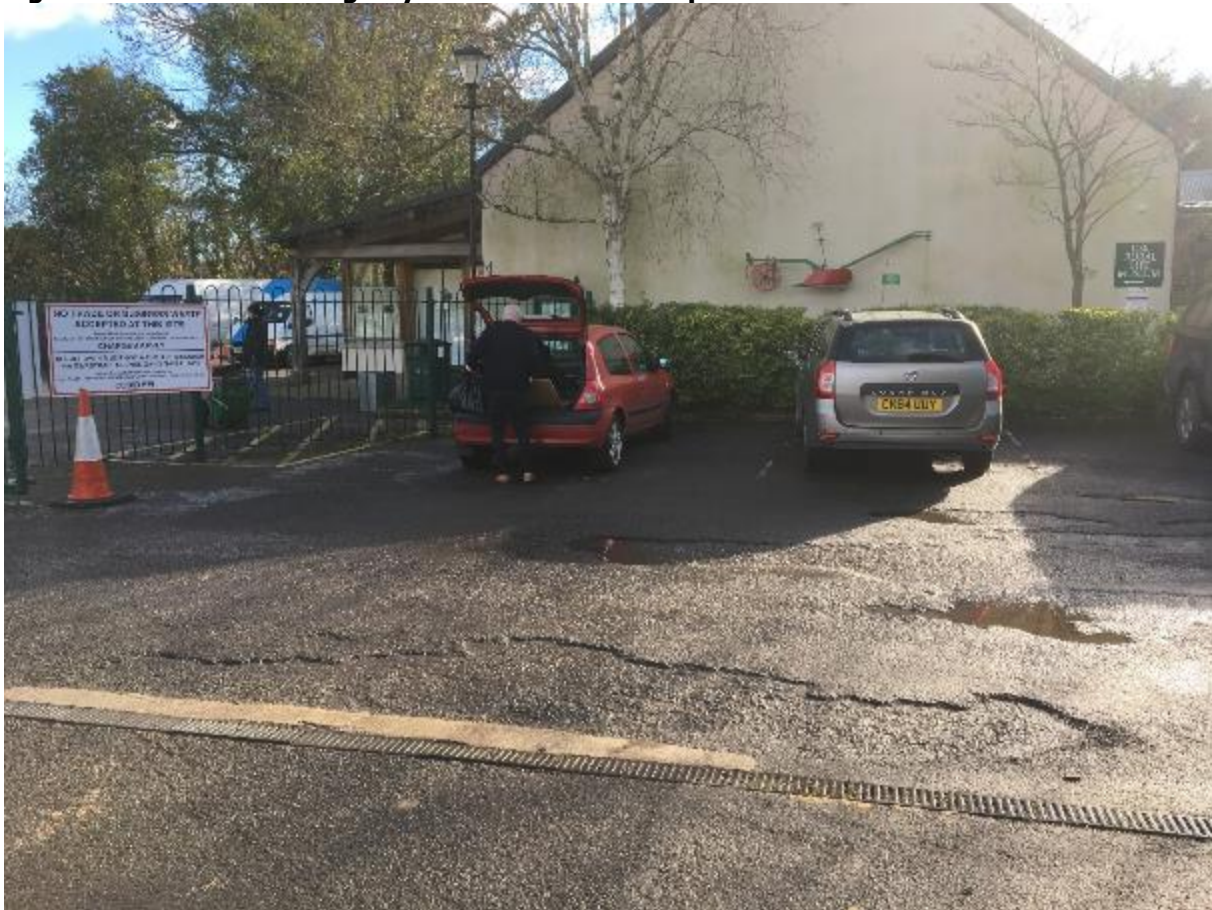
The HWRC is a pedestrian only site with users parking in the newly designated parking area just outside of the permitted boundary. Marked parking bays are provided in the additional operational area however they are now faded and require refreshing (Figure 31).

Figure 31: Marked Parking Bays in the Additional Operational Area

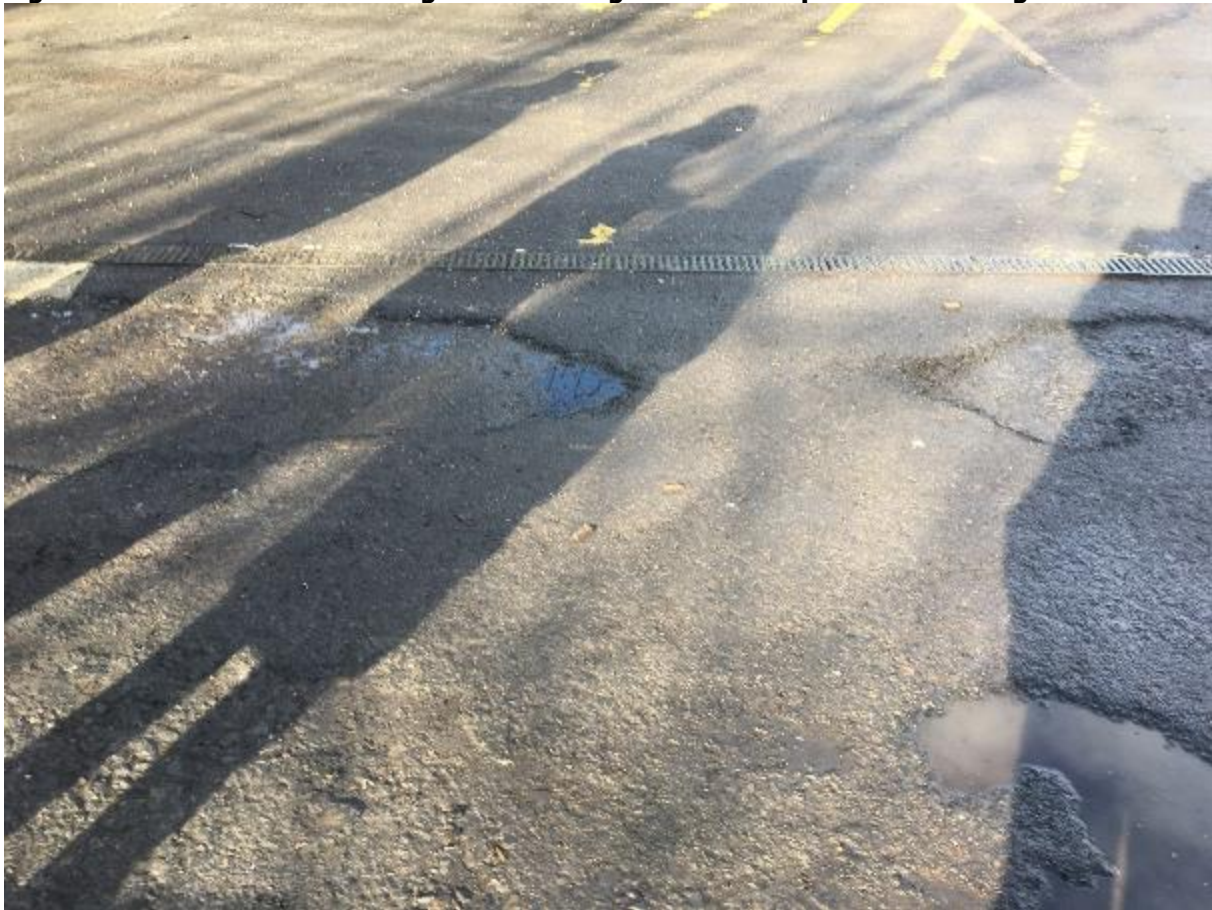
The vehicular and pedestrian areas and areas of waste storage are laid to asphalt and reinforced concrete hard standing. A number of areas of concern were noted in the additional operational area which accommodates the parking bays for users to park whilst they off load their materials and walk them into the site. Consideration should therefore be given to resurfacing the additional operational area.

Figure 33: Area within the Designated Parking Area that require Resurfacing
