Monmouthshire County Council

Definitive Map Modification Order

**TO ADD ROUTE, A TO G, FOOTPATHS 83 AND 84 CALDICOT
TO THE DEFINITIVE MAP AND STATEMENT**

The Seawall

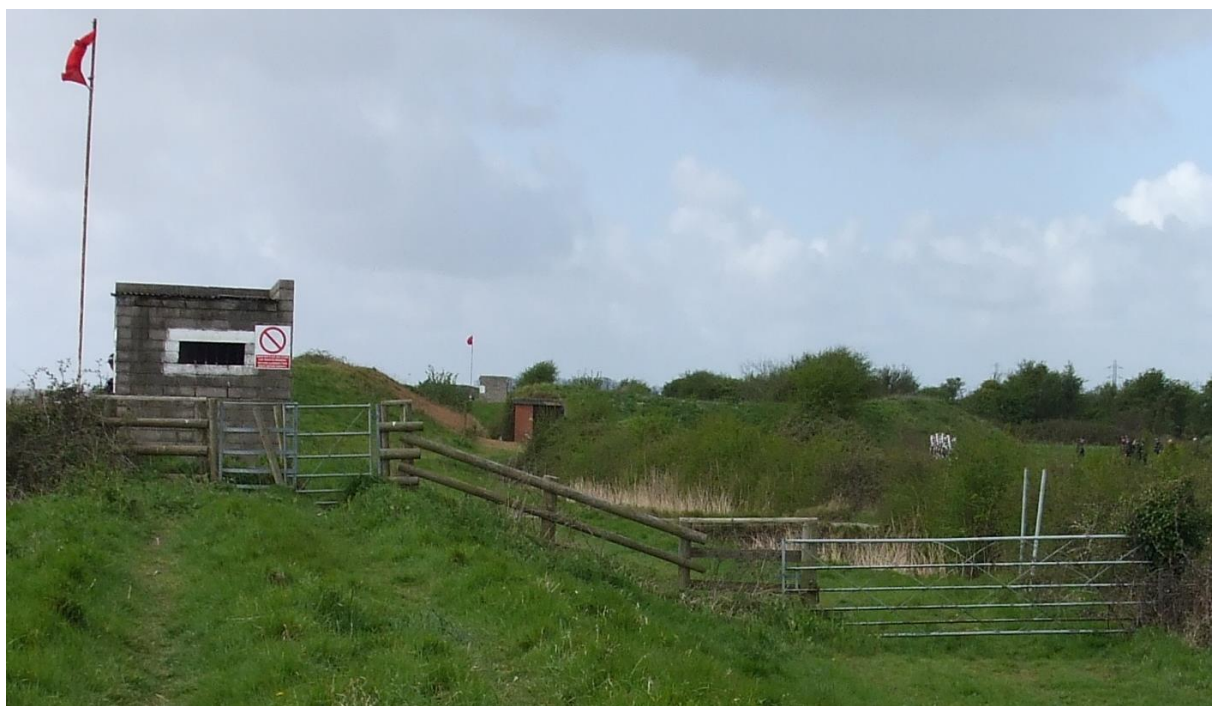
Photo A: Sentry box: Point F: 2008

- i) It is noted that sentry boxes are situated at the east and west boundaries of both Rifle Ranges. In connection with this section of the Route, A to G, the sentry boxes for Severnside Rifle Range have lookouts both directed seawards and overlooking the alignment of the Route that is along the crest of the sea wall. (Fig. 5.1). Furthermore, the sign directed to the walking public is on the wall of the sentry box that is facing any on-coming walkers beyond a kissing gate. Alternatively, the sign is not on the wall that is facing out to sea (Fig. 5.1: Photograph A).

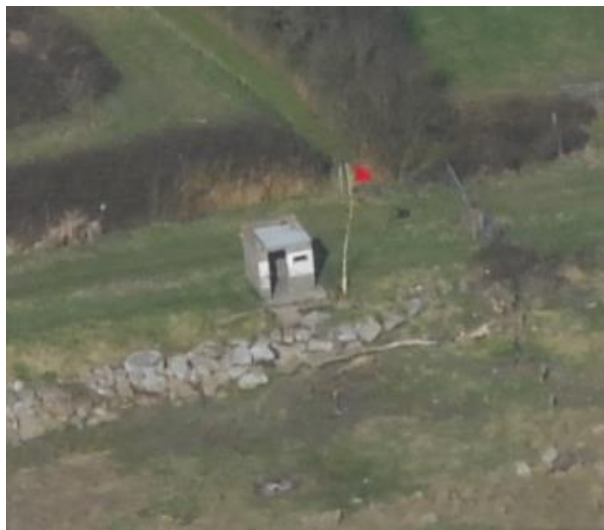
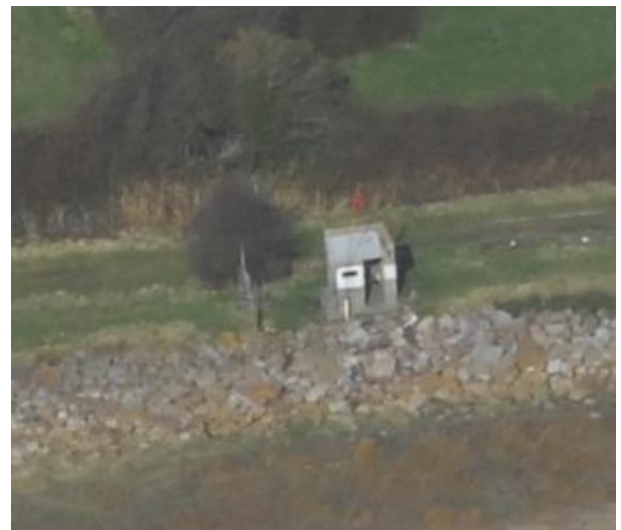
Fig. 5.1:

Photo B: Sentry box: Point F: 5th March 2008:
Ref.C01_0323

Photo C: Sentry box: Point G: 5th March 2008
Ref.C01_0323

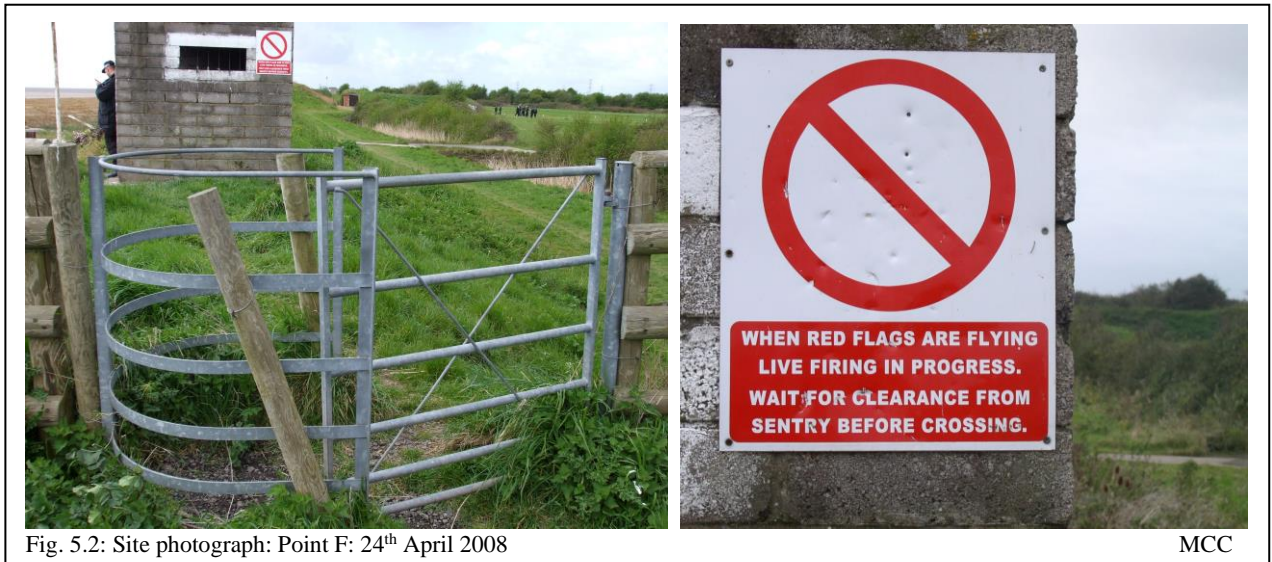
- ii) The context of the comment, “they could not understand why anyone would want to walk in front of 2 live firing ranges”, should not be misunderstood. That is, people would not want to or should not desire to proceed past a warden and a red flag when they can hear gun shots. The purpose of the flagpoles alongside the sentry boxes with notices facing the on-coming public stating, “WHEN RED FLAGS ARE FLYING LIVE FIRING IN PROGRESS WAIT FOR CLEARANCE FROM SENTRY BEFORE CROSSING”, is all there to instruct the public, telling them they may proceed along the Route when it is safe to do so and not when live firing is in progress (Fig. 5.2).

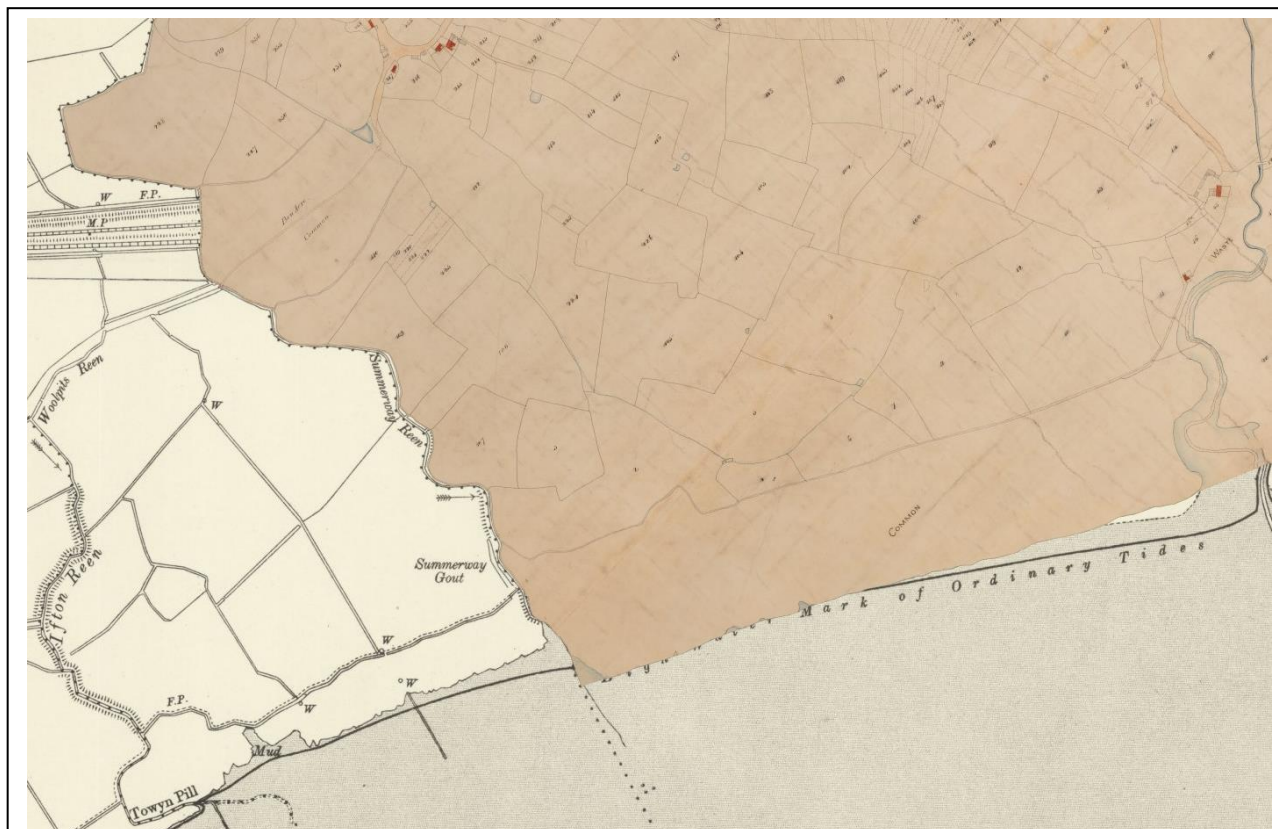
6.7. The 1843 Tithe Map for Caldicot (Fig. 6.5) held by the National Library Wales, online view, suggests the alignment for FP 6 Caldicot. There are roads shaded brown and rivers shaded blue on the 1843 Tithe Map. However, other maps need to be studied together with this one to best interpret the depiction of the feature along the northern boundary of the area marked “Common”. The double parallel lines mark a similar alignment for the road, previously observed on the 1830s maps, but it is not shaded in the conventional way for roads. However, the 1858 Tithe Map (Fig.6.7) does show this feature shaded blue for the depiction of drains.

Fig. 6.5: (1902 OS map on the left, no tithe map available) | 1843 Tithe Map Caldicot on the right: not to scale. NLW-online

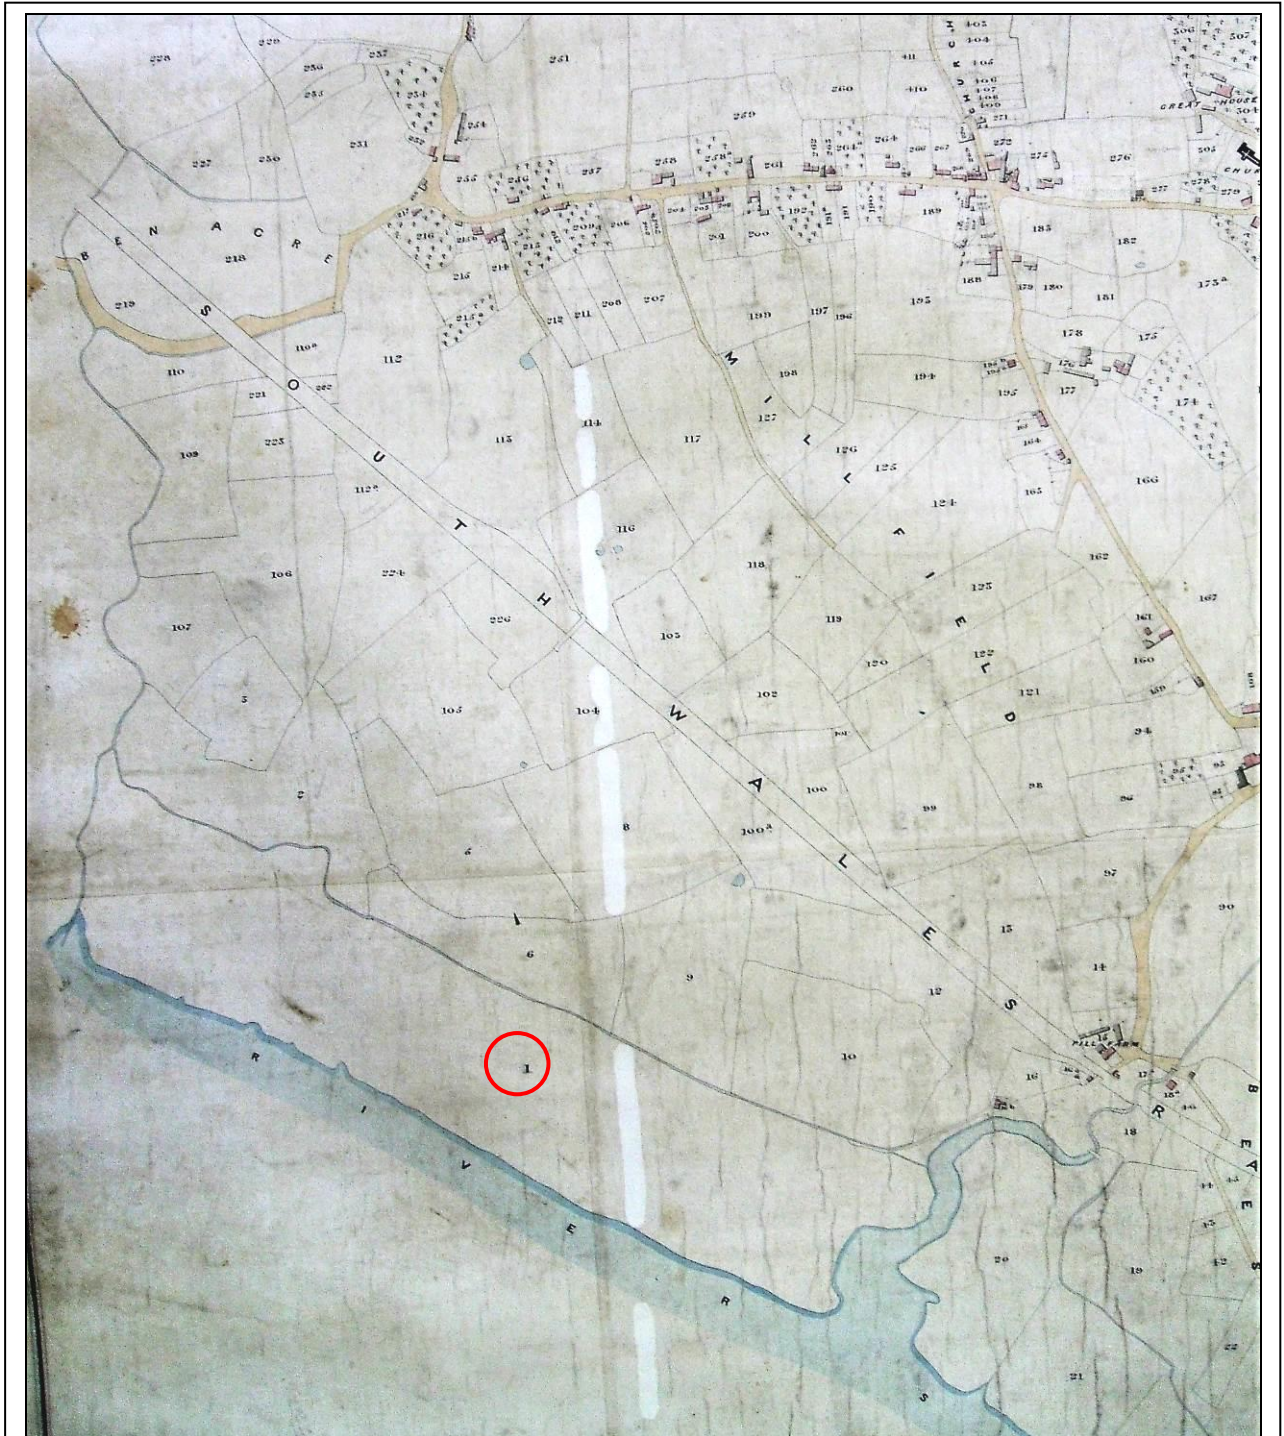
Fig. 6.7: 1858 Caldicot Parish Map: “Corrected and copied from the Tithe Map”: extract: not to scale

6.10. The combination of both the Tithe maps for Caldicot joined with no tithe map for Rogiet reduces the support for public vehicular or equestrian rights along or near the seawall.

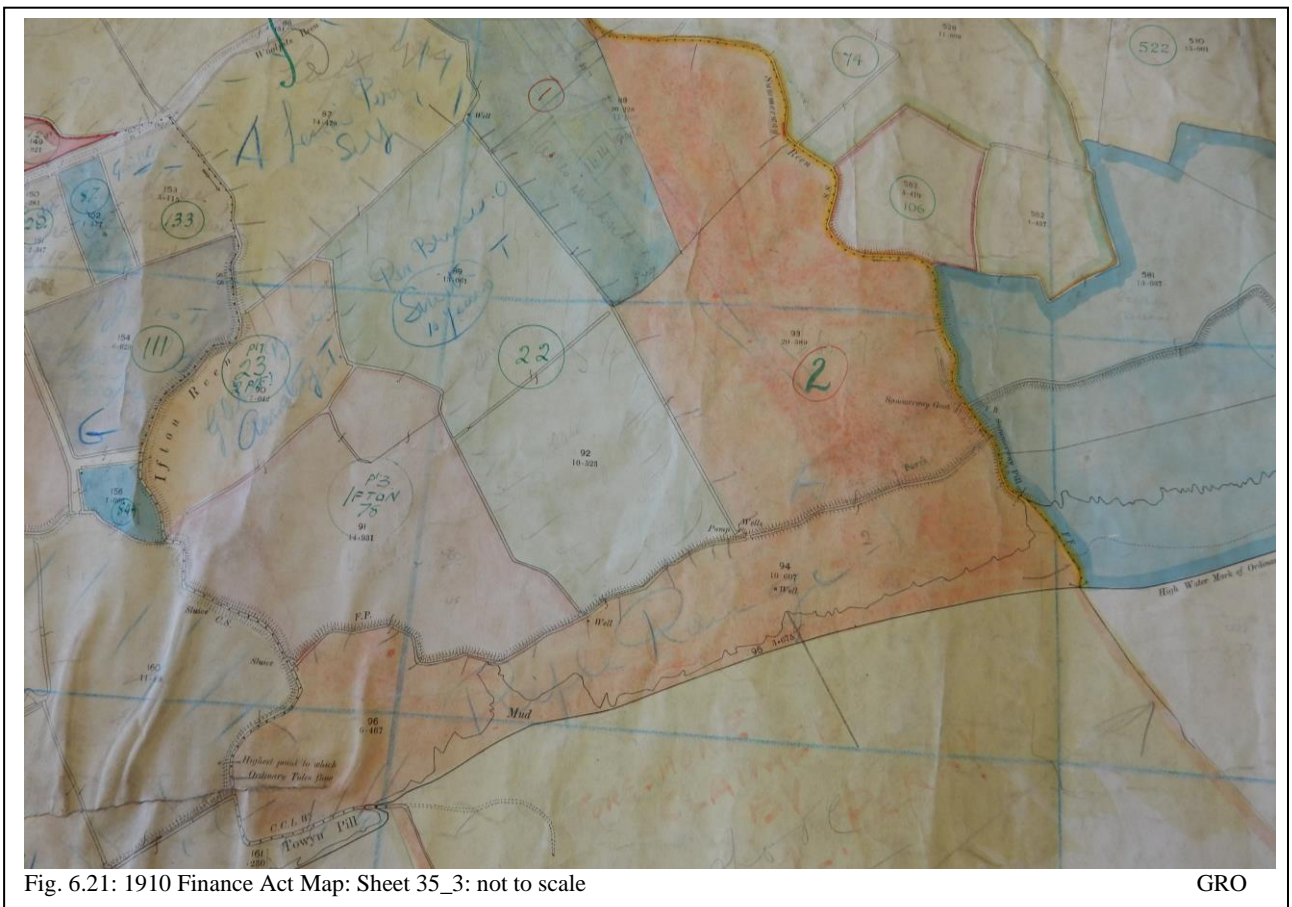
- 6.31. The 1910 Finance Act Map, working sheet 35.3 (Fig. 6.21) does not show the Route in question as ‘*uncoloured*’ or ‘*white out*’. This means that when this map is taken together with all the historical information investigated it is reasonable to determine that there are no public vehicular or equestrian rights.

- 6.32. The 1910 Finance Act map working sheet 35.3 has the words “*Butts*” and “*Rifle Range*” marked in pencil across the plot numbered 2. This indicates the location of the Rifle Range in 1909-1910 which precedes the start of the First World War in 1914.
- 6.33. The base map for the 1910 Finance Act map is the 1901 Ordnance Survey Map (Fig. 6.12) and this shows the alignment of a footpath along with the symbols for footpaths “*F.P.*” and footbridge “*F.B.*”.
- 6.34. The Finance Act Register that references the plot numbers on the accompanying map has not been found at the Gwent Record Office for the community of “*St Brides - Ifton Parish*”

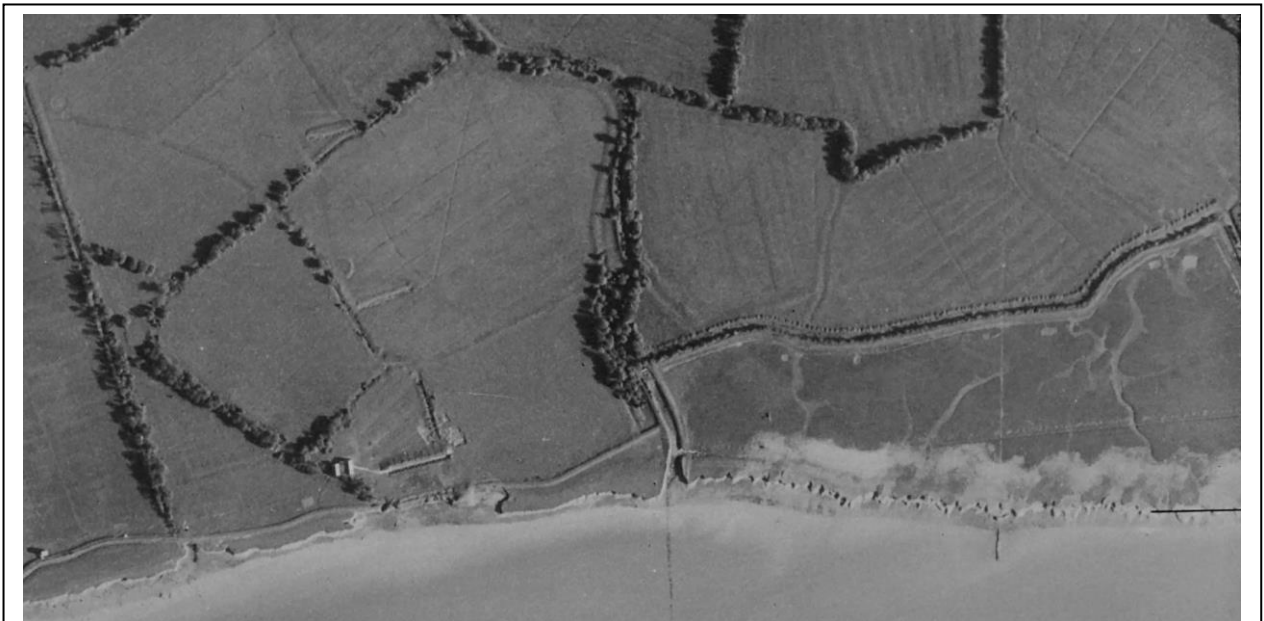
9.2. The 1947 aerial photograph (Fig. 9.1) shows the old alignment of the seawall.

9.3. The photograph (Fig. 9.1B) with labels shows a footbridge that is in the same location as the footbridge marked on many of the OS map 1900 - 1949 (Fig. 6.13). The same footbridge is also noted on the Definitive Map and Statement (Fig. 7.6).

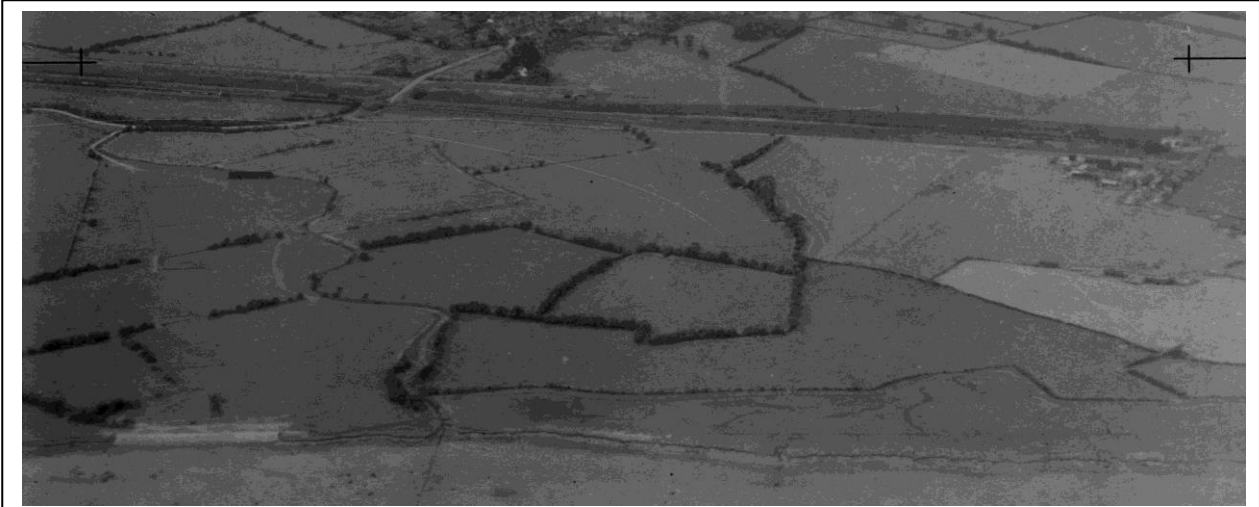
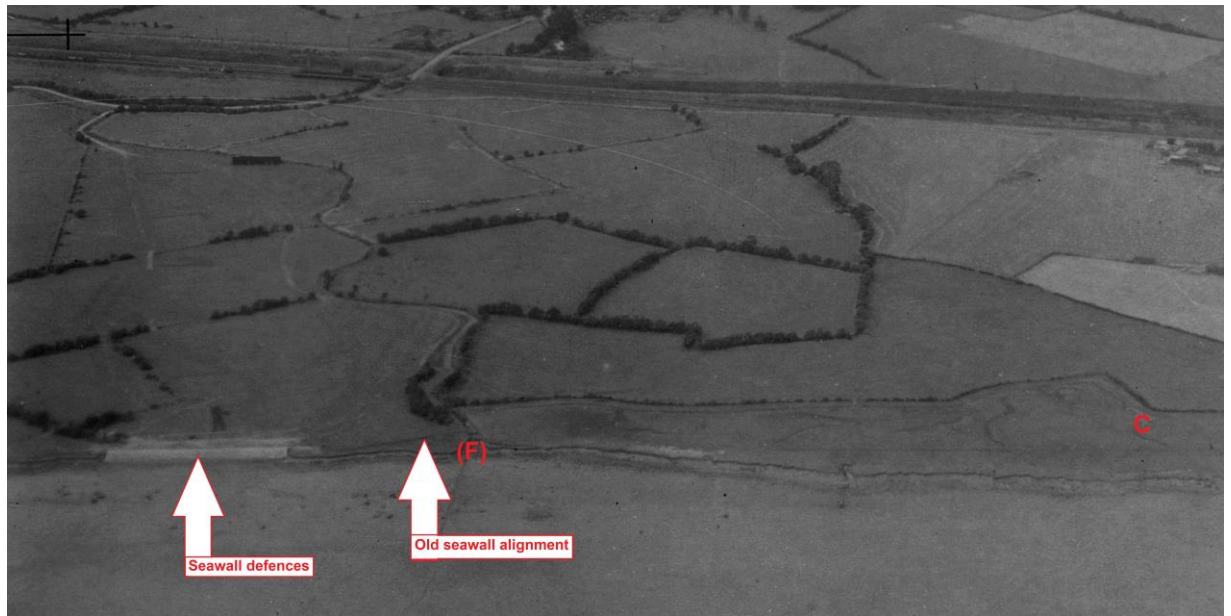
Photograph B: showing 1951 Seawall construction

9.4. The 1951 aerial photograph (Fig. 9.2) shows the early construction of the sea defences south of the “Targets” at the Severnside Rifle Range. This photograph gives the evidence that the development of the sea defences was undertaken during the period approximately starting in the early 1950s and continuing until completed in about 1965.

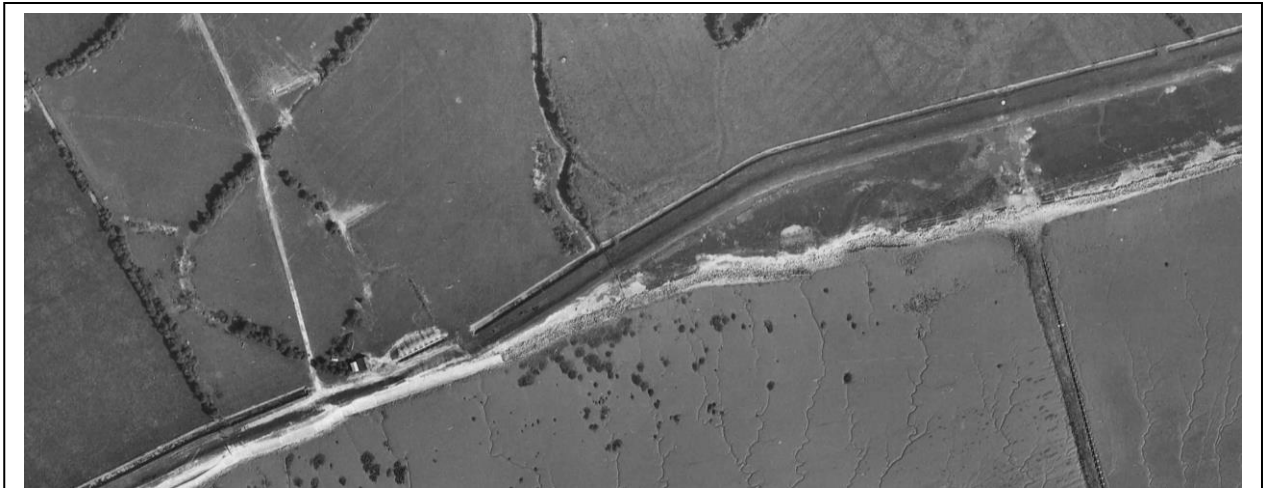
9.5. The 1966 aerial photograph (Fig. 9.3) shows the alignment of the sea defences to have been changed.

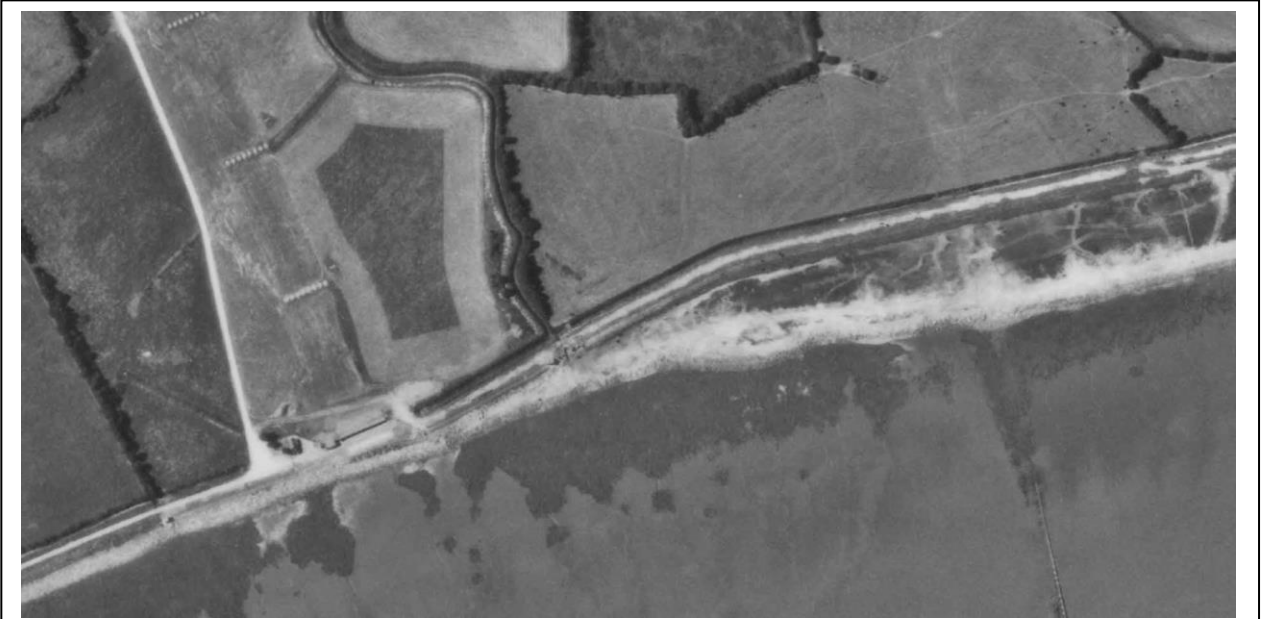
9.7. The 1984 aerial photograph (Fig. 9.5) shows a greater earth mound and the location of sentry boxes at points F & G. Additionally, from point F and proceeding southwest there is a faint narrow grey line illustrating the location of the footpath on the crest of the seawall.

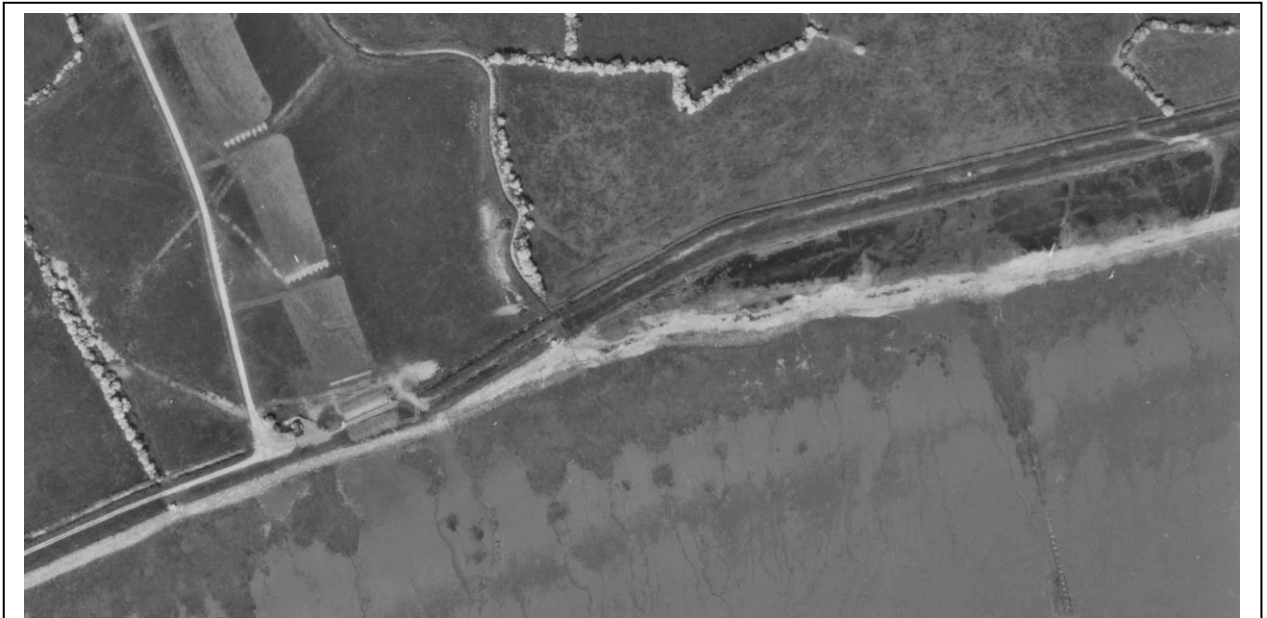
- 9.8. The 1985 aerial photograph (Fig. 9.6) shows again the sentry boxes located at points F & G.
- 9.9. Additionally, on this aerial photograph there are lighter marks at the south-eastern corner of the greater earth mound that indicate access available at its seaward side. This suggests that the greater earth mound has been pushed over the sea defences or “back filled” as reported by Mr J Purnell (chapter 11: point 11.2.iii).

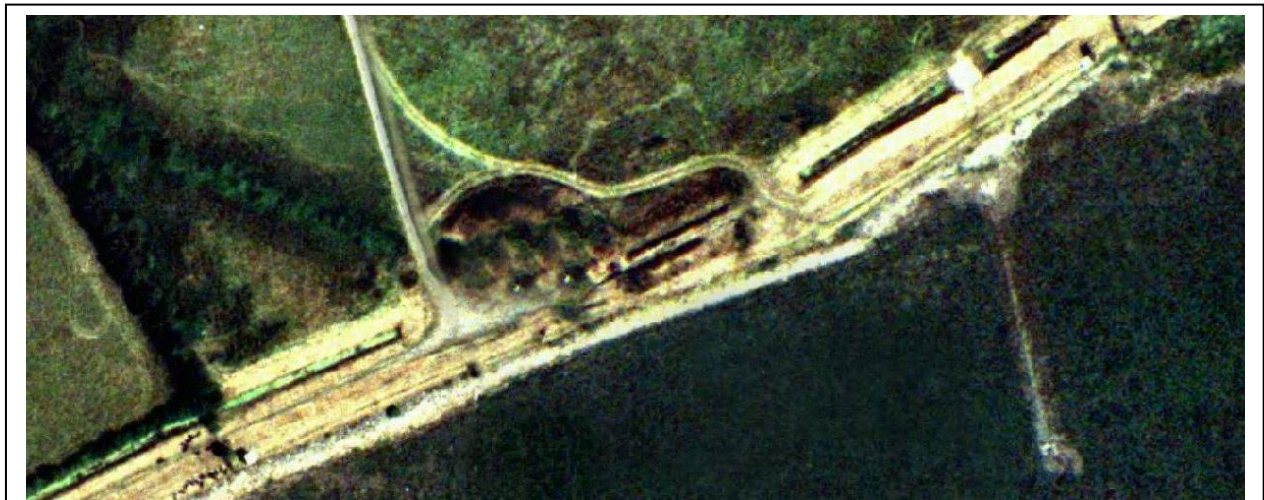
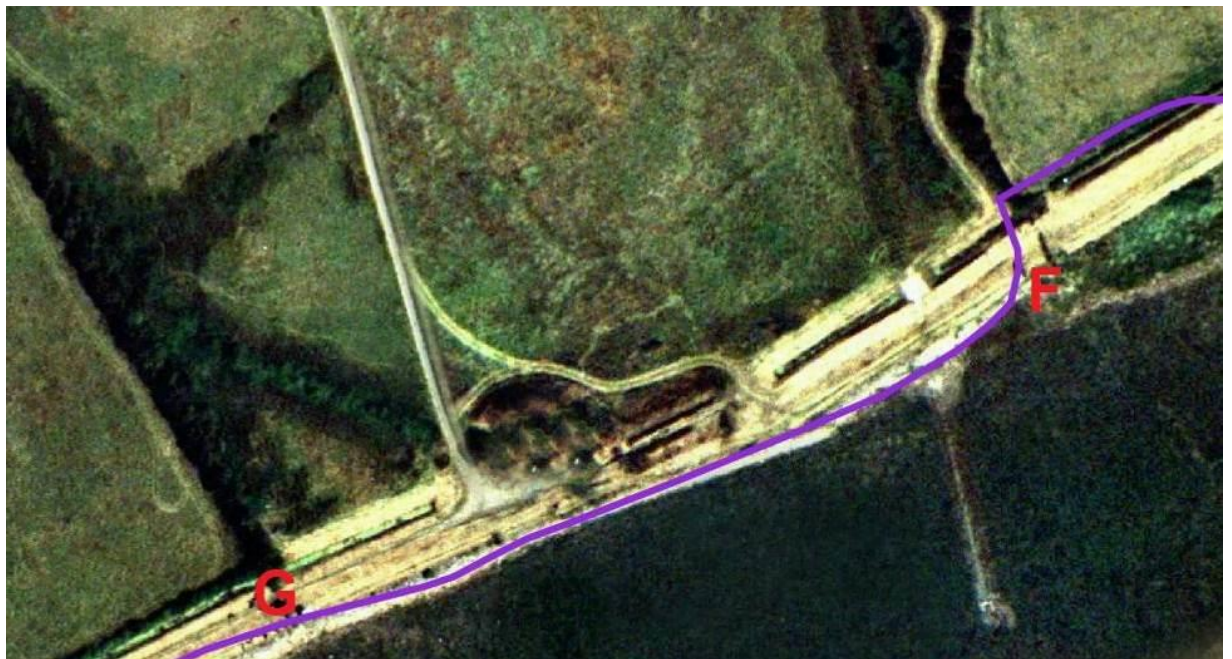
9.10. The 2000 aerial photograph A (Fig 9.7) shows extensive motor vehicular use of the area mainly on the inland side of the seawall. Although this photograph is unclear there are visible narrow white lines denoting the used route alignment to remain on the crest of the seawall.

Photograph B: The alignment of public right of way marked purple overlaid

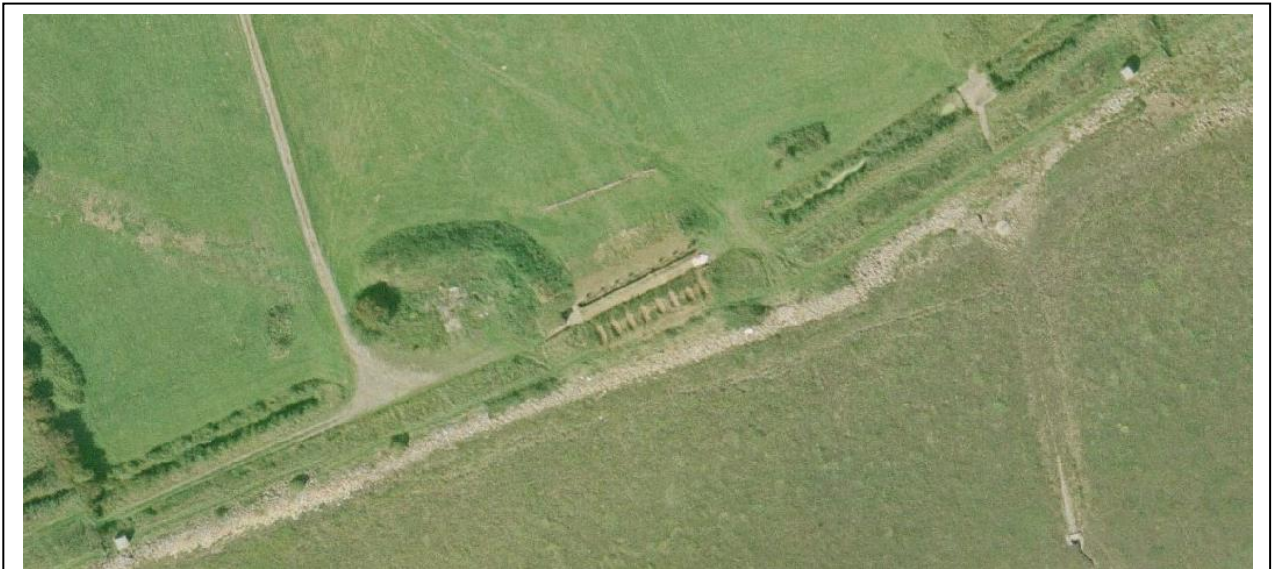
9.12. The 2005 aerial photograph (Fig. 9.8) shows more clearly the single alignment of the used footpath on the crest of the seawall between the two sentry boxes, points F and G.

Photograph B: The alignment of public right of way marked purple overlaid

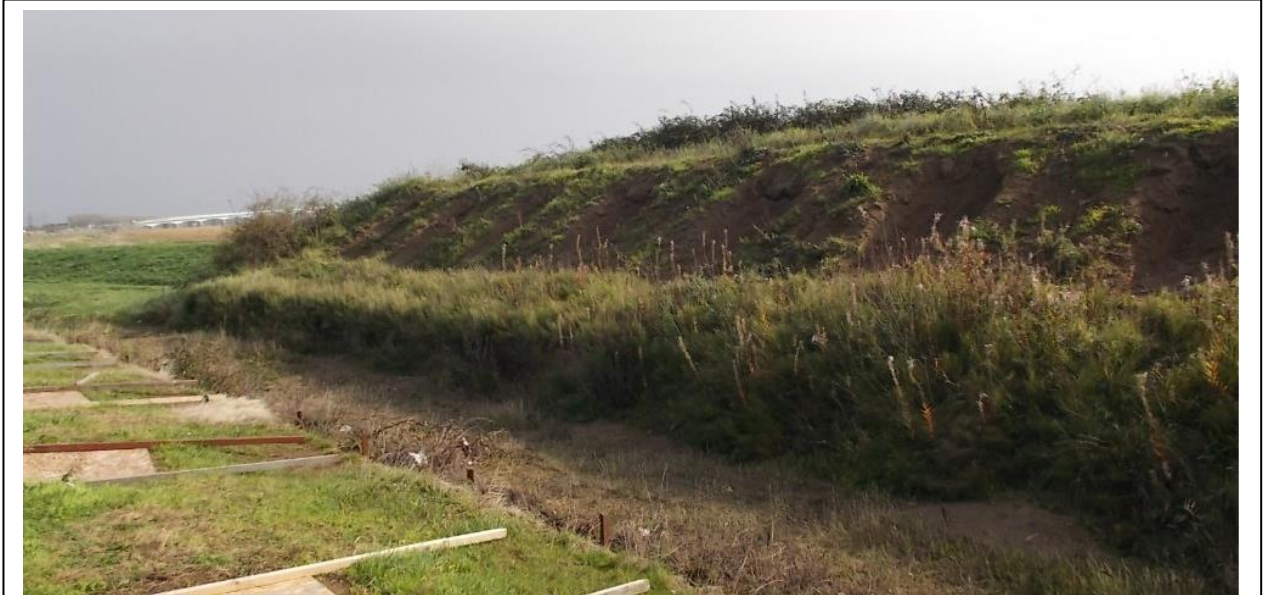
Fig. 9.9: 2017 site photograph showing greater earth mound

9.14. The steepness of the greater earth mound is better demonstrated in the 2017 site photograph (Fig. 9.9). This site photograph shows that the greater earth mound has been cut into and has eight scars. This cutting of the greater earth mound is probably the catalyst that is beginning to affect the sea wall.

9.22. The 2014 aerial photograph (Fig. 9.12) shows that the greater earth mound with the eight scars as there is no longer a shadow obscuring the feature. A better view of the greater earth mound is seen in the 2017 site photograph (Fig. 9.9).

- 12.36. The site photograph, (Fig. 9.9), shows in the foreground objects that look constructed of wood lying on a lower earth mound. Metal spikes protrude from the concrete trench behind which the ground is initially flat before it builds up into the greater earth mound (“butts” or “bullet catcher”).

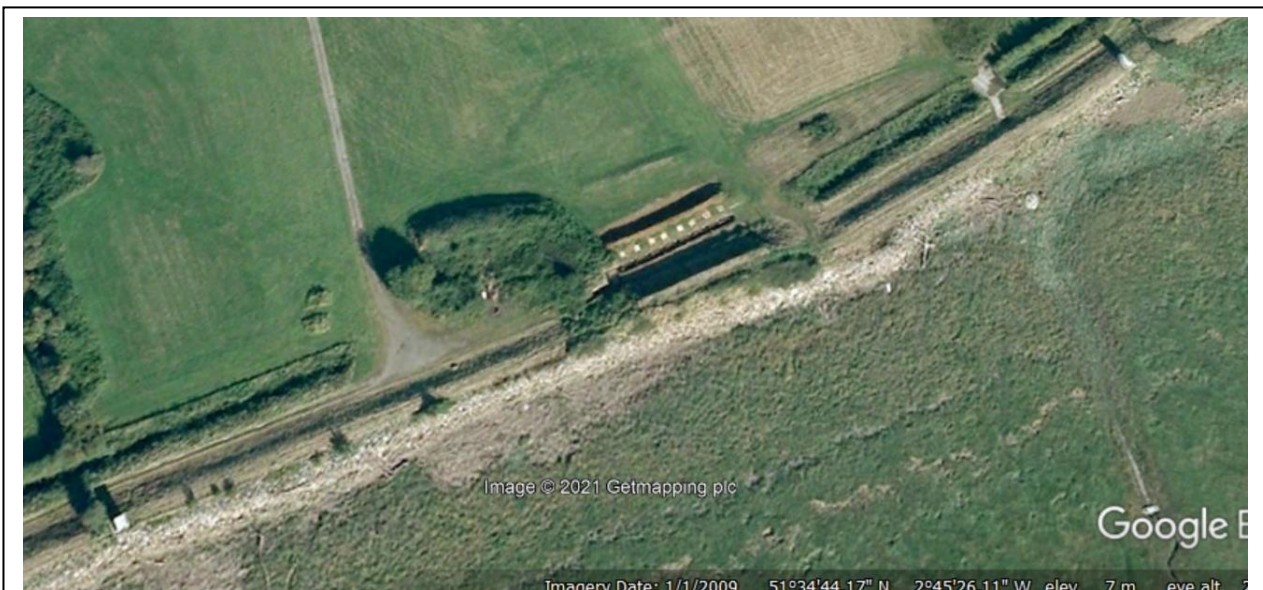
Fig. 9.10: 2009 Aerial Photograph

9.18. The 2009 aerial photograph (Fig. 9.10) shows that the shadow cast by the greater earth mound conceals the eight scars shown on the 2005 aerial photograph. However, the comparison of the shadows cast in the 2009/2010 aerial photographs demonstrate that there is a greater earth mound behind the targets than that of the seawall on either side. In other words, the shadow cast by the seawall is comparatively shallower than that caused by the greater earth mound of the larger target backstop.

9.19. The 2009 aerial photograph with longer shadows than the 2005 aerial photograph shows the seawall and the target area in detailed relief. The footpath between the two sentry boxes is on the crest of the seawall and passes along the top of the greater earth mound behind the target area. There are other worn marks showing routes around and in front of the smaller target mound area, but these would probably be for the management of Severnside Rifle Range.

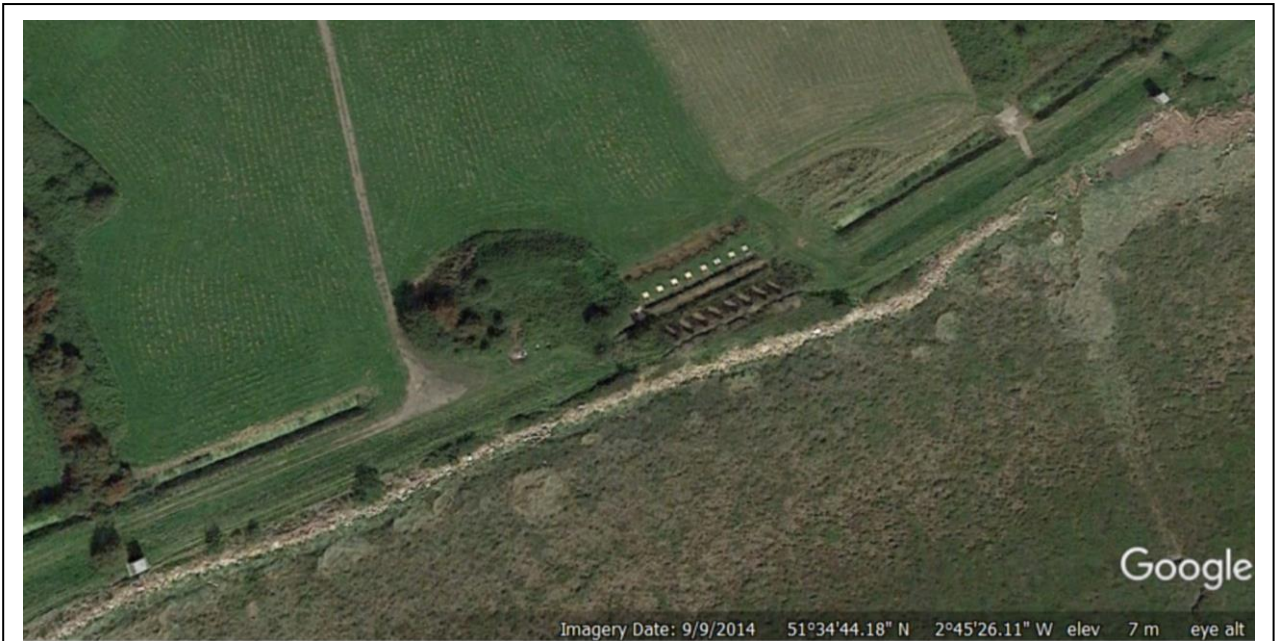
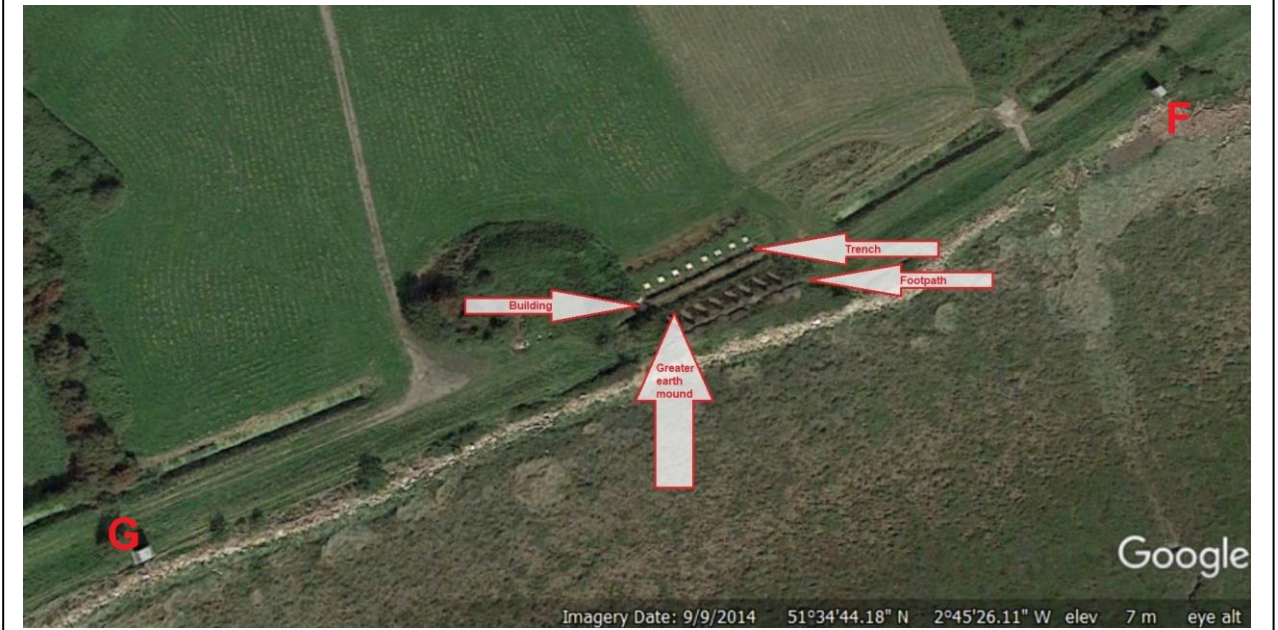
9.23. The 2014 aerial photograph B has been marked up to show a building at the east end of the targets, a trench, the greater earth mound, and the used footpath that on this photograph has a dark line probably caused by the height of the vegetation on the seaward side.

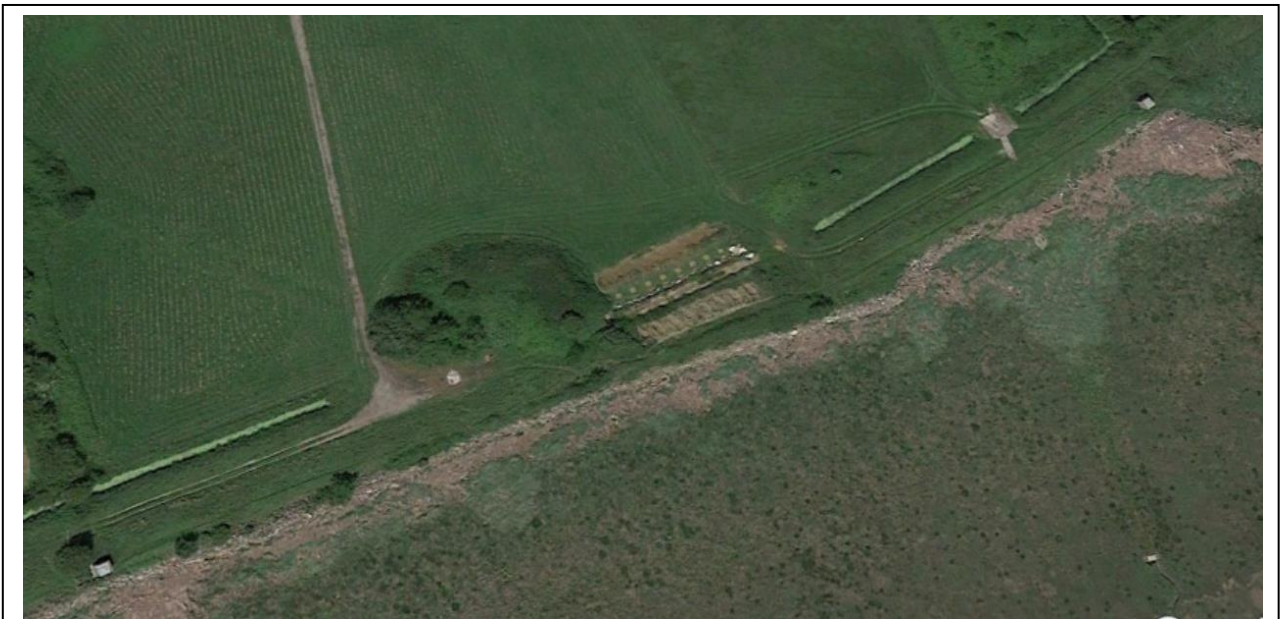
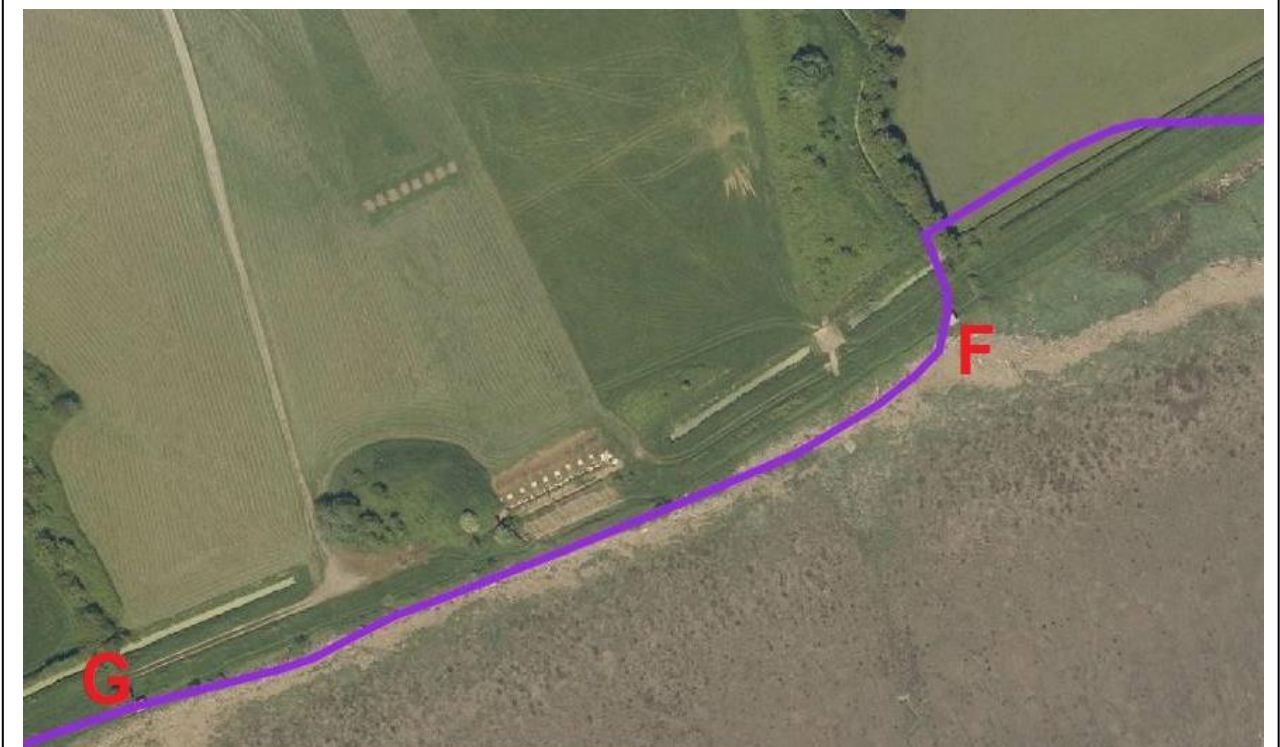
9.24. The 2017 aerial photograph (Fig. 9.13) again has less shadow and although faint there is still a single narrow worn line shown between the sentry boxes.

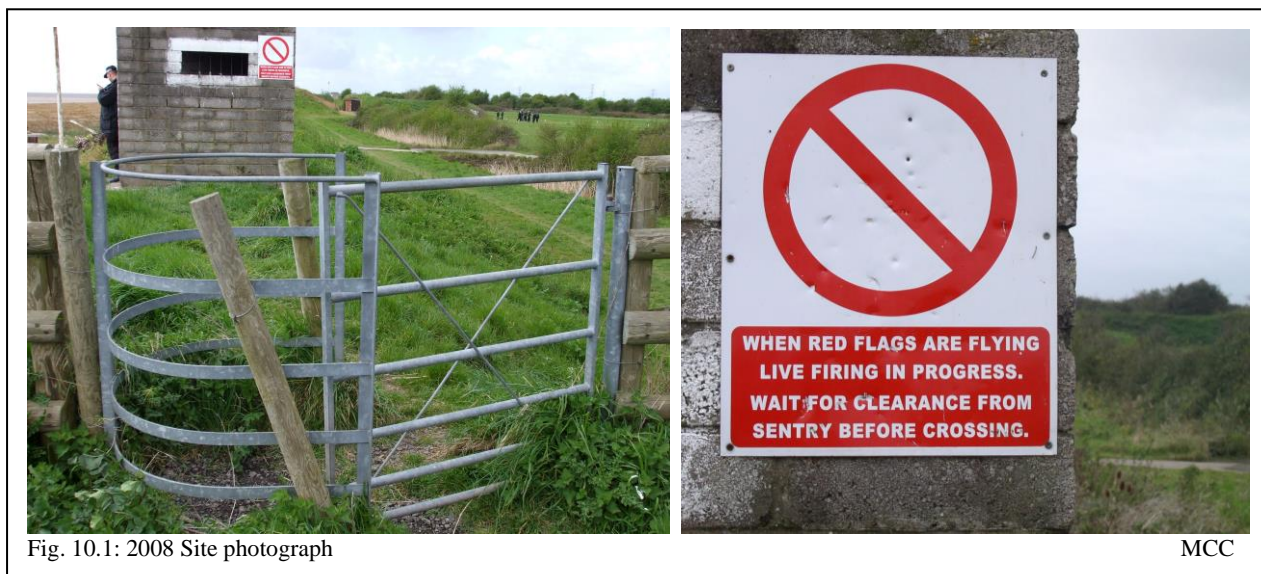
10.1. The work for the All-Wales Coast Path was undertaken in 2007/08 soon after the Coastal Access Officer had been appointed. A photograph taken at the site in 2008 (Fig.10.1) shows a metal kissing gate on the crest of the seawall. This evidence suggests that the kissing gate was installed prior to the work being undertaken for the new promoted Wales Coast Path. The installation of the kissing gate was to prevent cattle going onto the site which suggests that the footpath furniture had been there for a long time prior to the 2008 site visit.

10.2. Moreover, the 2008 site photograph shows the Severnside Rifle Range in use. The presence of a warden at the western sentry box, point F, indicates that the Rifle Range operators acknowledged and accepted that the crest of the seawall was used by walkers. Provision for everyone's safety and enjoyment of the area was made and is demonstrated in this photograph.

10.3. The notice on the sentry box, point F, states "*When red flags are fly live firing in progress. Wait for Clearance from sentry before crossing*". An additional and primary implication of this notice is that when the red flags are not flying then the public are able to use the Route along the crest of the seawall.

- 13.8. The notice on the sentry box, point F, (Fig. 10.1, chapter 10) states “*When red flags are flying live firing in progress. Wait for Clearance from sentry before crossing*”. This notice does not inform the public that the Route is not a public right of way. Instead, the initial implication of this notice is that when the red flags are not flying then the public are able to use the Route along the crest of the seawall.

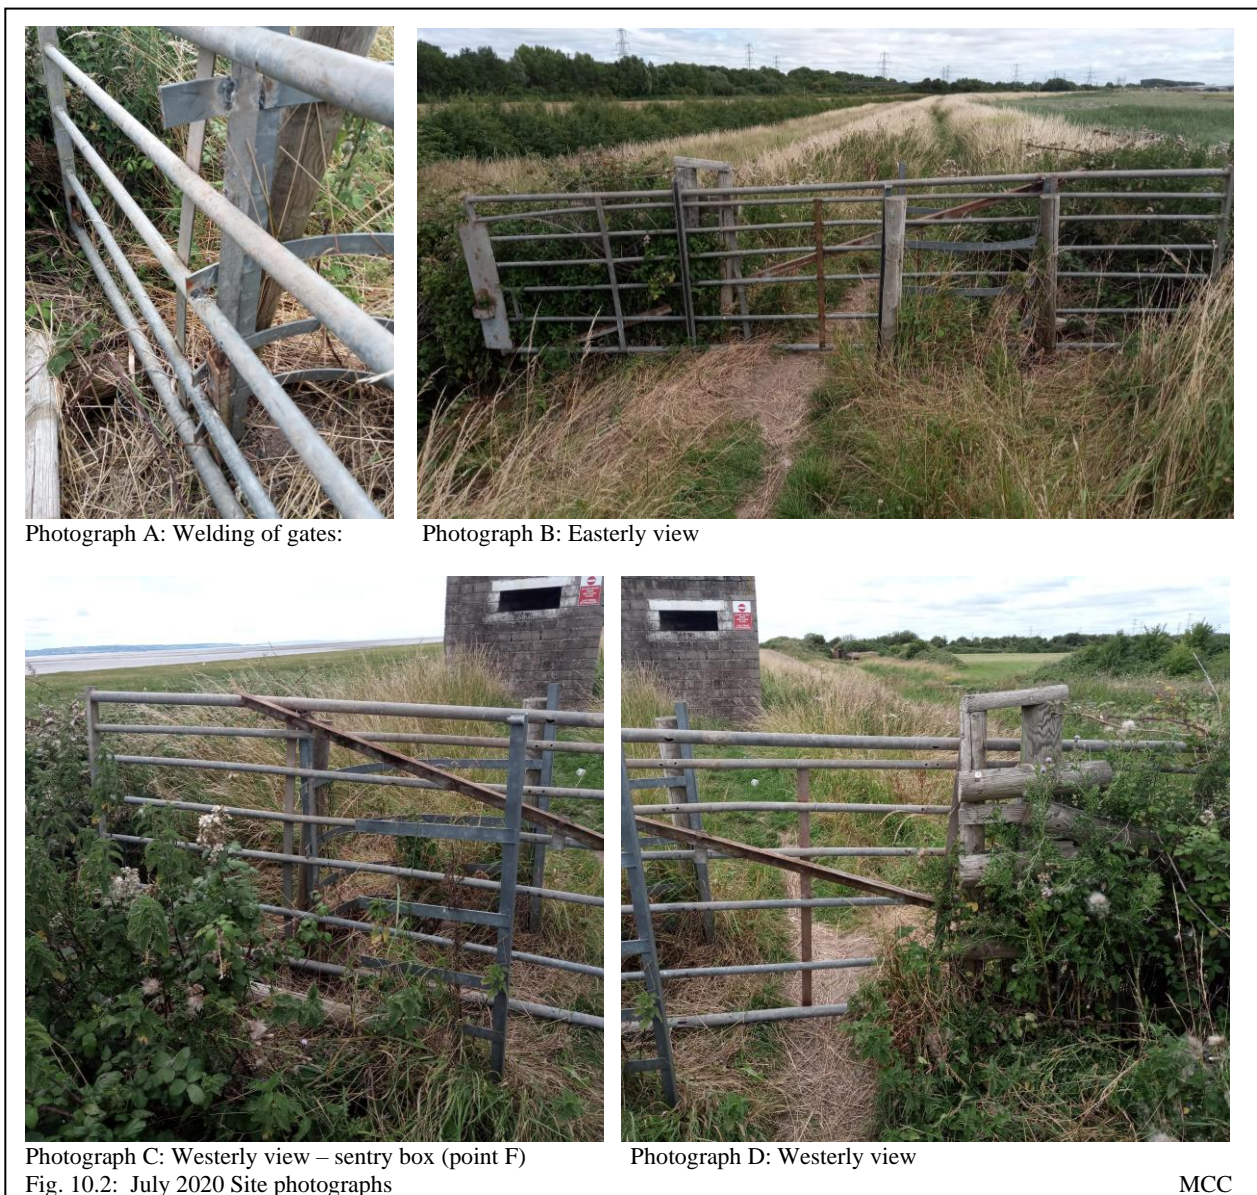
10.4. In July 2020 the field warden, on a site survey, took photographs of the kissing gate at the sentry box, point F (Fig. 10.2).

10.5. The kissing gate had been vandalised and obstructed by welding a field gate into it. It is unknown who had vandalised the kissing gate. Other public right of way furniture in the area has been vandalised to gain illegal access. It is not known who has caused this damage but there is evidence of motor cycling and cycling at the location.

10.6. The obstruction to the kissing gate, implemented by Severnside Rifle Range in July 2020, has brought the Route, A to G, into question.
