Monmouthshire County Council

Definitive Map Modification Order

**TO ADD ROUTE, A TO G, FOOTPATHS 83 AND 84 CALDICOT
TO THE DEFINITIVE MAP AND STATEMENT**

The Seawall

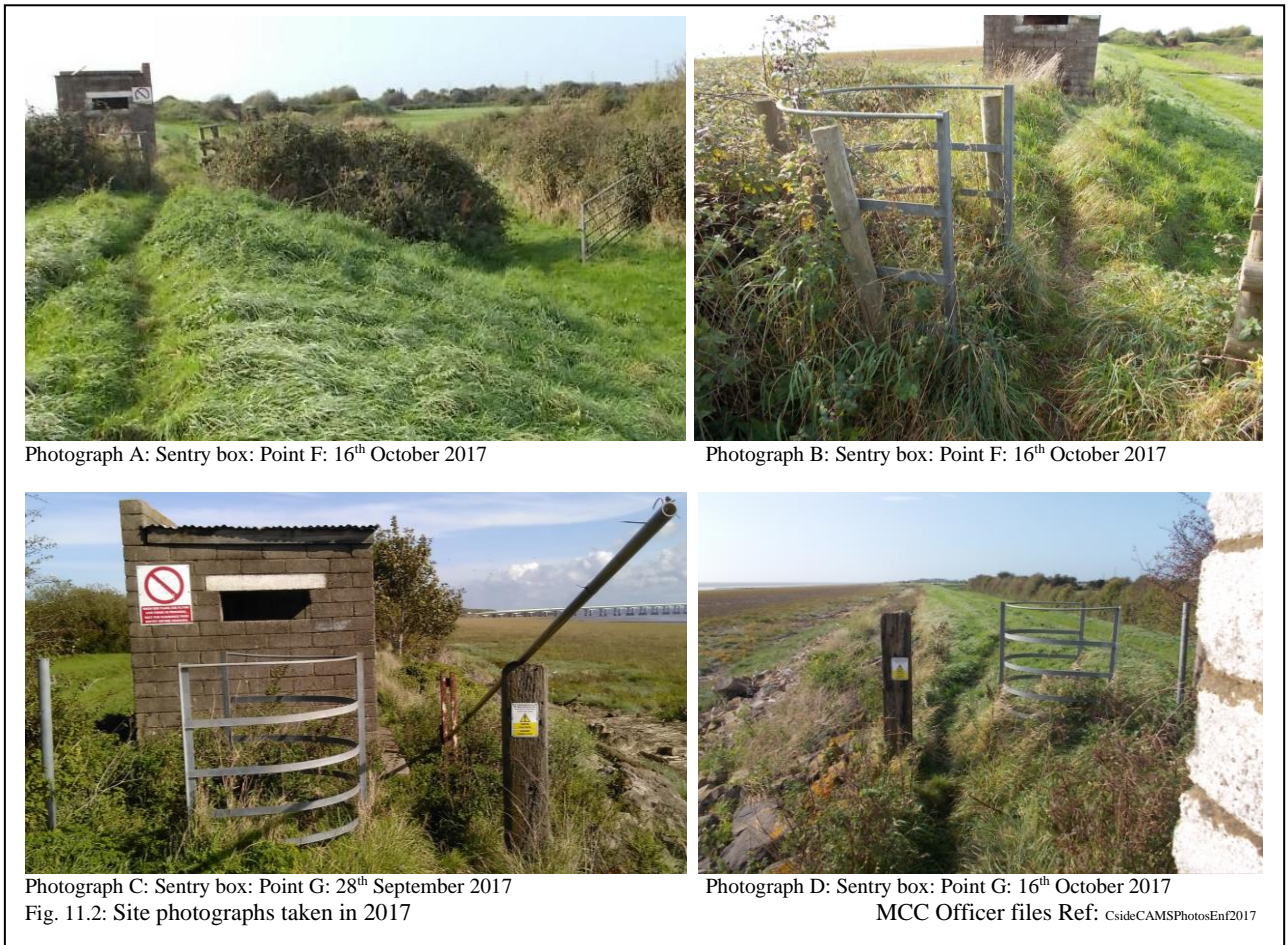
- d. The site photographs taken in 2017 (Fig.11.2), show broken kissing gates and a partially open field gate at point F, photograph A (Fig. 11.2).

- e. The damaged kissing gates and field gate, show that some are attempting to gain access illegally with either bikes, motorbikes, or vehicles. This is further supported by the damaged kissing gates that are nearby. Therefore, it is suspected that this behaviour is not associated with walkers and their reasonable use of the kissing gates.

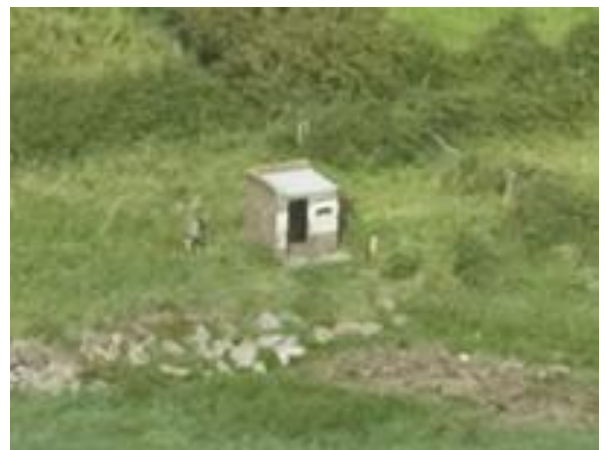
Fig. 11.3: Extract of site photograph 04/09/2012.
Walker with dog near sentry box, Point F, No red flag:
MCC Ref: Coastal Access G03-9580

- b. The relationship of two people makes no significant changes to the evidence. The flag staffs, sentry boxes, signs, and kissing gates on the crest of the seawall show established public use of the footpath. By keeping within the limitations of the signage, when the red flags were flying, the users were kept safe. It is this footpath furniture and signage that has obviously enabled Mr Morgan to exercise, thereby maintaining his health and well-being. Furthermore, the Rifle Ranges were not always in use and when the red flags were not flying then the public were able to walk without restrictions along the crest of the seawall (Fig.11.3).

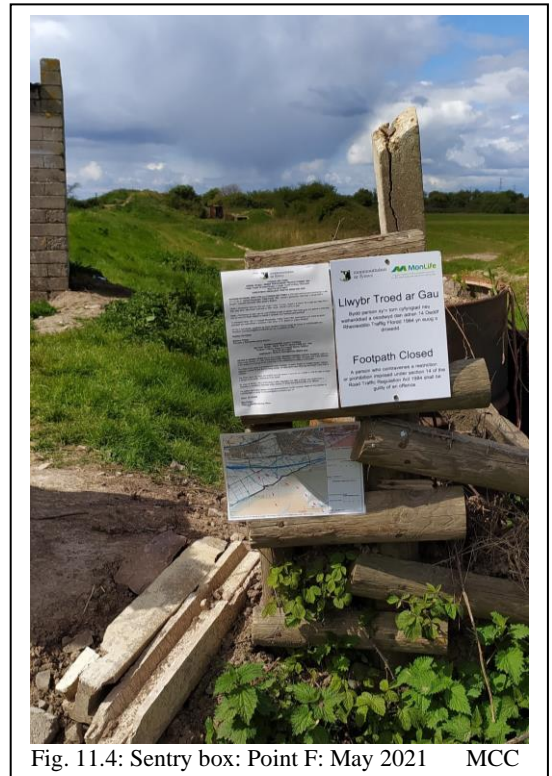
Fig. 11.4: Sentry box: Point F: May 2021 MCC

- b. The signs on the sides of the sentry boxes as seen in site photographs (Figs.11.1 & 11.2) are now no longer evident. Mr Shaun Pritchard, MCC’s Enforcement Officer, has frequently installed notices regarding the temporary closure of the registered public right of way (Fig.11.4). The Council is not going to place signage along the Route to permanently close it at the landowner’s request as the actions taken by Severnside Rifle Range to obstruct the alleged public footpath have brought it into question. Only after a decision regarding the public status of the Route in question has been made will it be possible to return

- b. The sign on the side of the sentry box, point F (Fig. 11.4), has been removed. Both Mrs Evans and Mr Wheeler report walking the Route, A to G, along the crest of the seawall *“when firing allowed without issue”*.
- c. Mr Shaun Pritchard has repeatedly installed notices regarding the temporary closure of the registered public right of way and these have been regularly removed.
- d. The frequent placement of notices on site has demonstrated a concern for public safety. Nevertheless, with the regard to need, nuisance and/or security these are not criteria that bear any influence on whether a public right of way *“subsists”* or is *“reasonable alleged to subsist”*.

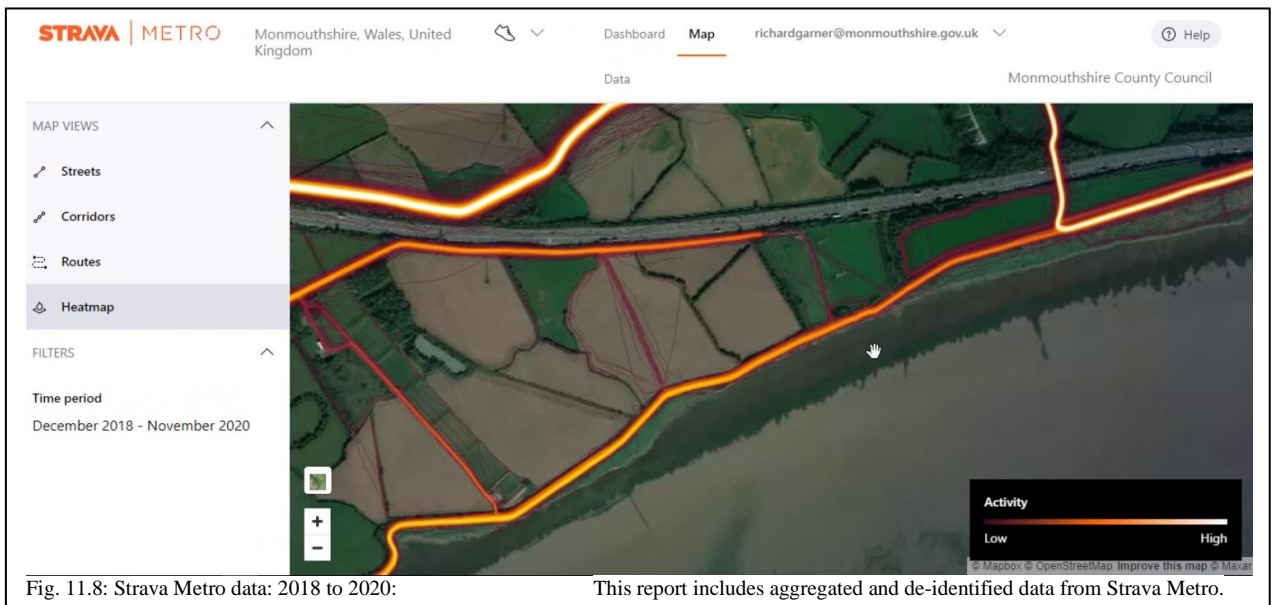
- 11.10. Strava/Metro, who have given permission for the use of their heatmap for the purposes of this report, work with millions of people who track their walks, runs and rides to the Strava app on their mobile phone or GPS device every week. The privacy of the individual is removed from the dataset and what is left is a vast source of trends and insights in a form of the Strava Heat map along with other analysis tools. This data collected is limited to the individuals who have the Strava app on their device.
- 11.11. The intensity of the heat line located along the crest of the seawall, shown on the Strava map (Fig. 11.8) during the period December 2018 to November 2020, is significant.
- 11.12. The intensely white/yellow line shown in the top left and right corners of the Strava map (Fig. 11.8) indicates that the All-Wales Coast Path (AWCP) to have the greater amount of usage.

- 11.13. The yellow line shown on the bottom left passes the M.O.D Rifle Range shows that there is less use of the crest of the seawall when compared with the more heavily used AWCP. The Severnside Rifle Range (directly north of the white hand icon (Fig. 11.8) is passed by an orange line that indicates a slight drop in usage when compared with other sections of the Strava map.

- 5.8. Officer Comment:
- i) The counter does show the use in the area for both rifle ranges regardless of the distance from the Severnside Range. This is demonstrated by the Strava Heat maps (Fig.11.8 & 11.9). Therefore, the combination of both the counter and the Strava data show continuous and regular use of the crest of the seawall.

- iii) Although not readily seen in this photograph (Appendix 5.12), there is evidence of walkers turning west. The difference of heavy and lighter use is demonstrated in the Strava Heat map where the white/yellow colour denotes greater use, and the orange/yellow colour denotes less (Fig.11.8). The All-Wales Coast Path (AWCP) is a promoted route resulting in it being frequently used thereby needing to be maintained regularly which has caused it to be even more heavily used.

11.14. The comparison between the 2018 to 2020 Strava map (Fig. 11.8) with the 2020 to 2021 Strava map (Fig.11.9) shows a decline in the usage of the crest of the seawall near the Severnside Rifle Range.
