Monmouthshire County Council

Evidential Report Edition 3i:

Definitive Map Modification Order

**TO ADD ROUTE, A TO G, FOOTPATHS 83 AND 84 CALDICOT
TO THE DEFINITIVE MAP AND STATEMENT**

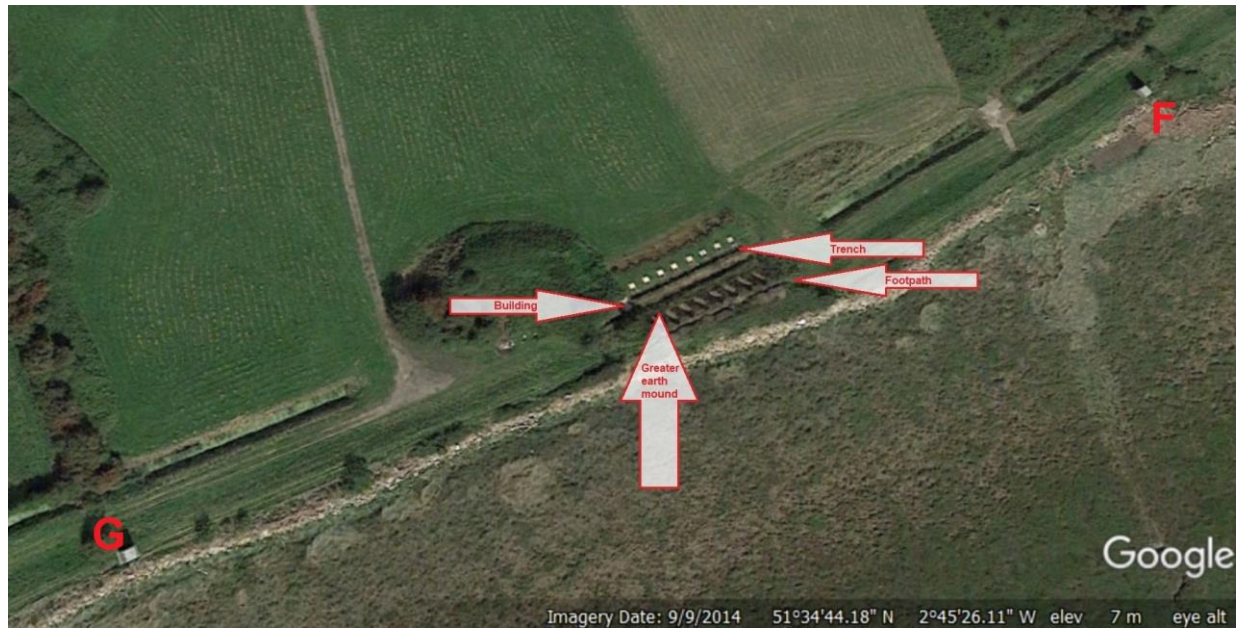
Photograph B:

9.23. The 2014 aerial photograph B has been marked up to show a building at the east end of the targets, a trench, the greater earth mound, and the used footpath that on this photograph has a dark line probably caused by the height of the vegetation on the seaward side.
