Caerwent

*Conservation Area
Appraisal &
Management Proposals*

Report Title: Caerwent Conservation Area Appraisal & Management Proposals
Client: Monmouthshire County Council
Project Number: 2009/089

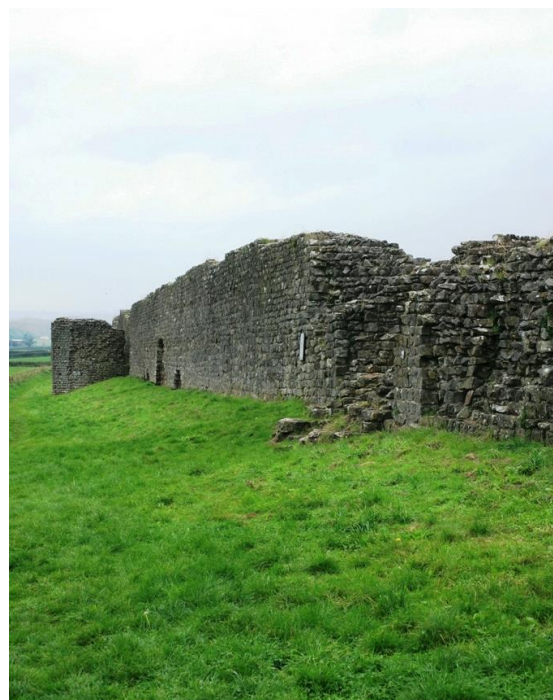
Fig.5 View of the town walls to the south side of the town

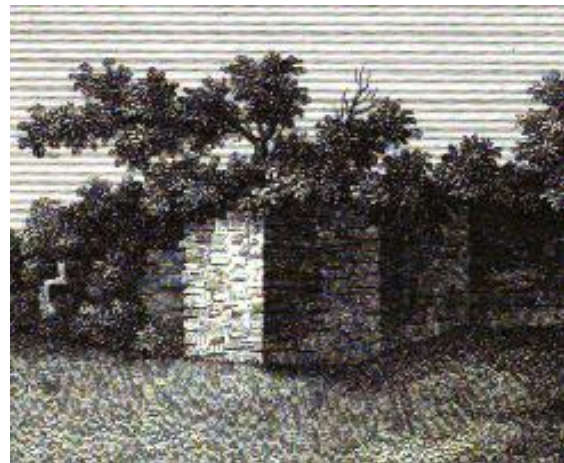
Fig.7 An early 19th century engraving of one of the bastions on the south wall

were carried out. Many antiquarians flocked to record the castles and ruins of the area with drawings and etchings showing the surviving structures as romantic ivy clad ruins (Fig.7). It was not until the 'Caerwent Exploration Fund' systematically explored two-thirds of the site between 1899 and 1913 that the extent of the former Roman town was realised. Further investigations were carried out in 1925 and in 1946-7 when the site was taken into state care (Brewer, 2006).

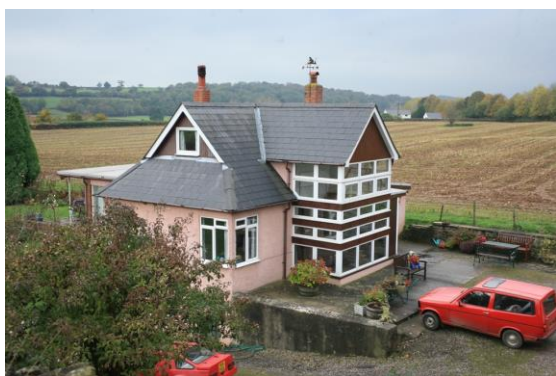
Fig.10 The eclectic use of materials and unique architectural treatment of Ashleigh Grove

7.3.6 Building materials comprise a mix of coursed rubble stone and brick with white painted render with red brick chimney stacks. Old Gunter’s Barn has stone walling. Ashleigh Grove **(Fig.10)** has a mix of rendered brick, weatherboarding and timber and glazing panels with a fully glazed north elevation. Roof coverings are generally natural slate, with the exception of Westgate Cottage with clay pantiles and corrugated iron to agricultural

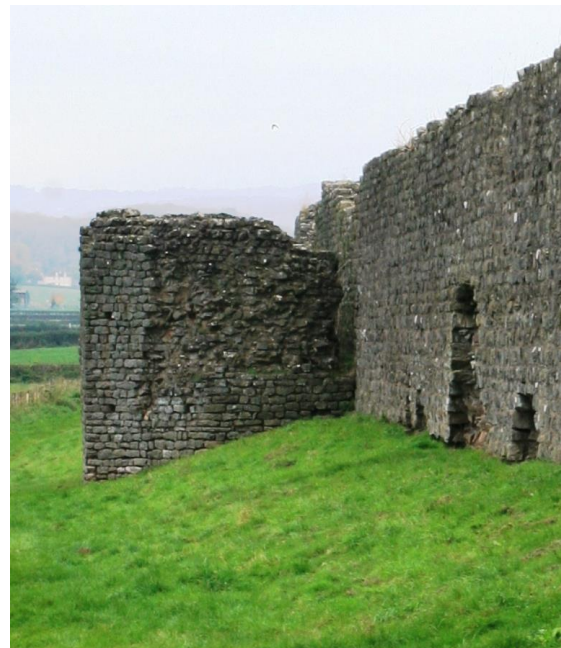
Fig.12 Bastion on the south wall projecting over the town ditch

7.3.7 Given the character area comprises of large open fields, excellent views to the surrounding countryside and back to Caerwent can be had throughout this part of the Conservation Area. Upon entering the area from the junction with the A48 from the west there are long distance views to the tower of St Stephen and St Tathan's Church. There are closer views to the church from the roadside just west of Westgate Farm where there are also good views south-west to the notable and prominent collection of buildings at the foot of the ridge on Rodge Farm (**Fig.11**). There are correspondingly good views from the area of Rodge Farm back into the Conservation Area with a foreground of fields taking in the full extent of the south wall, the Church of St Stephen and St Tathan flanked by trees, Great House Farm to the east, and New Cottages and Westgate Cottage to the west. The A48 is screened from view to the north by a belt of trees. Distant panoramic views north and west pick up the mostly wooded hillscape beyond. From Dewstow Road in the south-east, views north are terminated by the Norman motte rising from the corner of the town wall. There are excellent views north-west from this position taking in the full extent of the southern section of the town wall with its

exposed herringbone stonework and towers rising above the ditch to the front (**Fig.12**).

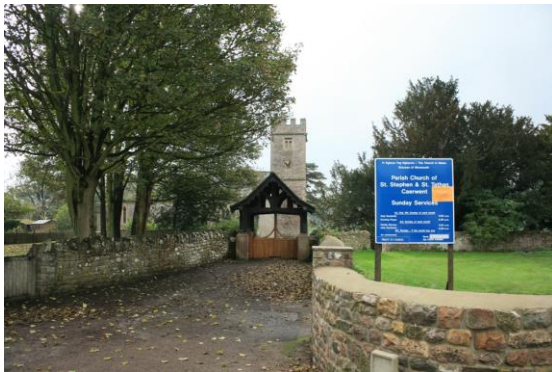
Fig.15 Stone walls are a strong feature of this part of the Conservation Area and in this case form a group with the lych gate of the church

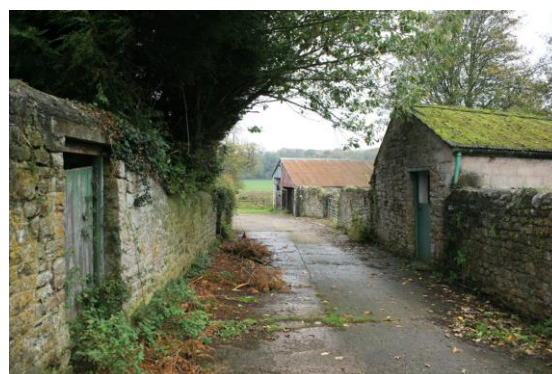
Fig.18 Series of stock yards with low stone buildings and walls enclosing them (Great House Farm)

overgrown. This track continues to the now blocked south gate. As such it is one of the few public paths which remain as part of the former Roman street plan. There is a series of single-storey outbuildings located parallel to one another on the west side of the farmhouse and forming the east side of the churchyard. They are orientated gable end facing the track (**Fig.18**). The track swings around in front of a further outbuilding, probably formerly stables and cart-shed, towards the farmhouse which is orientated north-south.

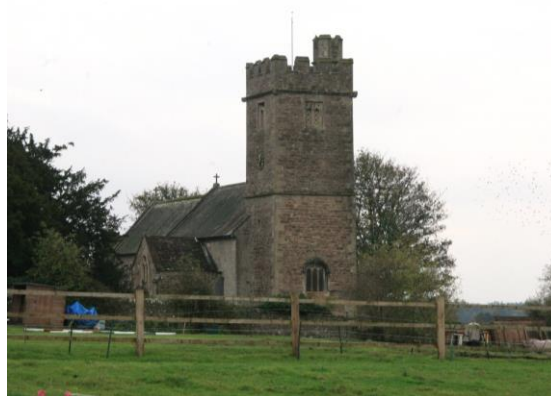
Fig.19 The Church of St Stephen and St Tathan: a mix of ashlar and coursed rubble stone with natural slate roof

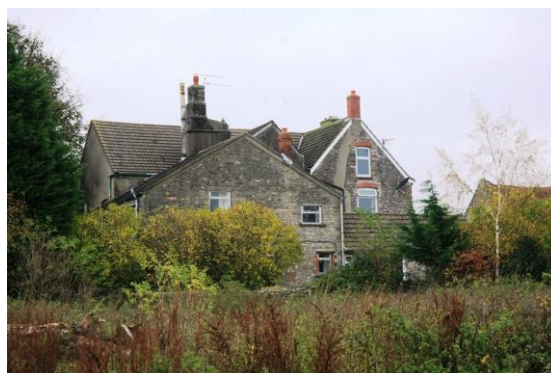
Fig.20 The prominent roof slopes of Great House farmhouse with modern concrete interlocking tiles

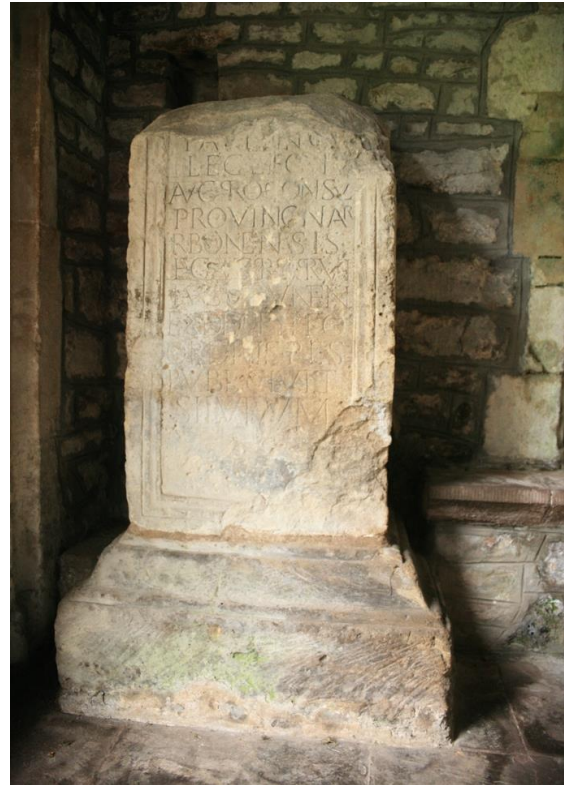
Fig.26 The inscription reads: "[To Tiberius Claudius] Paulinus, (once) commander of the Second Augustan Legion, (next) proconsul of the province of Gallia Narbonensis, (now) imperial governor of the province of Lugdunensis; by decree of the council of the community of the state of the Silures."

7.3.19 The area has a wealth of local features from the well designed unusual church lych gate to the post-Roman stone boundary walls. The Roman wall to the south is the best preserved section containing towers, the blocked South Gate with springing stones for the arch (**Fig.25**) and the Norman intervention of the earth castle motte breaking out of the south-east corner. Known below ground archaeology comprises a series of regular streets lined with buildings to the south and west of the church and baths to the north and south-east of the church. The church contains a number of Roman artefacts including two of Caerwent's finest survivals; the Paulinus Inscription statue base, and an altar dedicated to Mars-Ocelus (**Fig.26**).

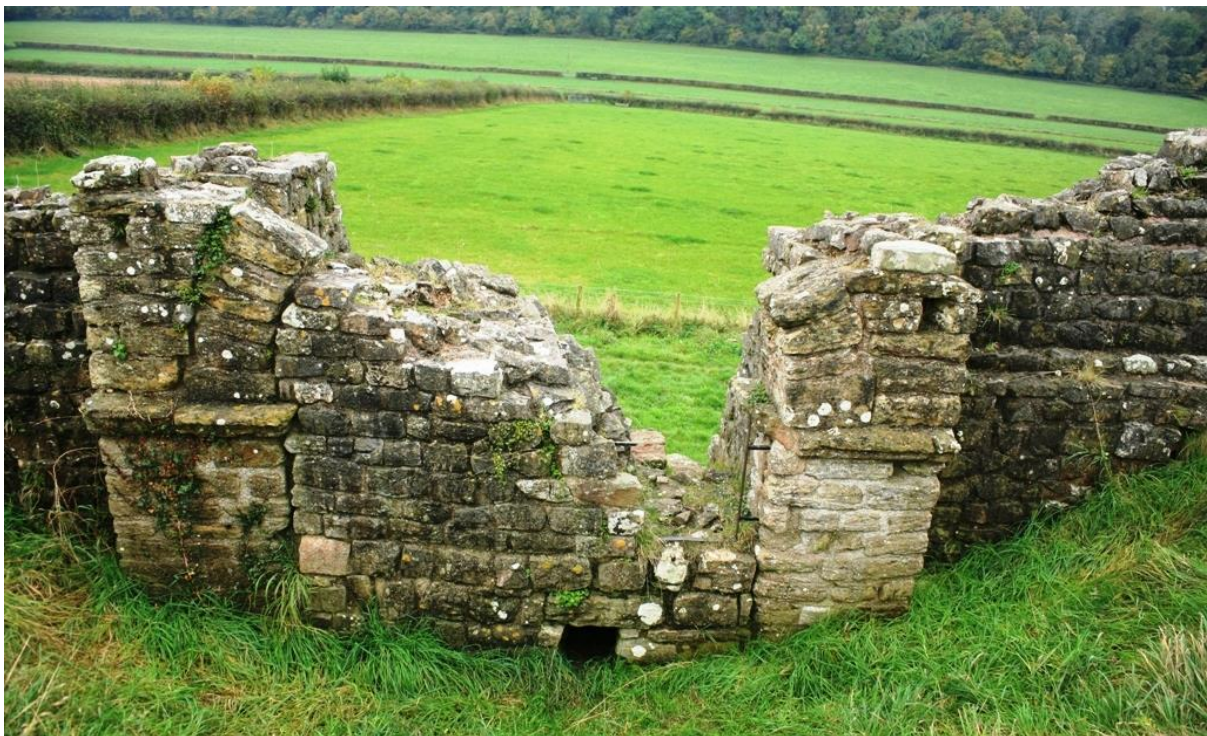
Fig.25 Ruinous South Gate with later Roman stone infill

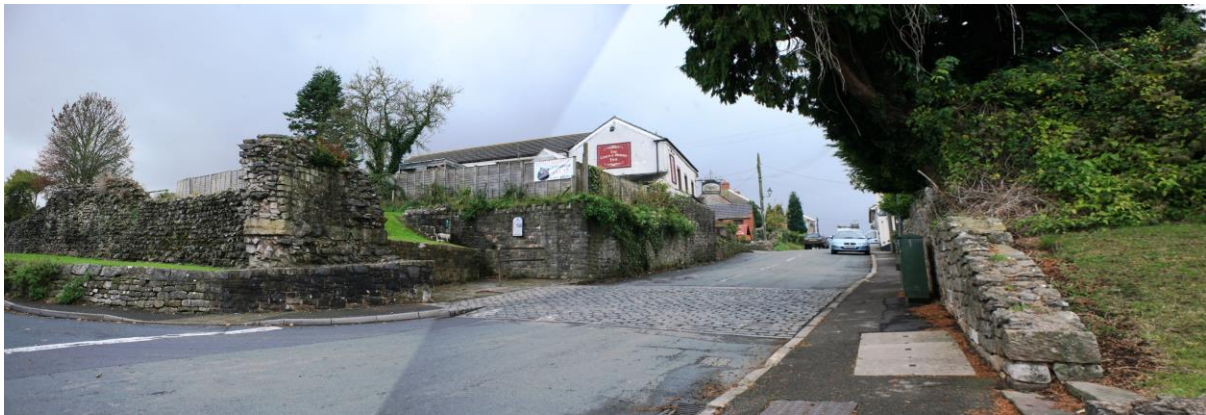
Fig.27 A series of stone setts in the road demarks the line of the Town Wall – the village core can be seen beyond

gardens of properties on the south side of the road. Apart from the approach to the East Gate (with cobbled road surface marking the entrance into the former town) this area has the character of a small linear village settlement with no real sense of the Roman town walls which encompass it (Fig.27).

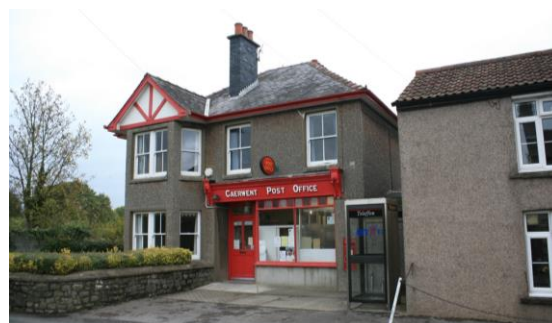
Fig.29 Caerwent Post Office - a good early 20th century timber shopfront

survival of sash windows and a shop front with consoles, transom lights and recessed door on the opposite side of the road to the north (Fig.29). Other buildings along the roadside such as the Coach and Horses Inn and the stone building known as The Stores have retained some special character, but they have undergone significant alterations. Modernisation to this part of the Conservation Area has led to the recent introduction of uPVC windows, concrete roof coverings and pebble-dashing to the detriment of the overall character and appearance of the Conservation Area (Fig.30).

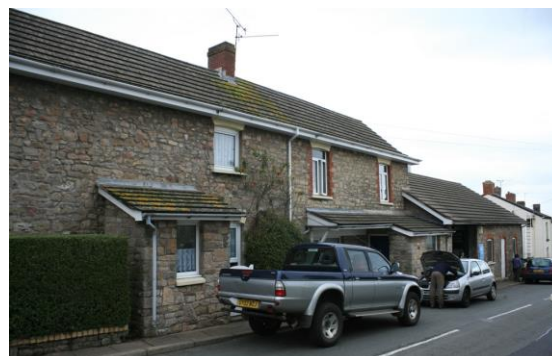
Fig.30 uPVC windows, modern roof coverings and removal of chimneys have eroded the character of the buildings in this part of the Conservation Area – compare this image with the historic photograph at Fig.57 in section 7.5

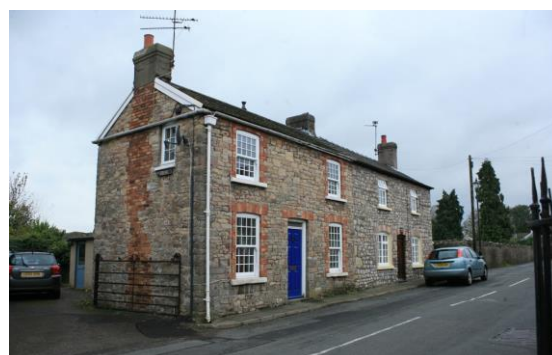
Fig.31 Roughly coursed stone with brick dressings and wrought iron gate to Weston House

7.3.23 The character area contains a mix of walling materials to houses. This includes exposed stone, white painted render and pebble-dashed buildings. Stone, laid roughly to courses, is the common building material to older properties. Roof coverings range from the traditional natural slate and clay double Roman pantiles, to modern concrete interlocking tiles. Chimney stacks are red brick or rendered with a striking blue brick stack to the Post Office. Brick is occasionally used as a dressing to window openings, for example The Stores, and red and yellow brick to Weston House and Ross House. Few original windows survive; notable exceptions are the timber vertical sliding sashes to the Post Office and small pane casements to The Steps. Stone walls are located to the front of many properties, some with large stones to lower courses and stone copings to gate piers. Hamara Gher retains its iron railings to the front boundary and there is a good iron gate to Weston House (Fig.31).

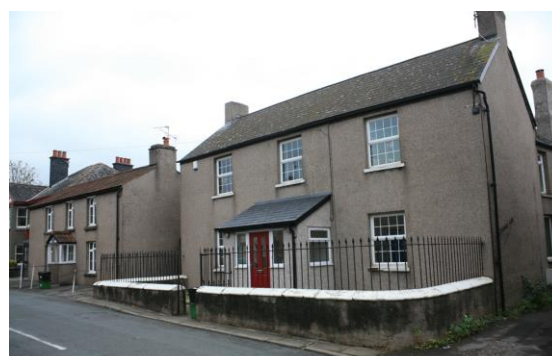
Fig.32 Some survival of iron railings to front boundaries

Local features include the Post Office shopfront, stone boundary walls extending up from the East Gate and in front of houses, and the survival of some iron railings (Fig.32).

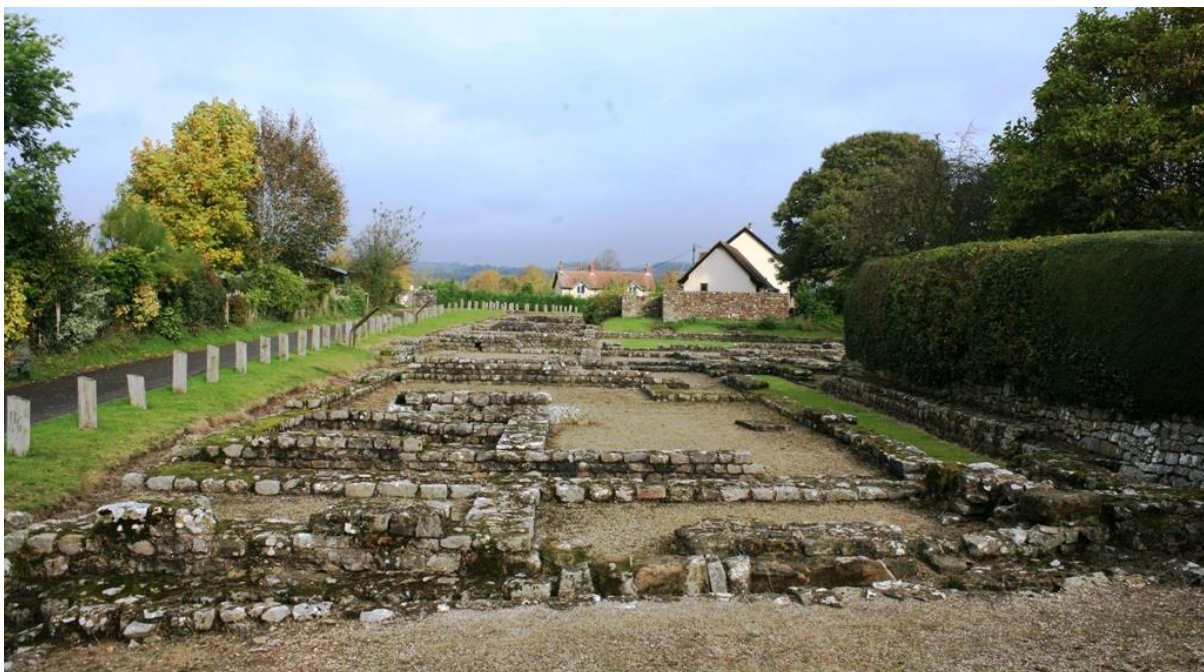
Fig.33 Excavated remains of Roman shops to the east side of Pound Lane

7.3.28 Pound Lane cuts through to the north and on its east side are the remains of a series of Roman shops (**Fig.33** previous page). Houses are two-storey or one-and-a-half-storey and generally long ranges, set on the side of roads with generous open gardens bounded by low stone walls. Gables set to the side of the road are also a notable feature of this sub area. The open spaces between built form is an important characteristic of this part of the Conservation Area. To the north, New House is set at an angle between Pound Lane and the northern access road. To the west the road opens out to fields and the exposed remains of a large 4th century courtyard house. At the junction of Pound Lane and the access road Widows Cottage is set on the west side of the road, gable end on. Opposite is Vine Tree, set at a similar angle, and then the chapel set back off the roadside behind a stone wall and graveyard, facing west. Attached to the chapel at an angle to the north are Byeways and Museum House. Travelling south the stone school building is positioned behind railings to the east with the semi-detached Myrtle Cottage and Briardene facing south, gable end on to the road (**Fig.34**).

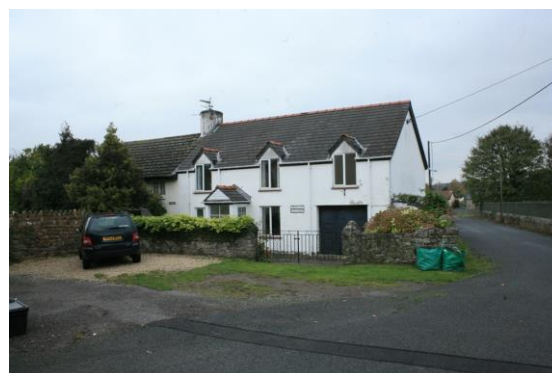
Fig.34 Myrtle Cottage, gable on to the roadside

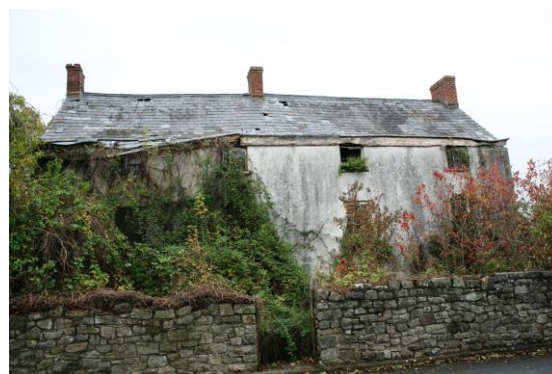
Fig.35 Caerwent House: a significant building in the Conservation Area is in a very poor condition

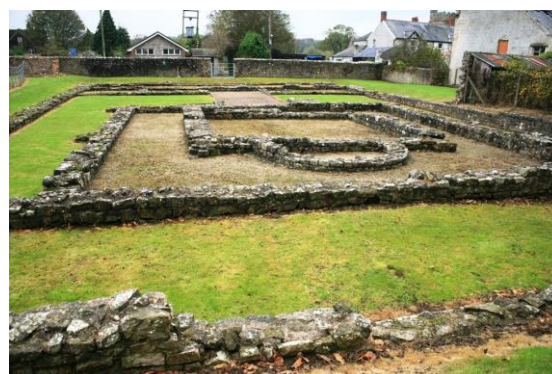
Fig.36 The excavated remains of a Romano-Celtic temple to the east of Caerwent House

the Forum-Basilica. Part of the remains of what was the principal public building of the Roman town and its market place are exposed with the remainder hidden in the garden of Laurel Dene and continuing under Caerwent House. East of Caerwent House is a Romano-Celtic temple, the entrance fronting the Roman road. The central position of these important Roman buildings within its grid of streets is no longer readable within the present-day townscape (**Fig.36**).

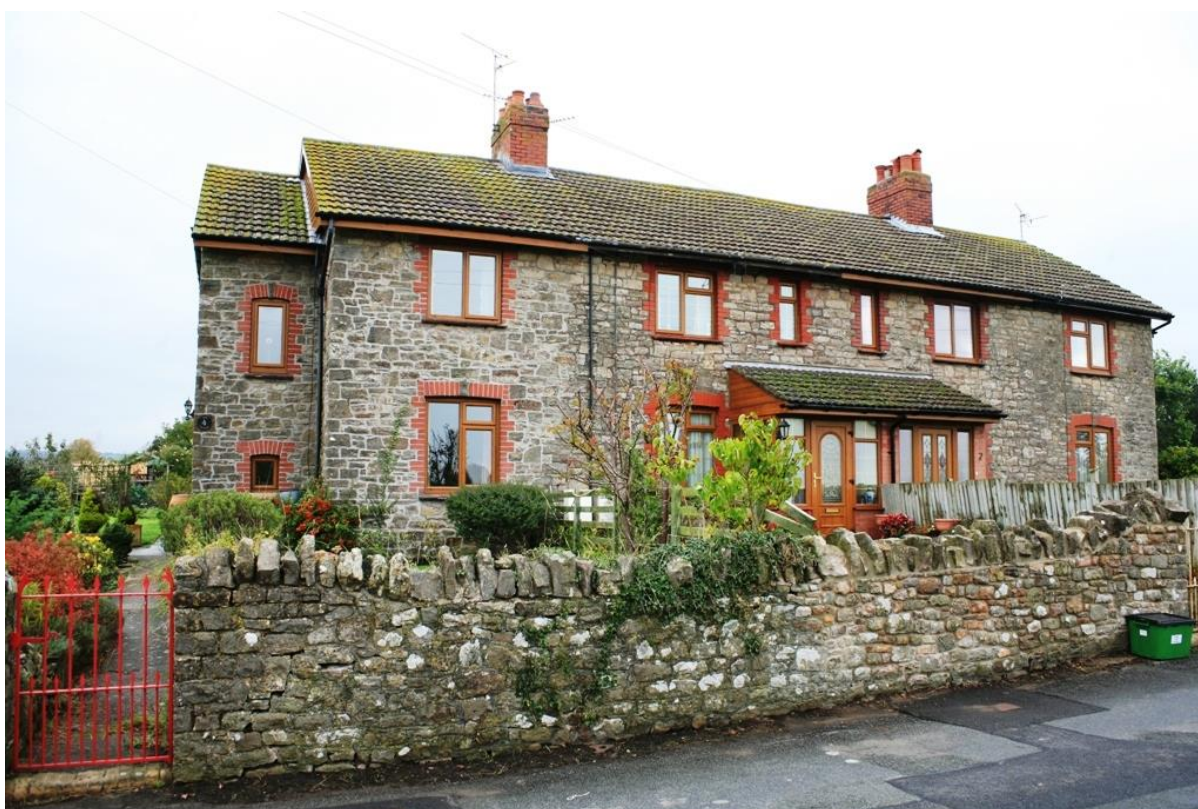
7.3.32 There is more consistency in terms of materials to this part of the Conservation Area, with the buildings predominantly comprising rendered stone painted white or cream. There are some whitewashed stone buildings such as the Cadw visitor barn and other exposed stone buildings such as the former school, Byeways and New Cottages. There is a mixture of stone and red brick outbuildings as well as modern but modest timber garden sheds. Stone façades (walls) often have red brick dressings around window and door openings. Chimney stacks are usually red brick, exposed or rendered. Roofs are generally natural slate with a small number of examples of clay pantiles and plain clay tile roofs. Many roofs to 20th century buildings and to older buildings are now concrete tiles. There are few original windows surviving. Caerwent House has good timber, six over six vertical sliding sashes, as does Byeways; others such as New Cottages have had wholesale replacement (**Fig.37**).

Fig.37 Modern windows and roof covering to New Cottage

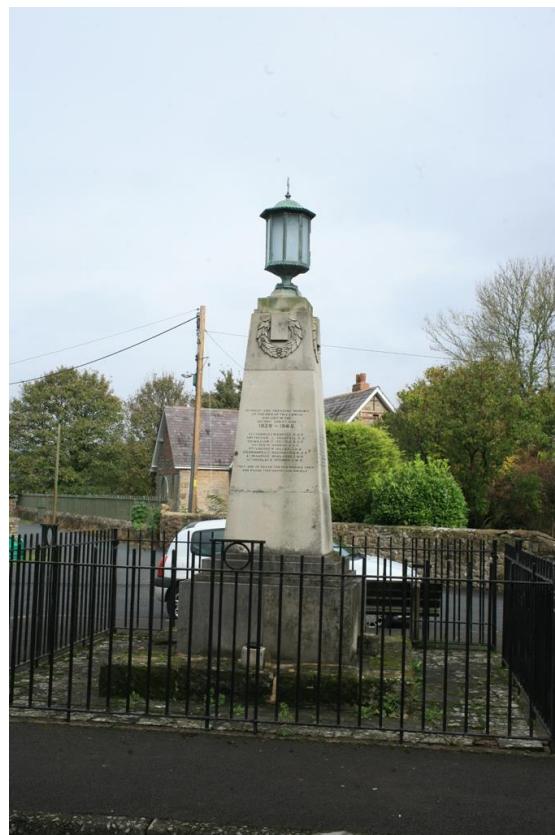
Fig.39 War Memorial at the junction of the east-west Roman road and Pound Lane is a key village landmark

the Roman town walls. The Portland stone War Memorial is a key local landmark. (**Fig.39**)

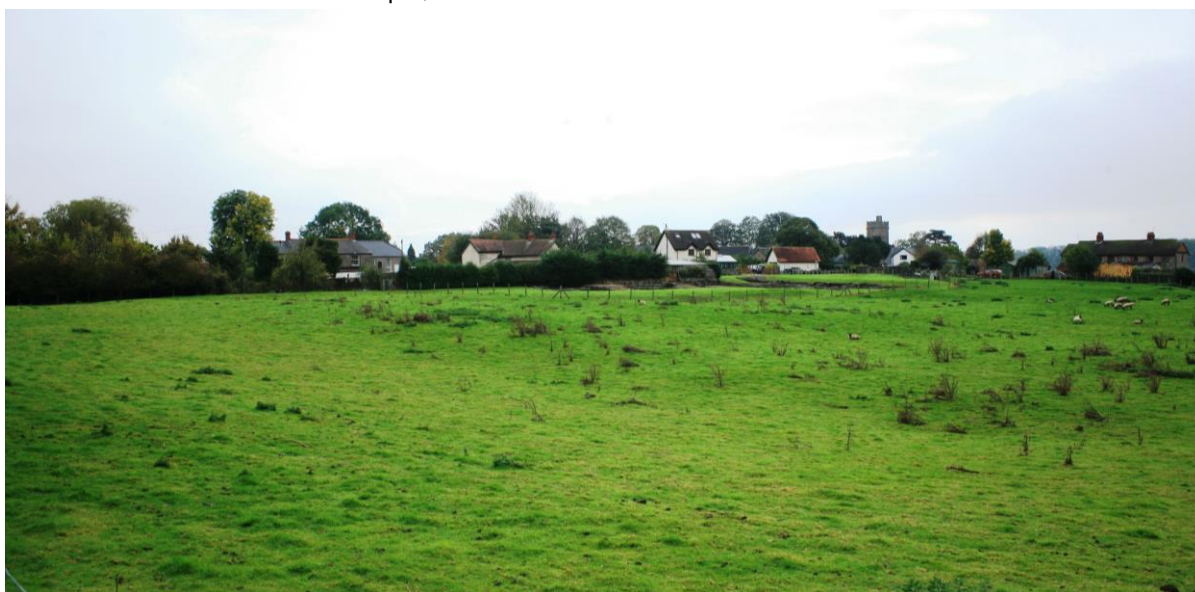
Fig.38 One of a series of views looking south-east towards the church with the Forum Basilica in the foreground taken from the open fields to the west

7.3.33 There are many key views across the character area to the Church of St Stephen and St Tathan with its landmark west tower. There are views south from the northern approach as the road narrows opposite the Evangelical chapel. More open views of the church are to be had from the fields in the north-west corner of the town wall. In addition to the church, the War Memorial is a focal point at the junction of roads, acting as a nodal point in the village and is seen in extended views along the roads crossing through the character area. From the fields to the north-western corner there are general views west towards the distant hills. The fields, east and west, act as important green spaces, many with public rights of way. The rough pasture fields to the east are dotted with groups of trees and piles of masonry, possibly remains of unexcavated Roman buildings adding to a sense that there is more to discover about the Roman town and later settlement. Views from these fields are restricted by the trees but there are glimpsed views south to the north side of the village core character area and more open views to the remains of the Forum Basilica (**Fig.38**).

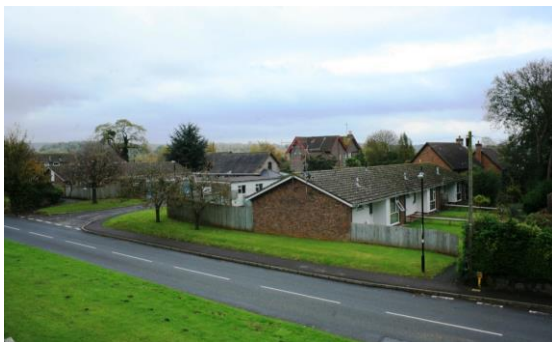
Fig.41 St Stephen's Close: modern development upon former gardens and orchards of the Vicarage

7.3.37 The houses in this character area are predominantly modest two-storey detached and semi-detached houses with occasional large, more dominant buildings (for example, Northgate Inn, Green Lane). Buildings to the north are set backing onto the Roman town wall. Those on the lane to the east are set facing the roadside, positioned behind small front gardens, some with driveways. The almshouses are set in a 'U' plan with front parking spaces and greens to the courtyard space facing the roadside. Caerwent Gardens and Vicarage Gardens have modest detached two-storey houses set at angles to the access roads with the Old Vicarage set back facing north. The closes occupy the original gardens of the vicarage and now significantly impact upon the setting of the original building and its coach house. St Stephen's Close contains two parallel rows of modern single storey blocks of houses facing inwards with car parking and garage blocks surrounded by close-boarded timber fences (**Fig.41**).

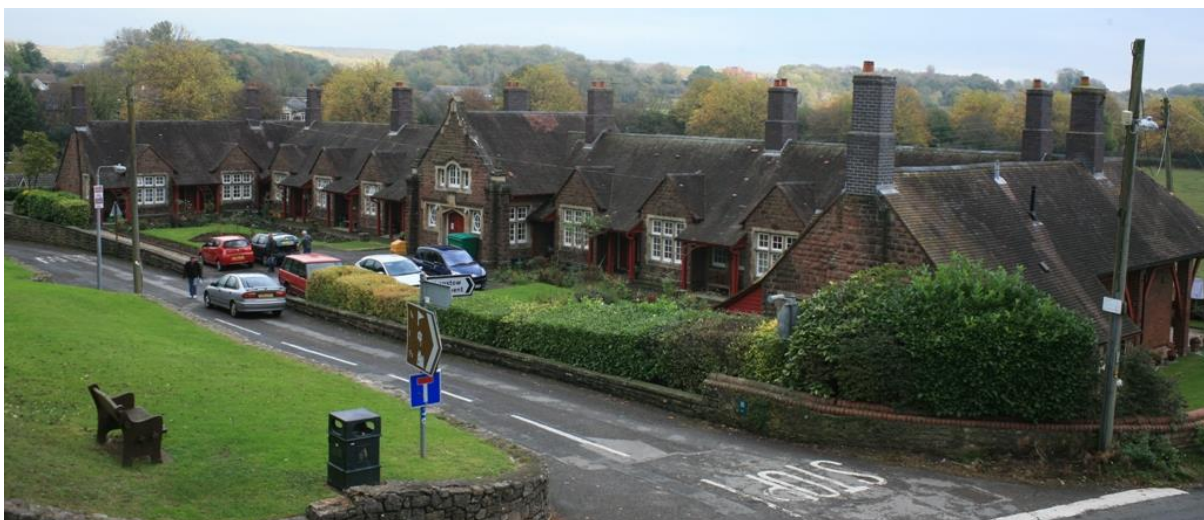
Fig.40 The Grade II listed Burton Homes Almshouses

7.3.36 The character area contains a variety of indifferent buildings, but there are some distinctive buildings such as the Old Vicarage and the twelve houses which make up the 1913 Burton Homes Almshouse complex (**Fig.40**).

7.4.13 The Burton Homes Almshouses (Grade II listed, **Fig.54**) facing the eastern walls were built in 1913 as 12 small, single storey house units traditionally arranged in a rectangular U-shaped plan, either side of a central entrance building. The design has Arts and Crafts and vernacular Revival elements, but it is also a rather free eclectic mix of styles and reinterpretations, with a Tudor styled door and 'squashed' tripartite windows above. Timber porches supported by slender red painted posts front and back, are an eye-catching feature. It is constructed in red sandstone, with Bath stone mullions, cills and copings.

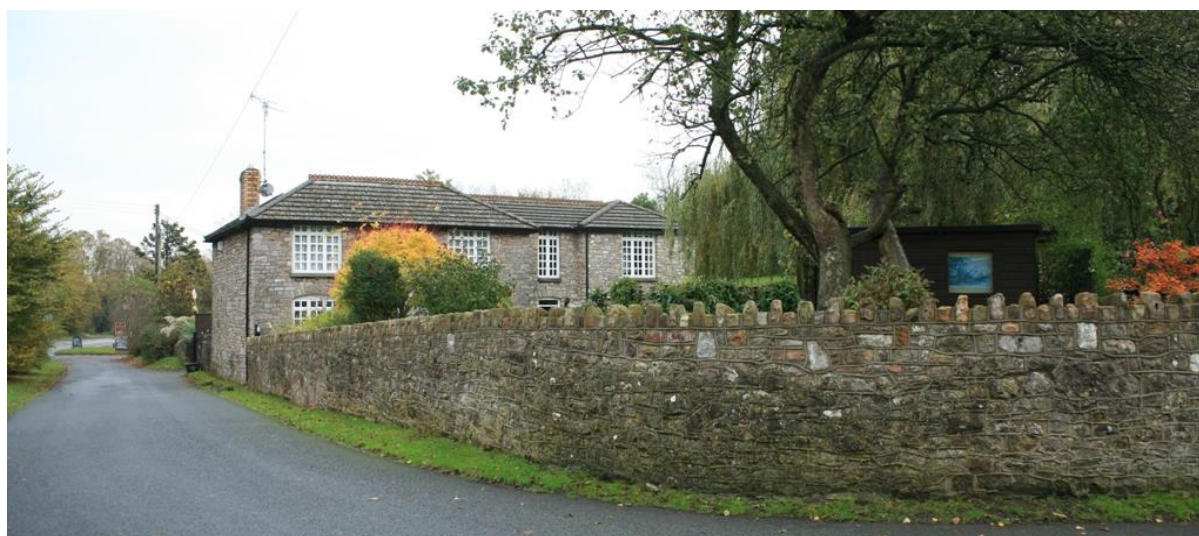
Fig.43 Green Lane with its large multi-pane casement windows, an unusual feature in the Conservation Area

is constructed of dressed rock-faced stone with Tudor style stone windows. 20th century housing developments are generally brick, modern red or brown facing bricks, with concrete roof tiles and dark stained windows and doors. There are stone walls lining stretches of the lane running along the east wall, topped with coped bricks to the east side. Stone cobbles on the road mark the East Gate entrance and form the boundary to the Village Core character area to the west. Natural slate, once the dominant roof covering, has often been replaced with concrete tiles. There are occasional plain clay tiles (Northgate Inn) or pantiles (Maybury). Most traditional windows have been replaced with modern uPVC designs, especially evident on the lane along the east wall. Timber casements can be seen to Green Lane, Burton Homes Almshouses and the Old Vicarage (**Fig.43**).

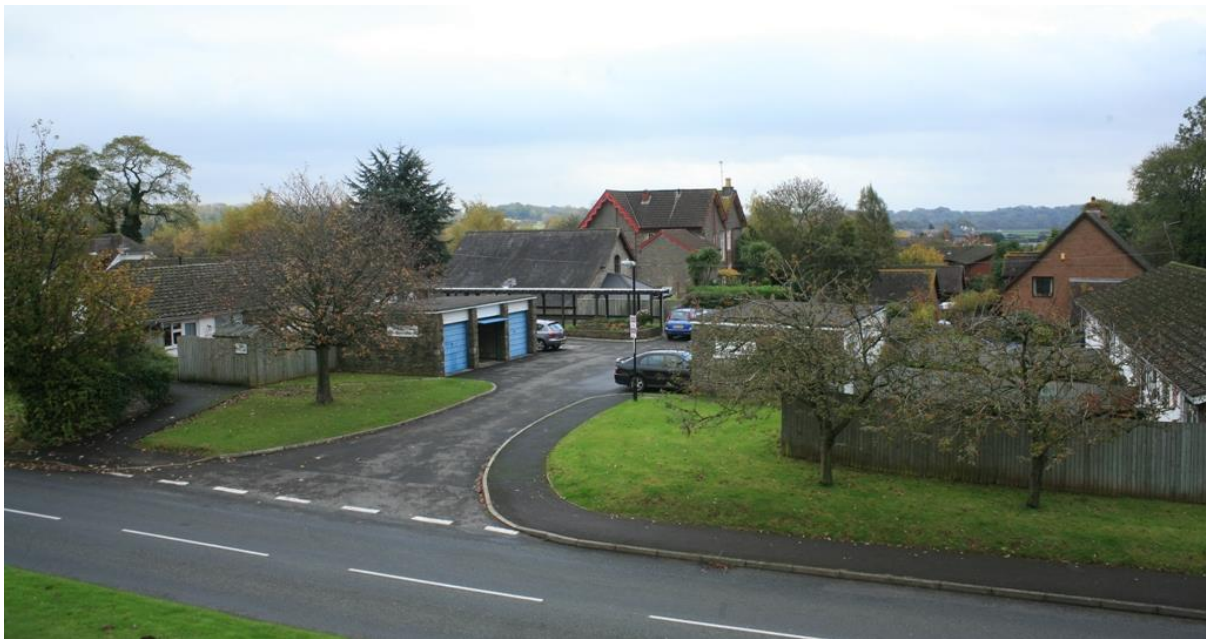
Fig.44 The Old Vicarage seen from the east walls of the Roman Town

the field to the east. There are good views east from the vantage point of the elevated land within the town wall on the east side, south of the East Gate to the Old Vicarage (**Fig.44**), surrounded by 20th century development. There are no open spaces of note.

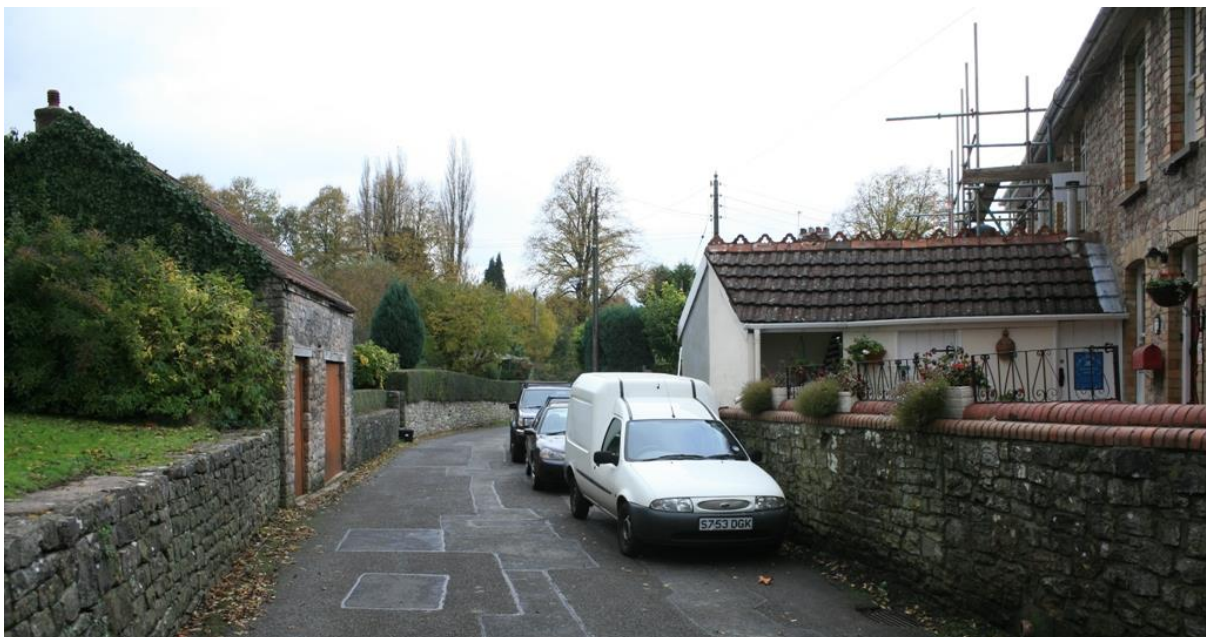
Fig.45 Low stone walls strongly define some sections of narrow lanes within this character area

7.3.41 The post-Roman stone walls lining the lane along the east wall are important features within this character area (**Fig.45**).

7.4.10 Two late 19th century semi-detached cottages to the east side of the lane running parallel to the north-east section of the town walls have hipped roofs and are interesting in that their single storey service wings are on the front elevation terminating along the line of the property line (see **Fig.45**). These brick wings contrast with the main stone building with buff brick dressings.

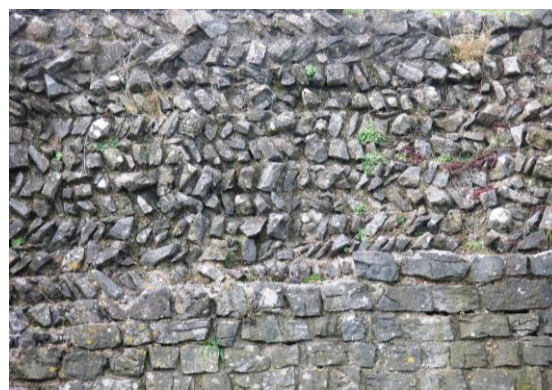
walls can be seen in places where the facing stonework is missing revealing the core of herringbone masonry (Fig.47). However, the impressive Roman town wall remains a key feature, best appreciated from outside the walls. These walls are a mix of limestone with dressed sandstone blocks. The north and south gateways are still visible, blocked with stone during the Roman period. The herringbone pattern construction of the central core of the walls is most visible on the south wall. To the north wall areas are lost under grass and obscured in gardens. The north wall and particularly the North Gate has a particularly poor setting and some sections have become 'domesticated', and in some cases rebuilt or built over, forming parts of ornamental gardens.

Fig.47 A detail of the Roman wall showing the herringbone stonework of the core structure and the facing stonework

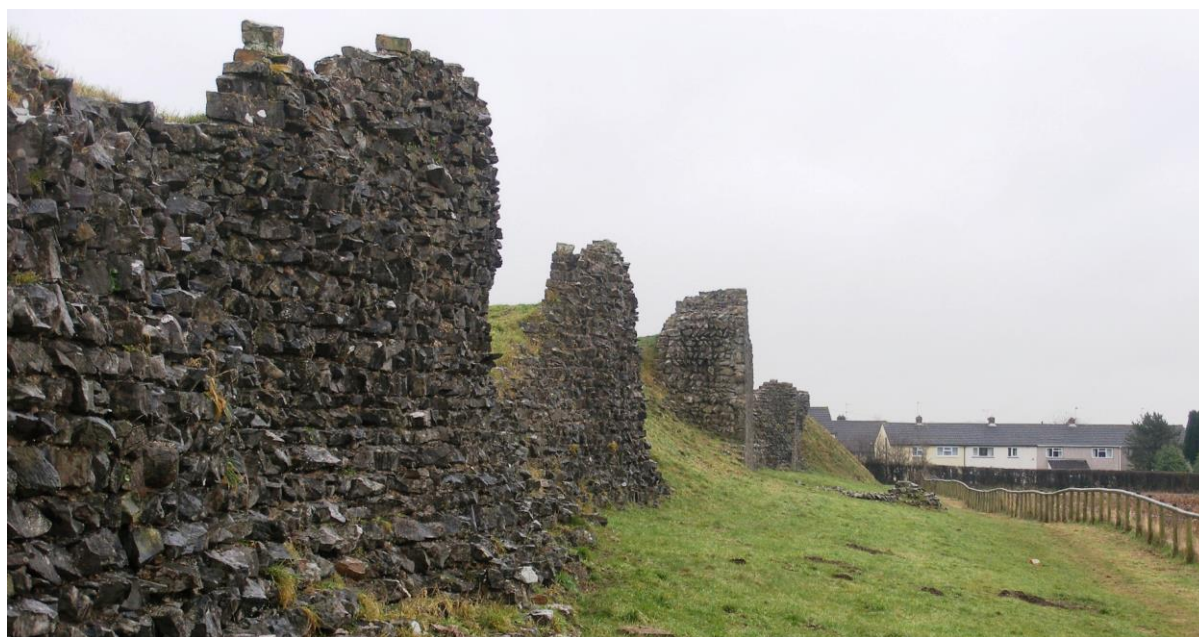
Fig.46 Roman walls and bastions overlooking the shallow valley on the south side of Caerwent

7.4.2 The walls and bastions are seen at their most striking chiefly along the southern boundary, rising to about 5 metres in height as the land falls away to the watercourse of the Nedern Brook (Fig.46). The eastern walls are also impressive but with fewer bastions, except at the East Gate. They are less visible from a distance as recent development extends to the road skirting the walls along this boundary. On the northern side some buildings back onto the walls, such as the Northgate Inn and the Kitchen Shop. The construction of the

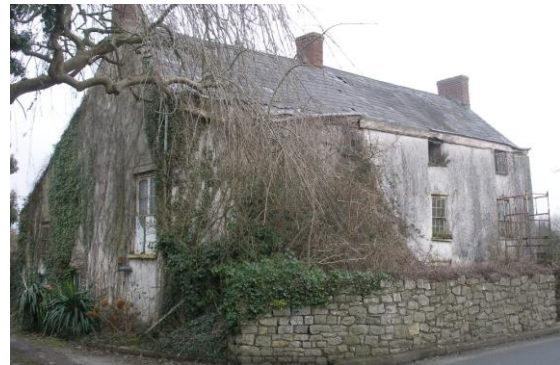
Fig.49 Caerwent House: a significant historic building in a critical state of disrepair

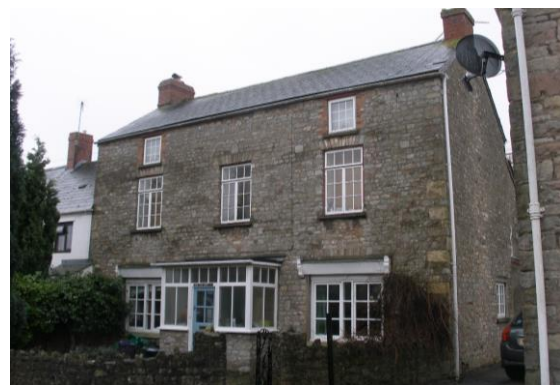
Fig.50 "The Old Ship": an attractive three storey former inn, with interesting windows and re-used shopfront

7.4.6 At the eastern end of the settlement within the Roman walls, on the south side of the main road, the three storey Old Ship former inn is dated 1760 (**Fig.50**). This is a simple building of coursed rubble with a shallow pitched roof, and former shop-type fascias either side of a glazed conservatory porch. The fenestration is interesting; those on the first floor being casements below a fixed full width light. The window openings are formed from rough stone voussoirs. On the back edge of the pavement next to the Old Ship is Ross House also dated c1760, a double pile two-storey stone house with end stacks.

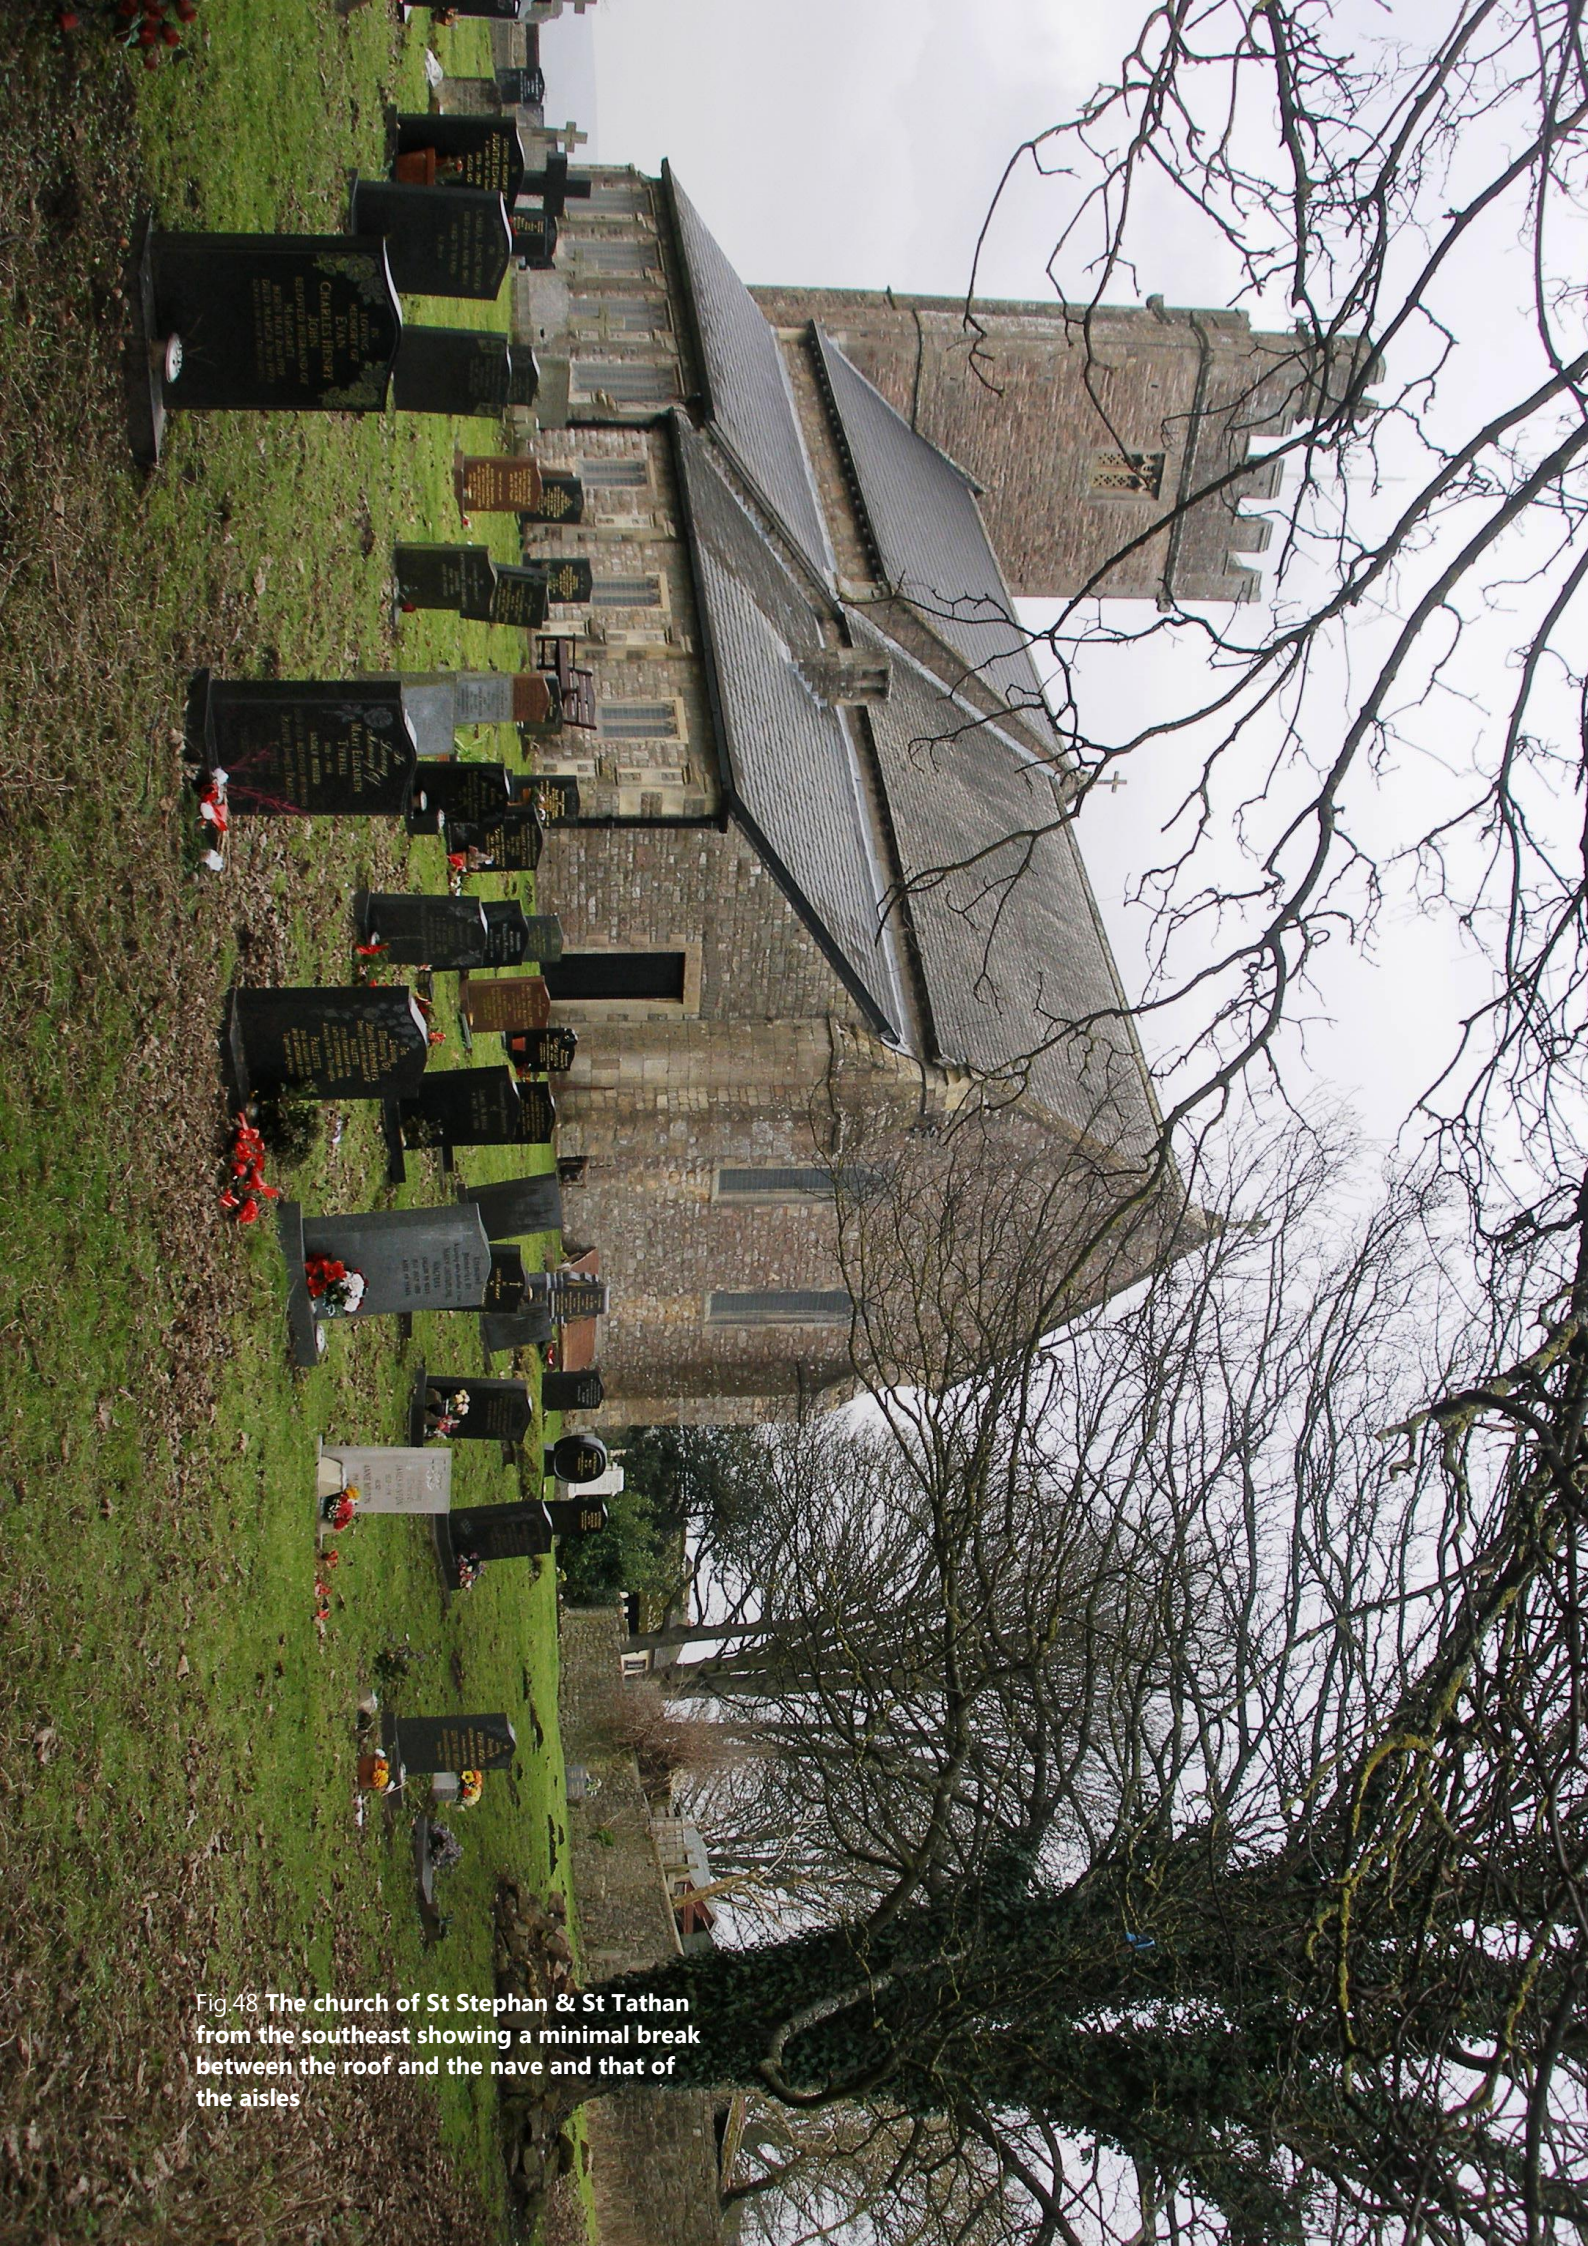
Fig.48 The church of St Stephan & St Tathan from the southeast showing a minimal break between the roof and the nave and that of the aisles

7.4.3 The church of St Stephen and St Tathan (Grade II* listed, **Fig.48** next page) is relatively large for a smaller community. It stands in an almost central location within the walls, just south of the main east-west road, a church is recorded in Caerwent from pre Norman times, but the existing church was begun in the 13th century, conventionally at the east end, in the Early English style. Most of the body of the church is from the Perpendicular period some 200 years later. The handsome west tower also dates from this time. It is given a visual strength and attraction through the 'entasis' (slightly tapering) of the walls. The tower is crenellated, with an external stair tower to the south. The nave and chancel do not have clerestory windows, as the roofs of the aisles extend almost to the eaves of the nave and chancel. The chancel is lit by narrow Early English lancets and the aisles by Perpendicular style square hood moulded triple windows. The church was extensively restored in the mid-19th century.

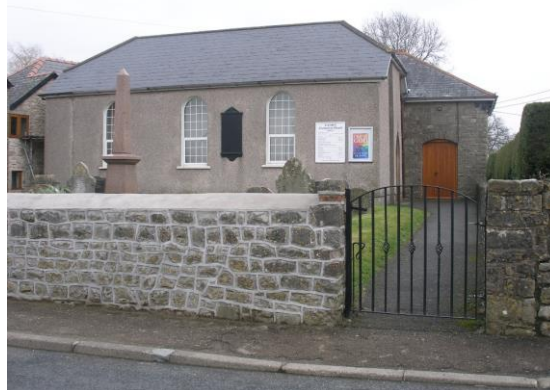
7.4.7 The Evangelical chapel (**Fig.51**) standing back from its frontage behind a small graveyard dates from the early 19th century. It has a simple rectangular plan with a side porch entrance and three tall arched windows on its main façade. The chapel has a half hipped slate roof and is rendered. The house on its northern boundary is probably of a similar date, certainly not later. It is a three bay, stone building which forms an attractive group with the chapel.

Fig.51 The simple Evangelical Chapel stands behind its graveyard and is framed by a well maintained cottage on its northern side

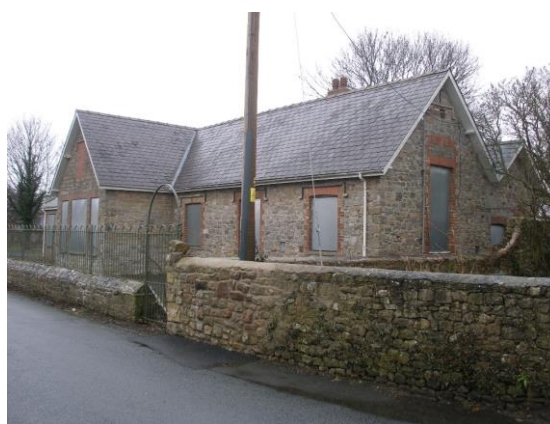
7.4.8 The former school, now a nursery, is a low, single storey cruciform plan building, probably from the mid-19th century (**Fig.52**). It is constructed from coursed rubble with red brick soldier arches and dressings to the windows. The window heads have square hooded drip moulds of a neo-Tudor type. The slate roofs have projecting gable eaves.

Fig.52 The former Village School: this robustly detailed late Victorian building is now used as a nursery

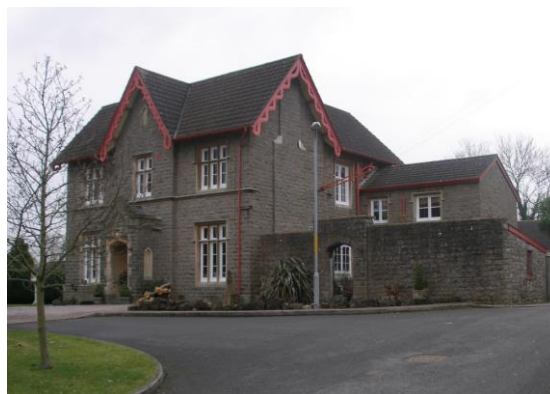
7.4.9 The former vicarage (**Fig.53**) to the east of the Roman town was built in 1845-6 by the architect J. H. Langdon. It is a tall neo-Tudor building having a symmetrical main façade with a central gable in the steep pitched roofs; the gables having decorative bargeboards. The windows are triple mullioned and transomed and the projecting porch has a Tudor arched doorway. It is a somewhat severe building in coursed grey sandstone blocks, its setting compromised to a significant degree by later development.

Fig.53 The former Vicarage, outside the walls, is a severe but well designed neo-Tudor building of 1845-6. It appears that its chimneys were removed at a later date.
