Caerwent

*Conservation Area
Appraisal &
Management Proposals*

Report Title: Caerwent Conservation Area Appraisal & Management Proposals
Client: Monmouthshire County Council
Project Number: 2009/089

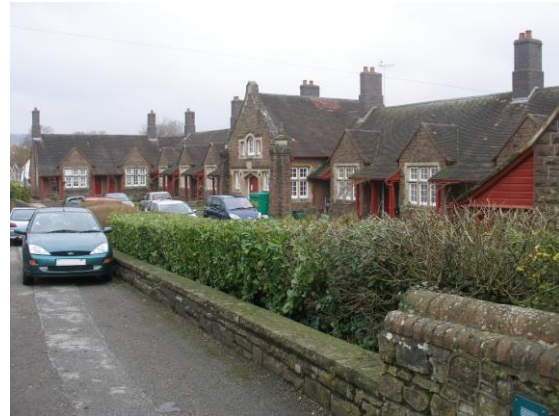
Fig.54 The Burton Almshouses (1913) are a good example of the rather eclectic mix of Arts and Crafts and Arts Nouveau styles prevalent at the time

7.4.13 The Burton Homes Almshouses (Grade II listed, **Fig.54**) facing the eastern walls were built in 1913 as 12 small, single storey house units traditionally arranged in a rectangular U-shaped plan, either side of a central entrance building. The design has Arts and Crafts and vernacular Revival elements, but it is also a rather free eclectic mix of styles and reinterpretations, with a Tudor styled door and 'squashed' tripartite windows above. Timber porches supported by slender red painted posts front and back, are an eye-catching feature. It is constructed in red sandstone, with Bath stone mullions, cills and copings.

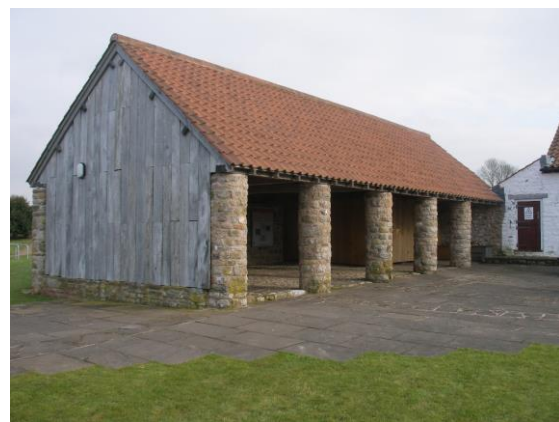
Fig.55 The recently, sensitively converted buildings providing a visitor facility and information point

7.4.14 The visitor facility building (**Fig.55**) adjacent to the car park and run by Cadw comprises two single storey converted farm buildings. One has rough stone columns with toilet cubicles recessed behind, in simple boarding, the other building is in white painted stonework. Both have pantiled roofs. These two buildings form a sensitive group of some considerable quality at the western edge of the built form within the walled town.

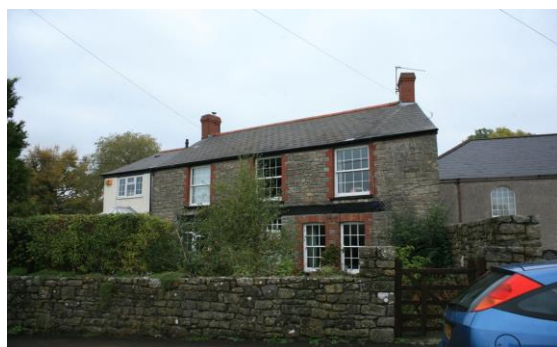
Fig.58 Stone laid to courses with red brick dressings and brick chimneys (Byeways, Pound Lane)

is the stone Byeways with sash windows and large timber lintel across the ground floor (see **Fig.58** in section 7.7).

7.7.2 Stone is a mix of local limestone and sandstone, predominantly grey but with some brown tinges to its colouration and is usually seen as rubblestone but laid to courses. Stonework to houses occasionally has red or yellow brick dressings to openings (**Fig.58**) and invariably with brick chimneys, sometimes rendered. Traditional openings in stone walls are small and timber casements were used. Later Victorian cottages have larger openings with timber vertical sliding sashes. Caerwent House, modified in the 19th century, has a good range of small pane timber sashes.

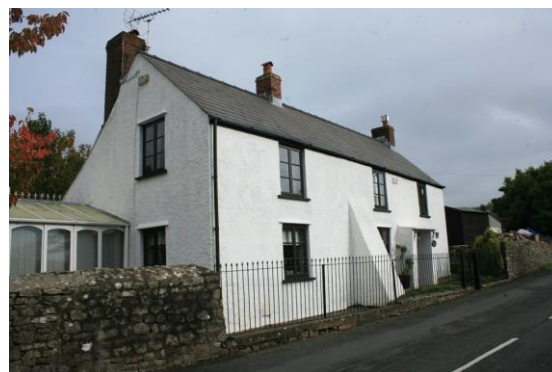
Fig.59 White painted render and natural slate roof, seen throughout the Conservation Area

7.7.3 There is much use of render to older houses and modern infill. This is generally painted (white, cream and other pastel shades) (**Fig.59**).

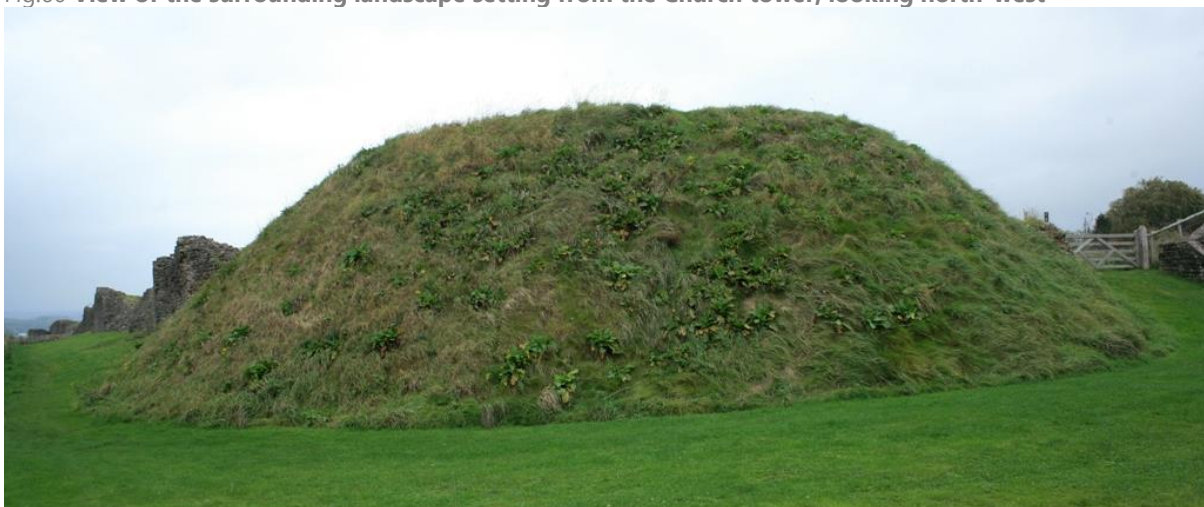
Fig.61 View of Roman town wall and Norman motte from the south

9.2.1 There are a series of strategic views south of the village looking north towards the impressive line of the south Roman town wall and Norman motte (**Fig.61**). From the south town wall there are expansive and open views of the surrounding open countryside. These views help to put the historic settlement in its landscape context. There are strategic views to the landmark church tower from the west and views out of the Conservation Area south-west to Rodge Farm.
