Llantilio Crossenny

*Conservation Area
Appraisal &
Management Proposals*

Report Title: Llantilio Crossenny Conservation Area Appraisal & Management Proposals
Client: Monmouthshire County Council
Project Number: 2009/089

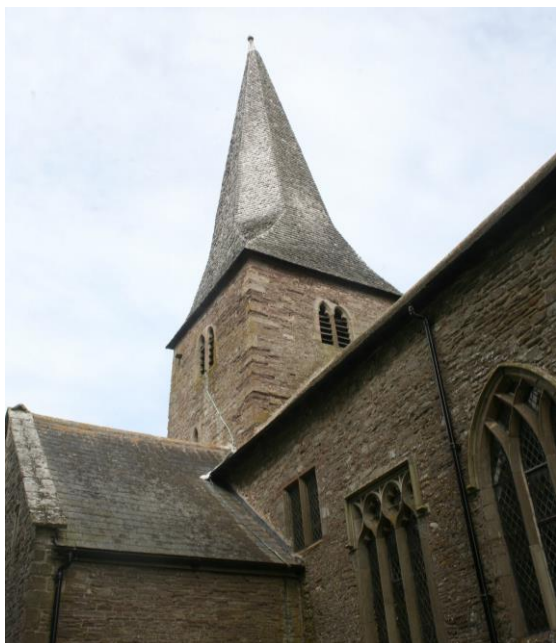
Fig.14 The sandstone church exhibits a fine shingle spire

7.3.6 The church is constructed of red sandstone rubble with ashlar dressings, slate roofs and shingle spire (**Fig.14**). The ruins of Llantilio Court are local rubble stone with substantial cut-stone sections of walls and stone and red brick vaulted cellars. The stone boundary walls to the gardens and grounds are coursed sandstone rubble with flagstone copings and cut stone mouldings to gateways (**Fig.15**). Gate piers in and around the farmstead are substantial structures with cut stone capping's. The Pavilion has rubble stone walls and a pyramidal clay tiled roof (**Fig.16**). The wall to the left of the entrance gate has 'hen and chick' coping stones. The farmhouse and stables/coach house are rendered with slate roofs and red brick chimney stacks. The house range has an ornate clock with decorative lead-work, slate roof and pinnacle. Farmhouse windows are replacement modern casements; those in the west range under Tudor style dripmoulds. Surviving windows to the coach house are multi-paned vertical sliding timber sashes. The timber veranda to the coach house is a feature of note. Farm buildings are coursed rubble stone, but display their estate status with flat cut-stone arches and dripmoulds to primary doorways. Later buildings and additions are red brick. Roofs are an attractive and vernacular mix of clay pantiles, natural slate and corrugated iron (**Fig.17**).

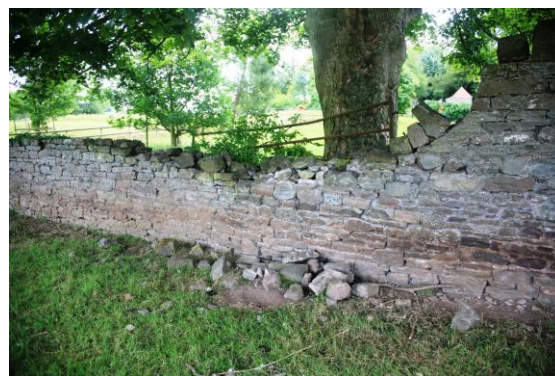
Fig.15 Coursed sandstone rubble walls are a feature of the former Court grounds

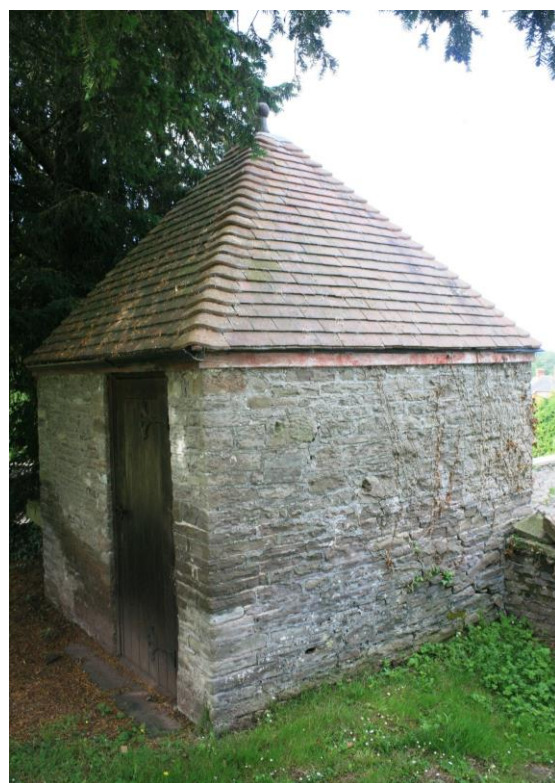
Fig.16 The Pavilion has a clay tiled pyramidal roof

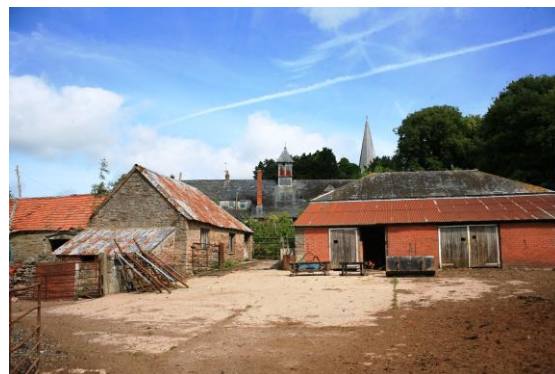
Fig.17 Agricultural buildings at Court Farm display a wide variety of materials including rubblestone, brick, clay tile, slate and corrugated iron

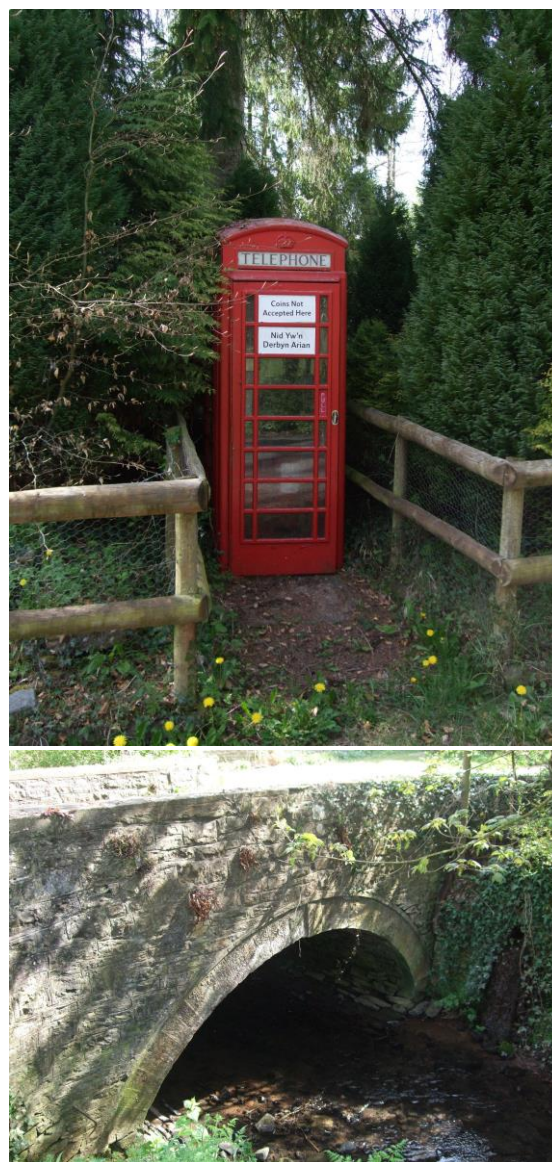
Fig.39 The traditional red 'K6' telephone box and stone arched bridge are features of considerable local note within the character area

7.3.22 The character area's features of local note include the estate-style stone cottages, the traditional red 'K6' telephone box and stone bridge over the White Castle Brook (**Fig.39**). Natural features such as the mixed native hedges, grass verges and paddocks significantly contribute to the special character of the Conservation Area.

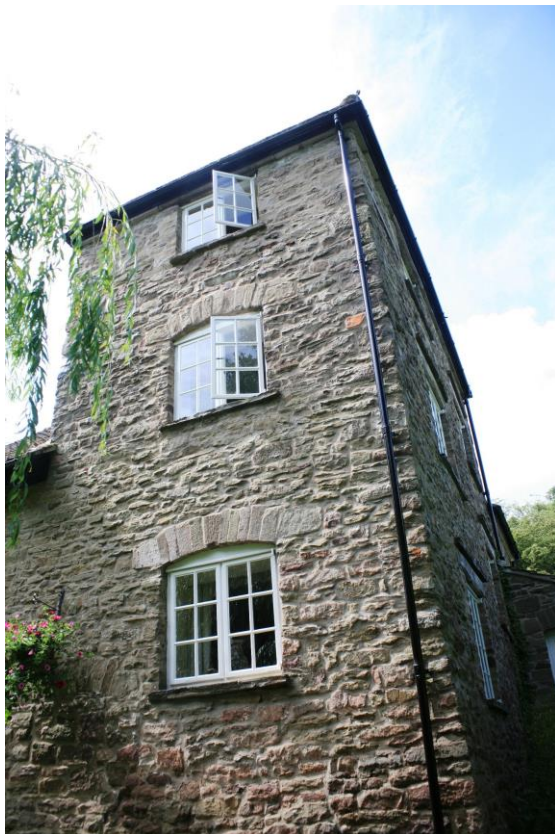
Fig.41 Characteristic rubblestone walls at Llantilio Mill

7.3.26 The mill is constructed of random rubble stone with cut-stone semi-circular arches above windows with stone sills (**Fig.41** & see **Fig.4**). The roof is clay pantile with stone chimney stacks. Windows are two light multi-pane casements. Mill Cottage is whitewashed rubblestone with dormer windows with barge boards, a natural slate roof, and rendered chimney stacks. The stone bridge is constructed of squared local stone.

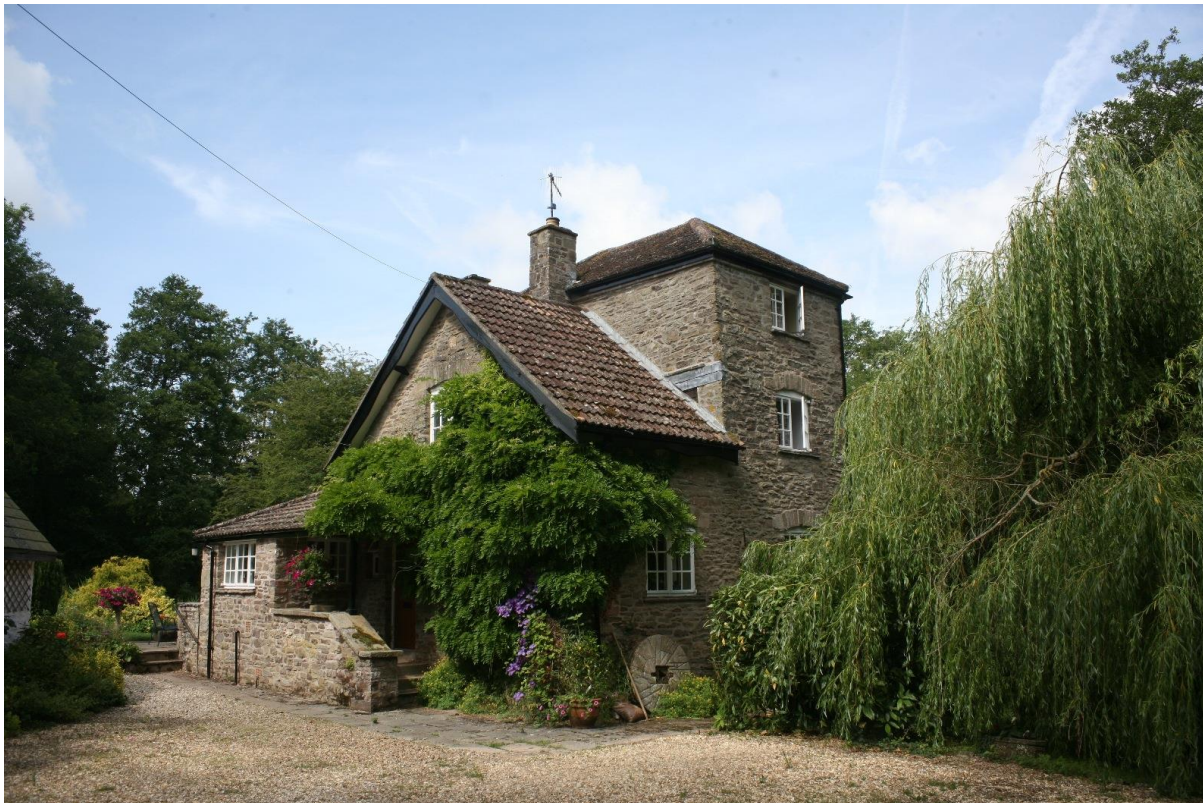
Fig.40 Llantilio Mill (top) and Mill Cottage (bottom) are isolated and form a striking group of some considerable historic and architectural interest to the south-east of the Conservation Area

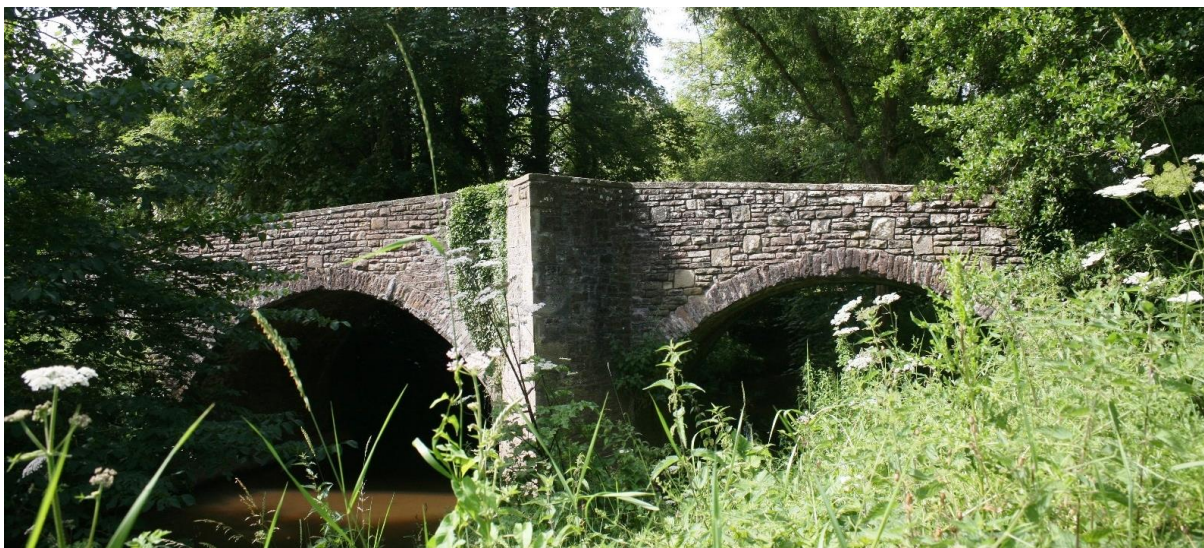
Fig.43 The stone bridge is a local feature of historic and architectural significance and forms part of the eastern approach to the village

7.3.28 The stone bridge is an important local feature forming part of the important approach to the village across the river from the south (**Fig.43**). The meadows are an important natural feature and essential wildlife habitat. The mill is a significant historic building; conversion has resulted in the loss of the original timber fourth storey of the mill 'tower' and insertion of additional window openings, but these alterations have been sensitively achieved, retaining the building's historic and architectural interest.

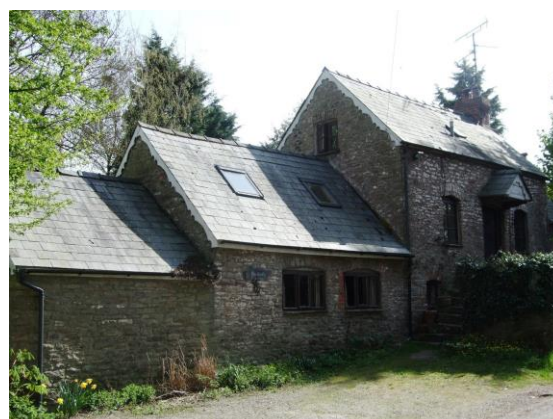
Fig.44 Former Blacksmiths. A typical vernacular composition of main building and secondary wings set out in linear fashion and of diminishing heights.

7.4.4 The former Blacksmiths (**Fig.44**) is located near the bridge, and is a linear range of buildings of diminishing heights having an upper entrance approached by a stepped platform. It is constructed of rubble under a recent slate roof and is now converted, but retains its original character and setting.

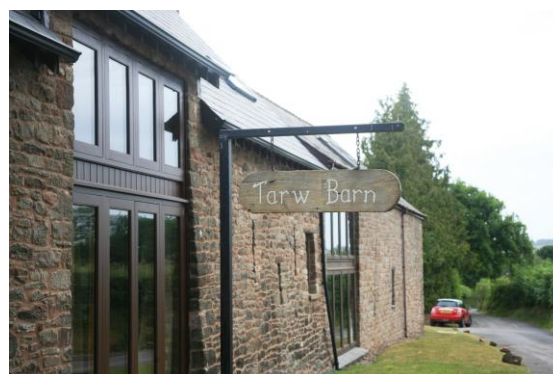
Fig.45 The Barns at White House Farm are attractive, converted traditional farm buildings but retaining many of their external characteristic features

7.4.5 The barns on the road frontage on the south-east side of White House Farm (**Fig.45**) may be contemporary with the early 18th century White House farmhouse. Whilst these are converted to residential use, they retain their simple form, slit windows and large cart door openings under a pent roof, albeit the openings are now fully glazed. The plain sandstone rubble walls are well constructed and the roofs recently re-clad with natural slate.

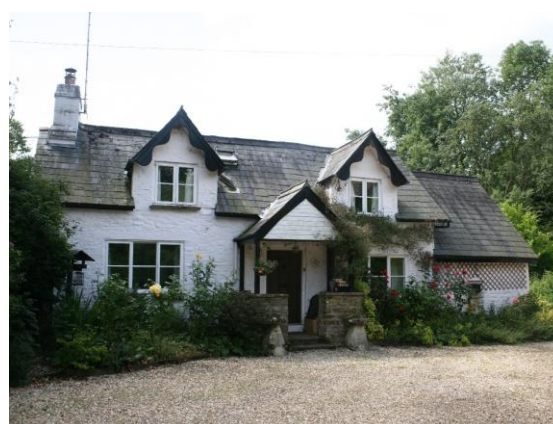
Fig.46 Cottage near the former Water Mill. Its basic form is that of a vernacular dwelling although it appears to have been adorned with later Victorian additions including the decorative bargeboards

7.4.6 Mill Cottage (**Fig.46**) is single storey with two large attic dormers. It was probably altered in the 19th century when the decorative bargeboards and porch were added, however it retains its long, low vernacular character.

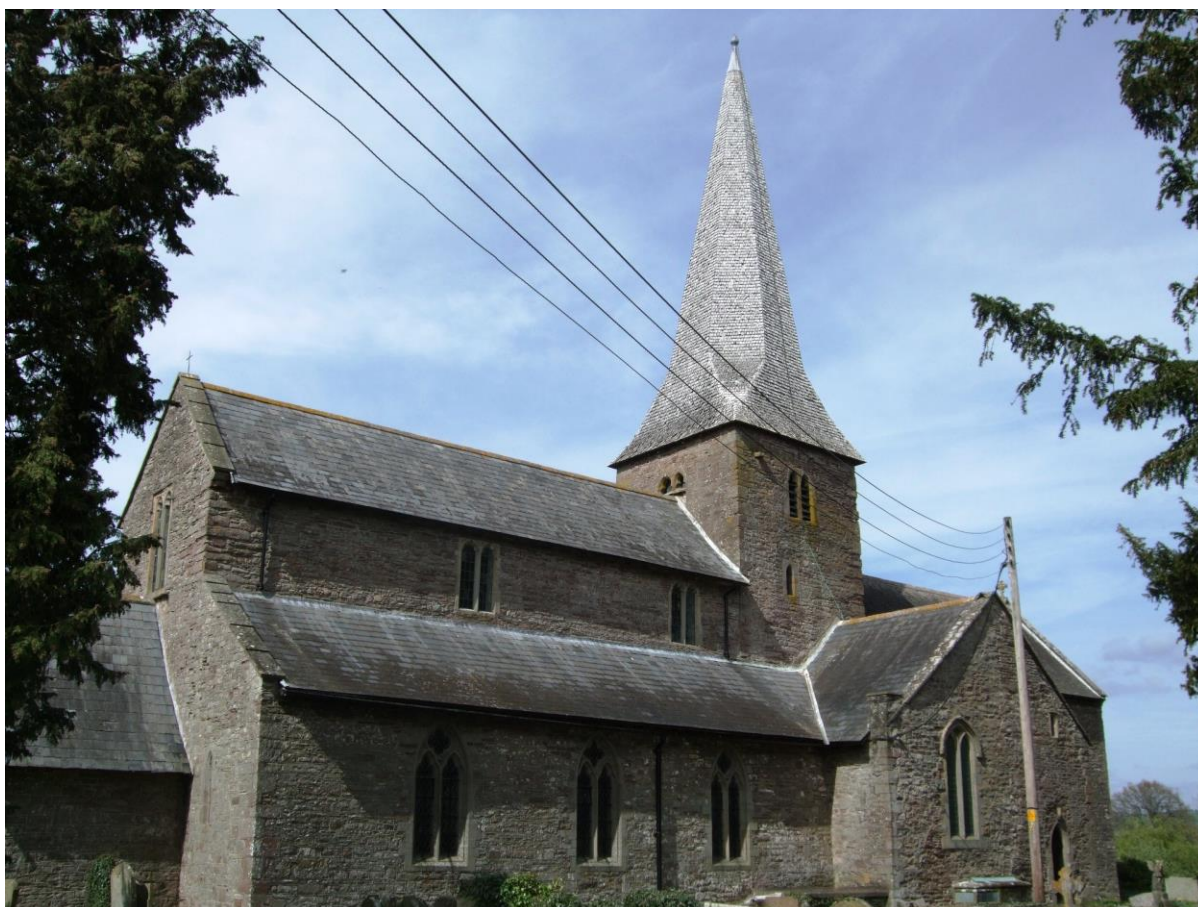
Fig.47 St Teilo's Church, a magnificent mainly 12th century cruciform church with an 18th century shingle-clad spire, is located in a commanding position in the village. The 15th century raised clerestory and west window contribute to its striking profile

7.4.7 The Church of St Teilo (Grade I listed, **Fig.47**) standing in a prominent position in the village, has a striking spire clad in wooden shingles, which can be seen from many vantage points within the Conservation Area and from the wider landscape setting. The church is constructed in Old Red Sandstone rubble, with ashlar dressings and a natural slate roof. The spire was added to the late 12th century tower in 1708-9. The core of this outstanding cruciform plan church dates from the 12th century, which is illustrated by the typical narrow lancet windows found in the aisle walls. The chancel and nave are out of alignment with each other, an unusual but not unknown feature of medieval churches. In the 15th century the nave was substantially heightened, producing a clerestory, which contributes to the quality of the fine interior space.

7.4.8 The raising of the nave has resulted in the unusual profile of the west end (masked in most churches by a west tower) recalling many Italian and Romanesque churches. The west window, at clerestory level, is contemporary with these 15th century alterations. It has a central mullion with cinquefoil cusps to each light. The window has a flat head rather than the more usual gothic pointed arch. The impact of mid-19th century restoration is relatively modest, and mainly confined to additional windows in the south aisle (in Early English style) and in the north aisle. The grand scale and interior character of the spaces remains essentially medieval.

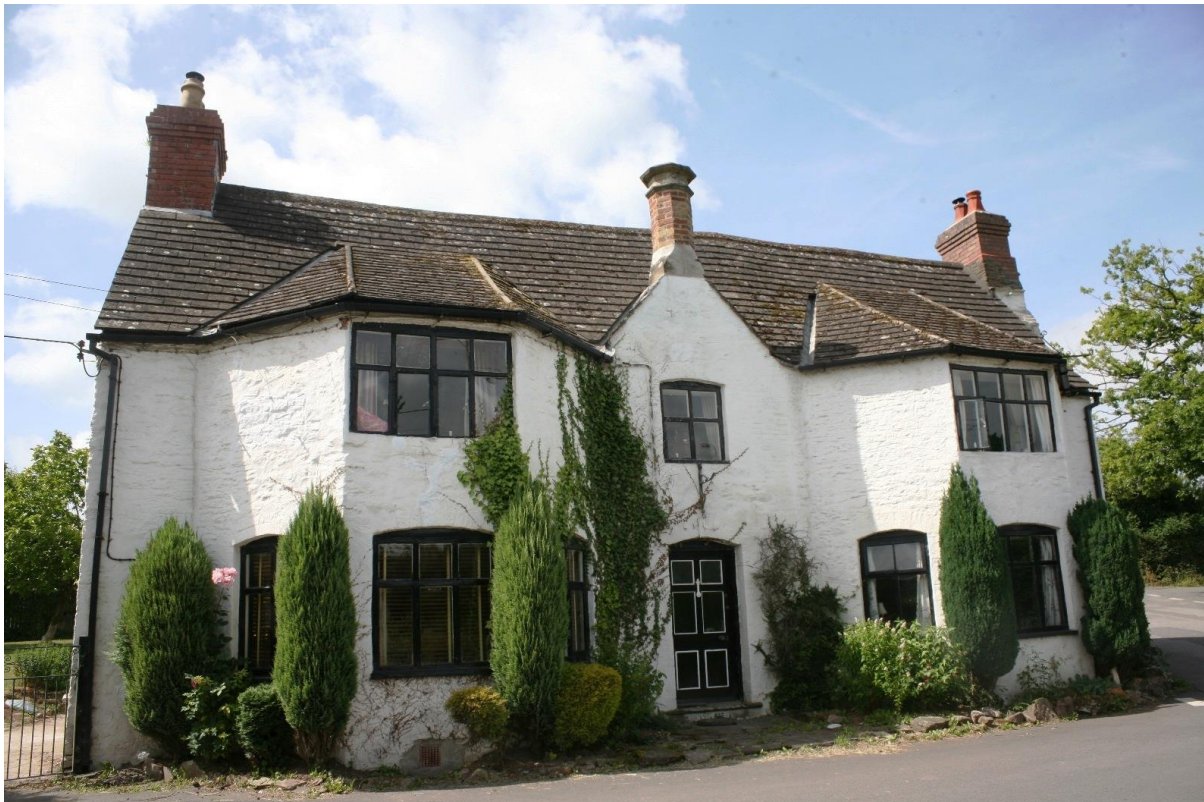
Fig.48 Hostry House. A wide fronted house, much altered but with 16th century origins, located in the centre of the village. The central gable chimney and shallow canted bay windows are unusual features

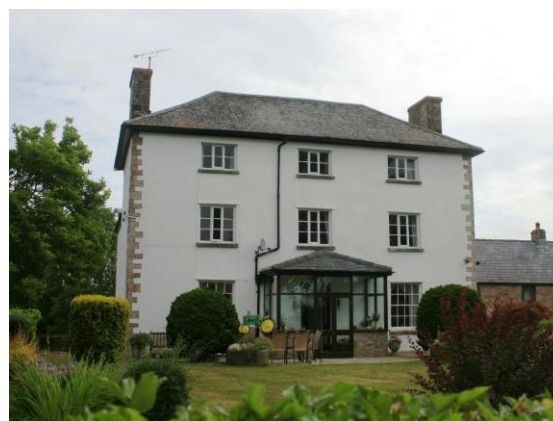
Fig.50 White House Farmhouse. A strictly symmetrical early -18th century farmhouse, with sash windows on the ground floor and casements above. The central porch is modern

7.4.11 White House Farmhouse (Grade II listed, **Fig.50**) is an interesting comparison with Weir House, illustrating some of the differences in the developments in architectural design between the 17th and 18th centuries. White House Farmhouse also has a three storey symmetrical front elevation and is three bays wide. Furthermore it has tall stone end stacks and a hipped roof, although the pitch of the roof is lower. The main elevation is rendered, a Georgian preference in an attempt to imitate expensive ashlar stonework rather than the more 'vernacular' appearance of rubblestone, and utilises dressed stone for quoins and window cills. The first and second floors have casement windows (untypical, and probably later replacements). The ground floor has multi-paned sash windows either side of the modern porch enclosing the front door.

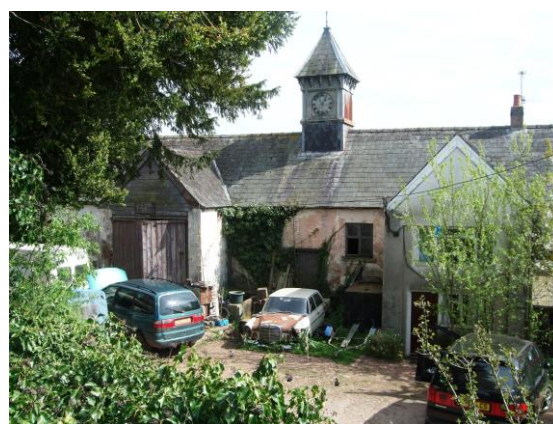
Fig.51 Court Farm. This range with its eye catching clock tower is unfortunately in a poor state of repair

7.4.12 Court Farm (**Fig.51** & **Fig.52**) is located immediately south of the church, at a lower level. The buildings are in a poor state of repair, yet retain their intrinsic historic and architectural value. The farmstead is an irregular group of buildings, with a late 18th to 19th century range with a threshing barn (marked by the full height doors in gabled porches) and possible former stables that served Llantilio Court, now partly converted into residential use. The centre of the long ridge is topped by a clocktower, with a tall pyramidal roof. Behind this range is a single storey U-plan range with a pantile roof which faces away from the barn/stable range. The central bay has a wide centrally placed door with an unusual canted drip mould as part of its lintel although it is possible that the ashlar work of this doorway has been inserted into the rubble stone wall. This building may have originally been a stable.

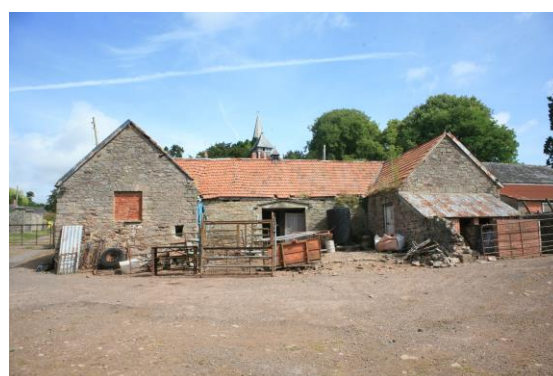
Fig.52 Court Farm. A fine U-plan stable range with an unusual canted drip mould lintel. The pantiled roof is a colourful contrast to the natural slates on almost all the buildings in the village

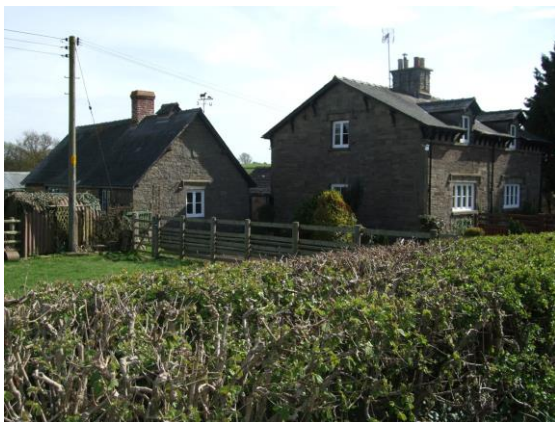
Fig.53 Llwyncelyn. The former estate cottages with the former Laundry to the left were built in 1878. These handsome semi-detached cottages were later converted to a single house

7.4.15 'Llwyncelyn' (Grade II Listed, **Fig.53**) was built in 1878 as a pair of semi-detached estate workers' cottages. The cottages, entered at each gable end, have now been joined internally to form a single house but otherwise they retain their original external character. A substantial central stone chimney stack unites the building. The low-pitched slate roof with projecting eaves and projecting bargeboarded gable ends give a somewhat Italianate character to the building. The eaves are supported by boldly expressed brackets. These are '1½' storey cottages with an attic storey lit by half dormers with low pitched roofs. On the ground floor of these rubble stone cottages, a pair of four light mullioned windows with stone cills and drip mould lintels, complete this attractive, well-proportioned building.

7.4.16 Immediately to the east of Llwyncelyn and somewhat set back, lies the former Laundry (Grade II listed) (**Fig.53**). This building also dates from 1878, as indicated by its simple date plaque, high on the gable wall. It is constructed of the same materials although it has less architectural detail; simple eaves, a slightly higher pitched roof and a brick chimney. However, it has similar four light mullioned windows. The main clue to its original function is the louvre on the ridge line.

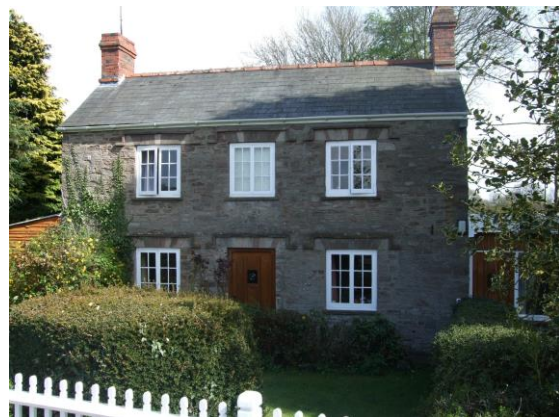
Fig.54 Hostry Cottage. A well-proportioned estate cottage built circa 1878, in good condition, set back from its white picket fence

7.4.17 A few metres along the road from Llwyncelyn is another estate cottage, Hostry Cottage (Grade II listed), set back behind a white picket fence and a post box (**Fig.54**). This cottage, although built at approximately the same time as Llwyncelyn c1878, is of a design more akin to a vernacular cottage. This is in a wide frontage two storey style, with brick gable end chimneys and a symmetrical façade of central door, (the door itself a recent design), and five casement windows. The stone lintels are constructed of stone voussoirs, with Jacobean style drip moulds. The cottage is constructed in sandstone rubble with some ashlar dressings.

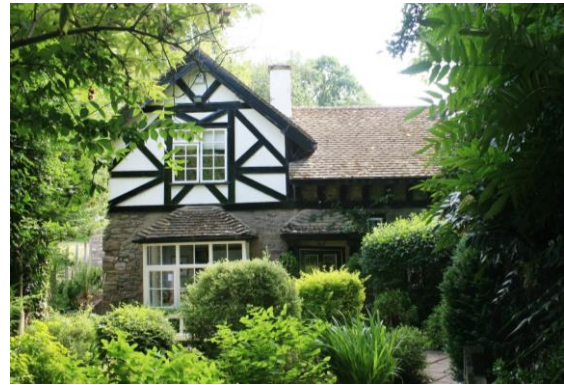
Fig.55 Raglan Lodge. A late 19th century estate cottage. A decorative half-timbered first floor and projecting bay windows feature in this deliberately picturesque composition

7.4.18 Another rather larger estate cottage (Raglan Lodge, **Fig.55**) possibly built at the same time or probably a little later, is situated north-east of the former water mill. This is of a more picturesque, cottage orné design. The cottage has an informal asymmetrical plan, of two storey and single storey elements. The ground floor elements are of rubble sandstone, the first floor is quasi or faux timber-framing, 'black and white' appearance, with a medium to low pitched roof (possibly re-tiled). Windows are casements; some on the ground floor are squared bays under hipped roofs.

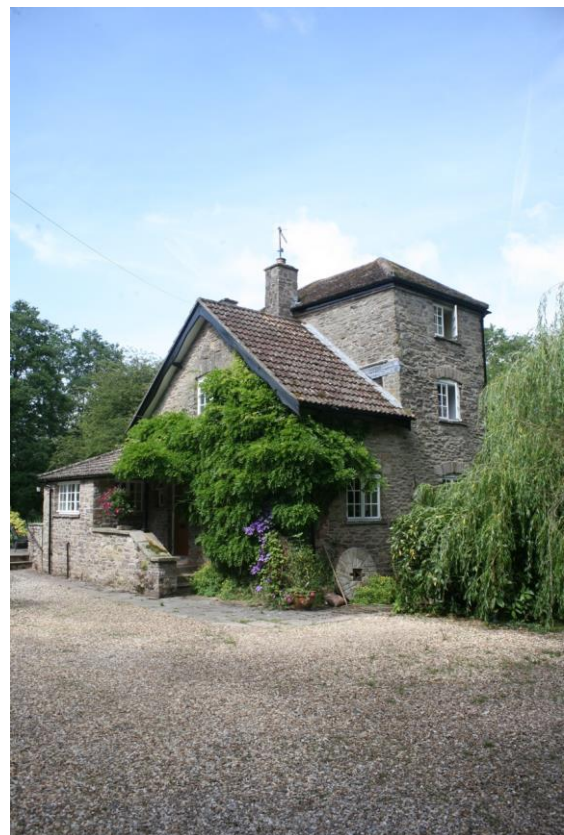
Fig.56 Former Water Mill. Originally the tower was slightly higher and had a, presumably, Victorian timber-framed top storey. The building has been converted to residential use

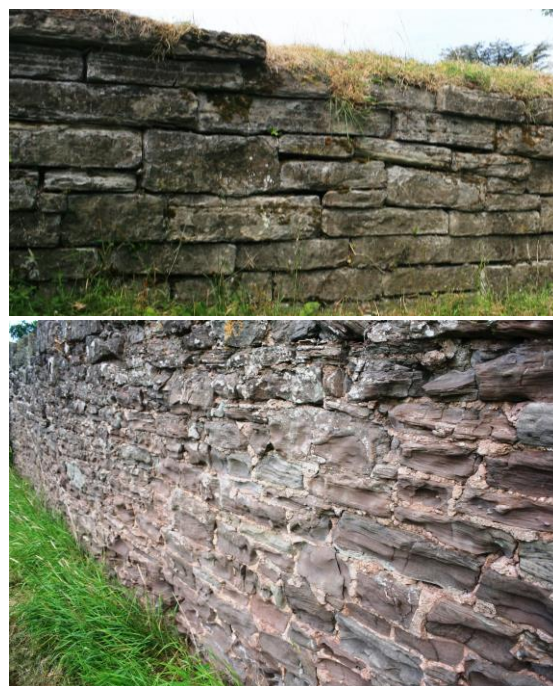
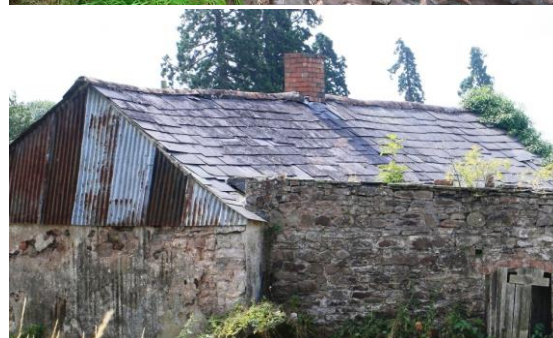
Fig.57 Examples of walling materials used in the Conservation Area

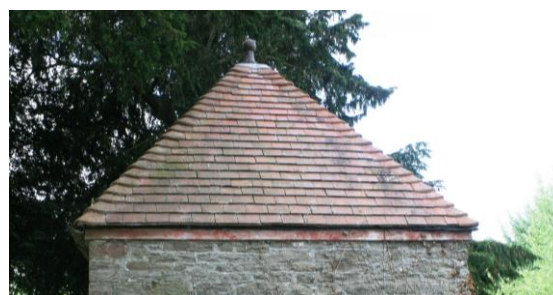
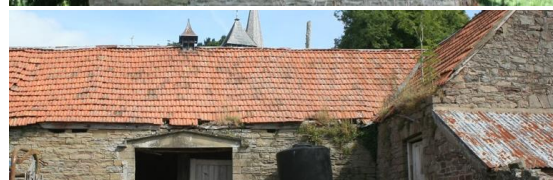
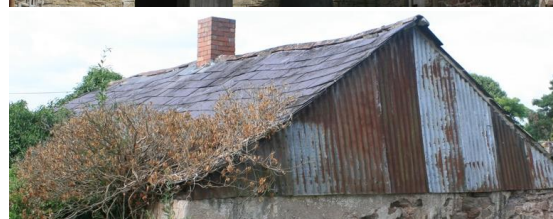
Fig.58 Examples of roof materials used in the Conservation Area

7.7.5 Traditional houses still retain natural slate roofs. Some agricultural buildings and lower order buildings have Victorian clay interlocking tiles, for example, the outbuildings at Court Farm (**Fig.58**). This is generally seen at low pitches to simple gabled roofs with brick or stone ridge chimney stacks. There has been some replacement with late 20th century concrete interlocking tiles (Hostry Hall). Modern 20th century buildings often have concrete interlocking tile roofs or cement fibre slates.

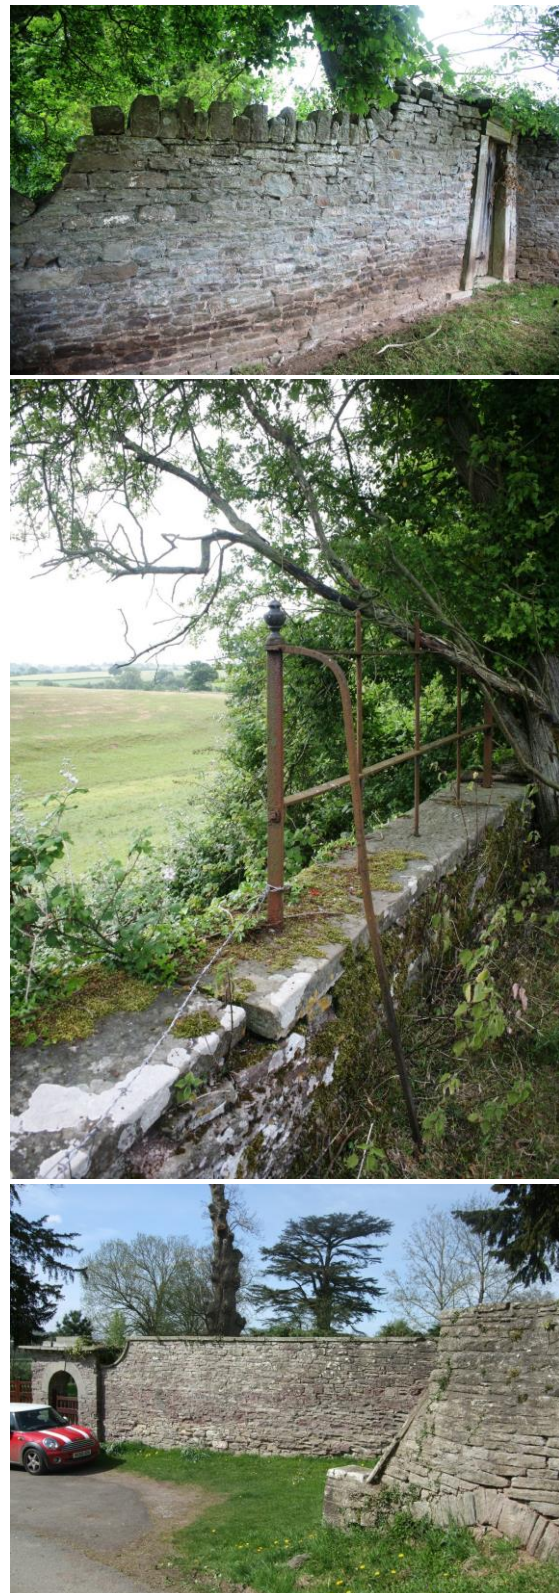
Fig.59 Examples of boundary walls and retaining walls within the Conservation Area
