Pwyllgor Trwyddedu a Rheleiddio

Item No	Item	Pages
1.	Ymddiheuriadau am absenoldeb.	
2.	Datganiadau o Fuddiant.	
3.	Deddf Bywyd Gwyllt a Chefn Gwlad 1981 – Adran 53 Gorchymyn Addasu Llwybr Map Diffiniol, A i G, Llwybrau Troed 83 a 84 Cil-y-coed – Mur y Môr.	1 - 150

1. Introduction: Background	1 - 2
2. Legal Basis	3 - 5
3. Land registry	6
4. Objections.....	7
5. Pre-Order Consultation	8 - 19
6. Evidence – Historical Maps.....	20 - 35
7. Definitive Map and Statement	36 - 40
8. Historical maintenance	41
9. Aerial Photographs	42 - 54
10. Site Photographs	55 - 57
11. User Evidence	58 - 68
12. Summary	69 - 75
13. Conclusion.....	76 - 77
14. Recommendation.....	78

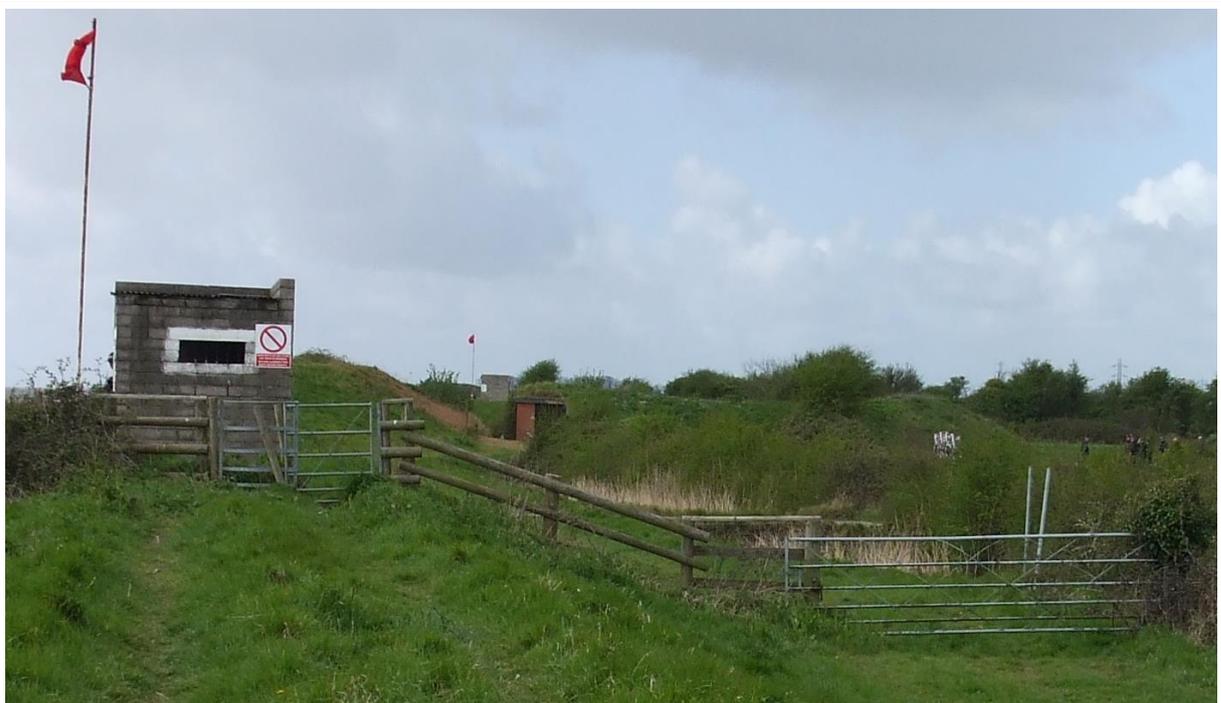
Photo A: Sentry box: Point F: 2008

- i) It is noted that sentry boxes are situated at the east and west boundaries of both Rifle Ranges. In connection with this section of the Route, A to G, the sentry boxes for Severnside Rifle Range have lookouts both directed seawards and overlooking the alignment of the Route that is along the crest of the sea wall. (Fig. 5.1). Furthermore, the sign directed to the walking public is on the wall of the sentry box that is facing any on-coming walkers beyond a kissing gate. Alternatively, the sign is not on the wall that is facing out to sea (Fig. 5.1: Photograph A).

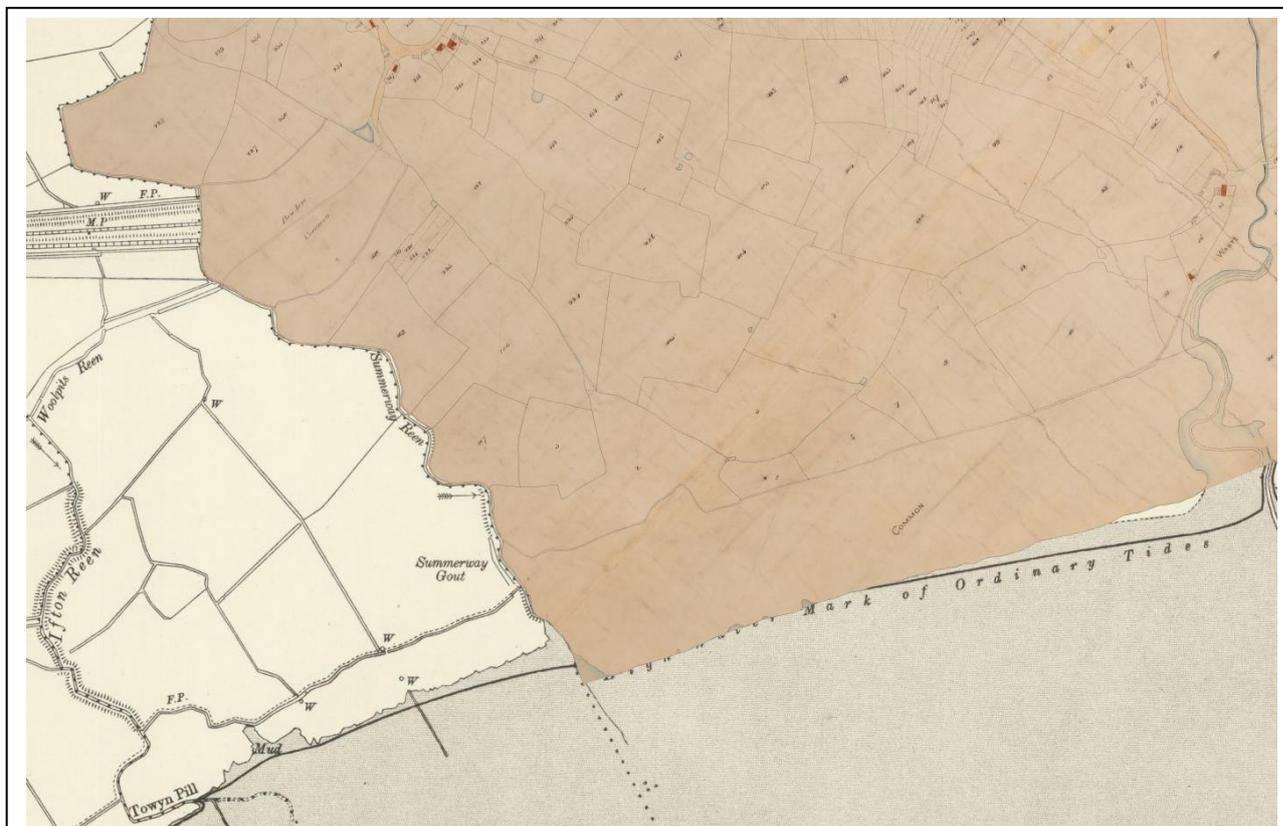
6.7. The 1843 Tithe Map for Caldicot (Fig. 6.5) held by the National Library Wales, online view, suggests the alignment for FP 6 Caldicot. There are roads shaded brown and rivers shaded blue on the 1843 Tithe Map. However, other maps need to be studied together with this one to best interpret the depiction of the feature along the northern boundary of the area marked “Common”. The double parallel lines mark a similar alignment for the road, previously observed on the 1830s maps, but it is not shaded in the conventional way for roads. However, the 1858 Tithe Map (Fig.6.7) does show this feature shaded blue for the depiction of drains.

Fig. 6.5: (1902 OS map on the left, no tithe map available) | 1843 Tithe Map Caldicot on the right: not to scale. NLW-online

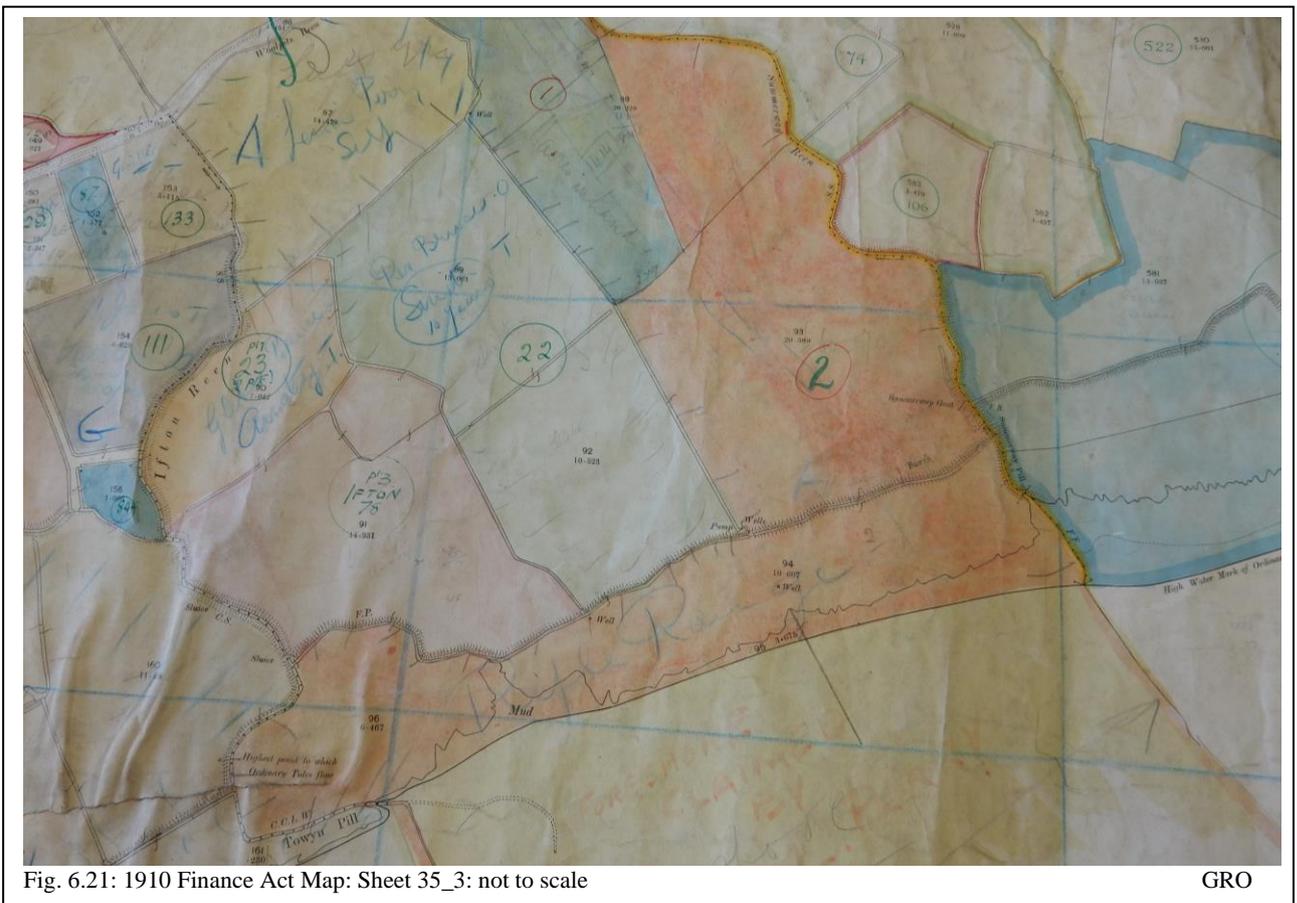
- 6.31. The 1910 Finance Act Map, working sheet 35.3 (Fig. 6.21) does not show the Route in question as 'uncoloured' or 'white out'. This means that when this map is taken together with all the historical information investigated it is reasonable to determine that there are no public vehicular or equestrian rights.

- 6.32. The 1910 Finance Act map working sheet 35.3 has the words "Butts" and "Rifle Range" marked in pencil across the plot numbered 2. This indicates the location of the Rifle Range in 1909-1910 which precedes the start of the First World War in 1914.
- 6.33. The base map for the 1910 Finance Act map is the 1901 Ordnance Survey Map (Fig. 6.12) and this shows the alignment of a footpath along with the symbols for footpaths "F.P." and footbridge "F.B.".
- 6.34. The Finance Act Register that references the plot numbers on the accompanying map has not been found at the Gwent Record Office for the community of "St Brides - Ifton Parish"

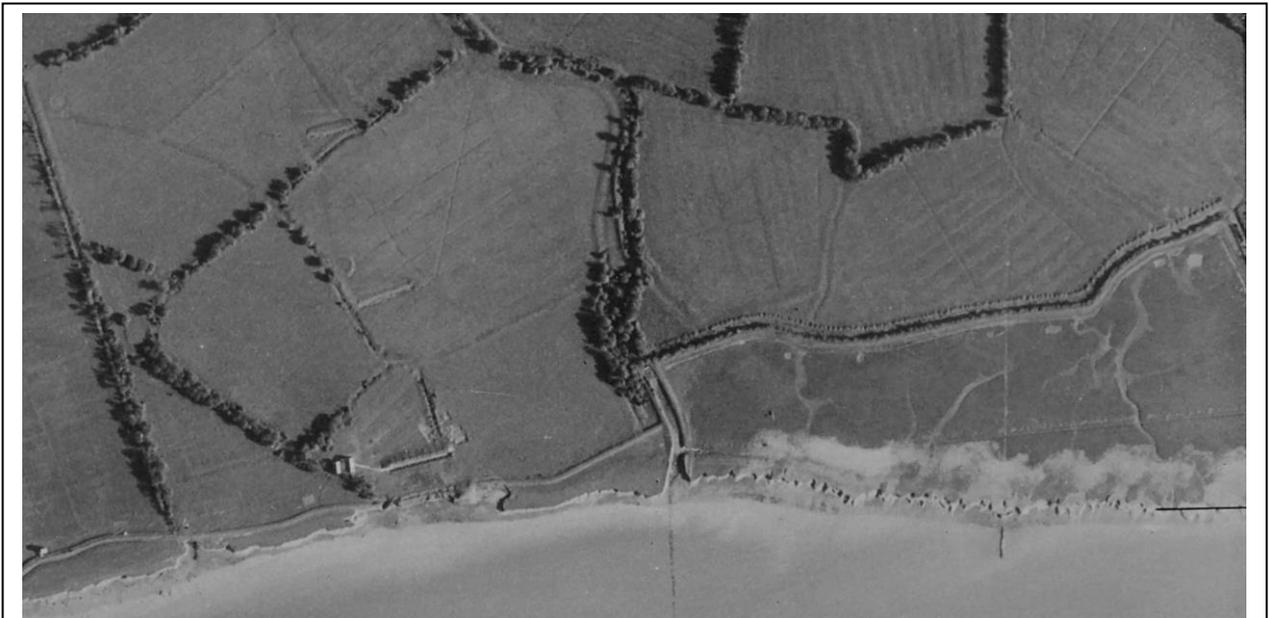
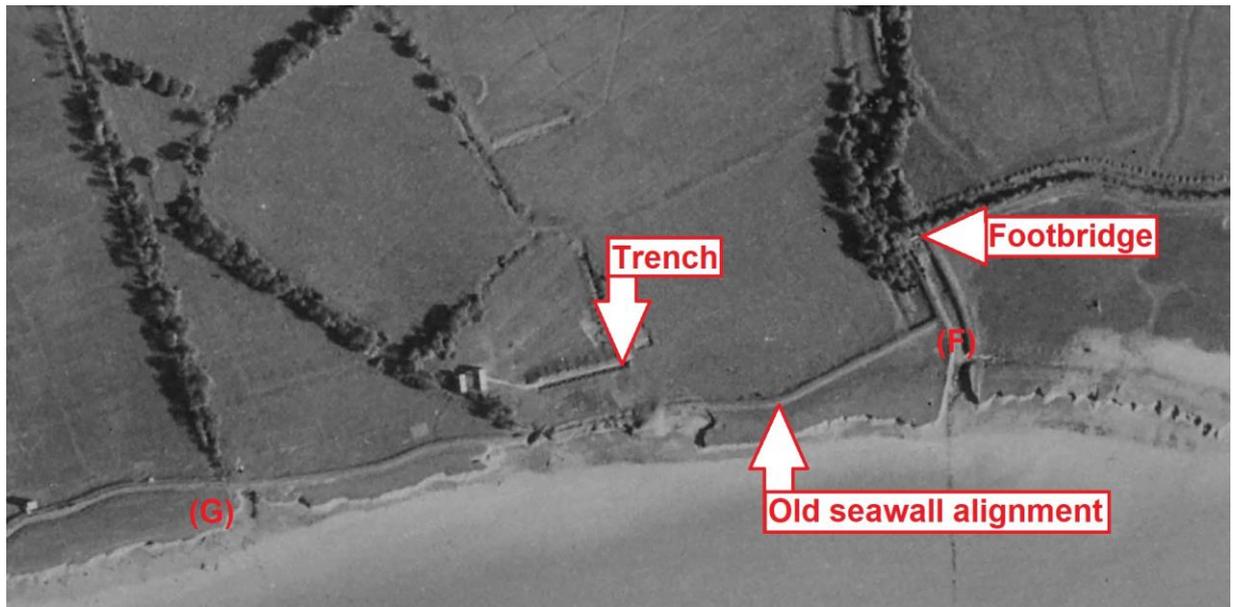
9.2. The 1947 aerial photograph (Fig. 9.1) shows the old alignment of the seawall.

9.3. The photograph (Fig. 9.1B) with labels shows a footbridge that is in the same location as the footbridge marked on many of the OS map 1900 - 1949 (Fig. 6.13). The same footbridge is also noted on the Definitive Map and Statement (Fig. 7.6).

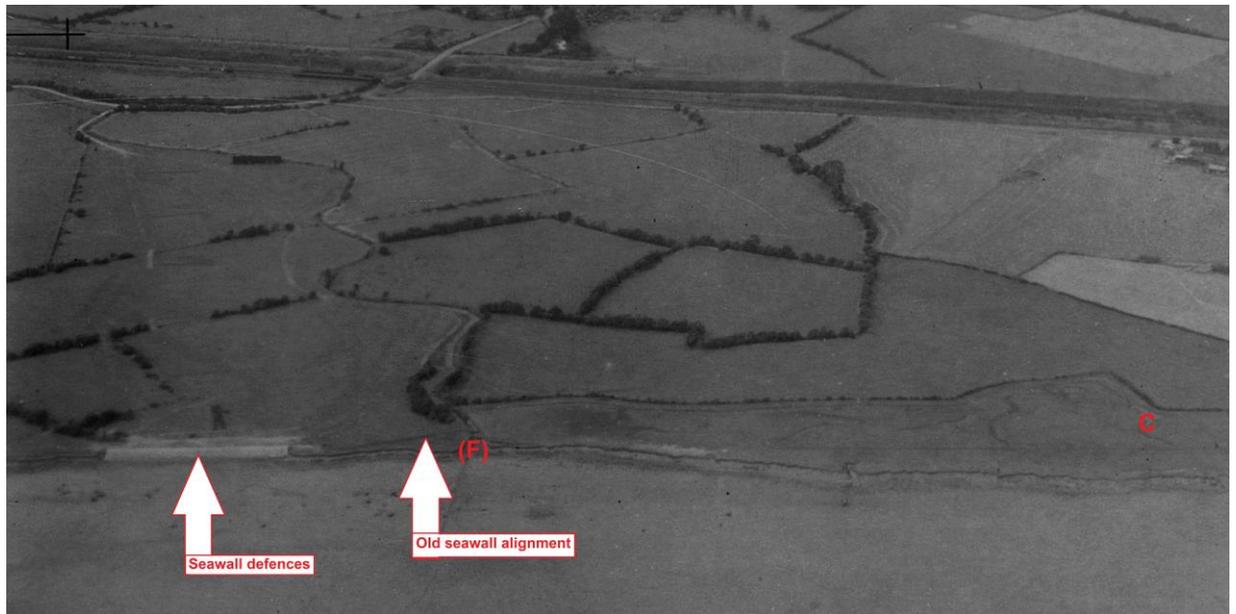
Photograph B: showing 1951 Seawall construction

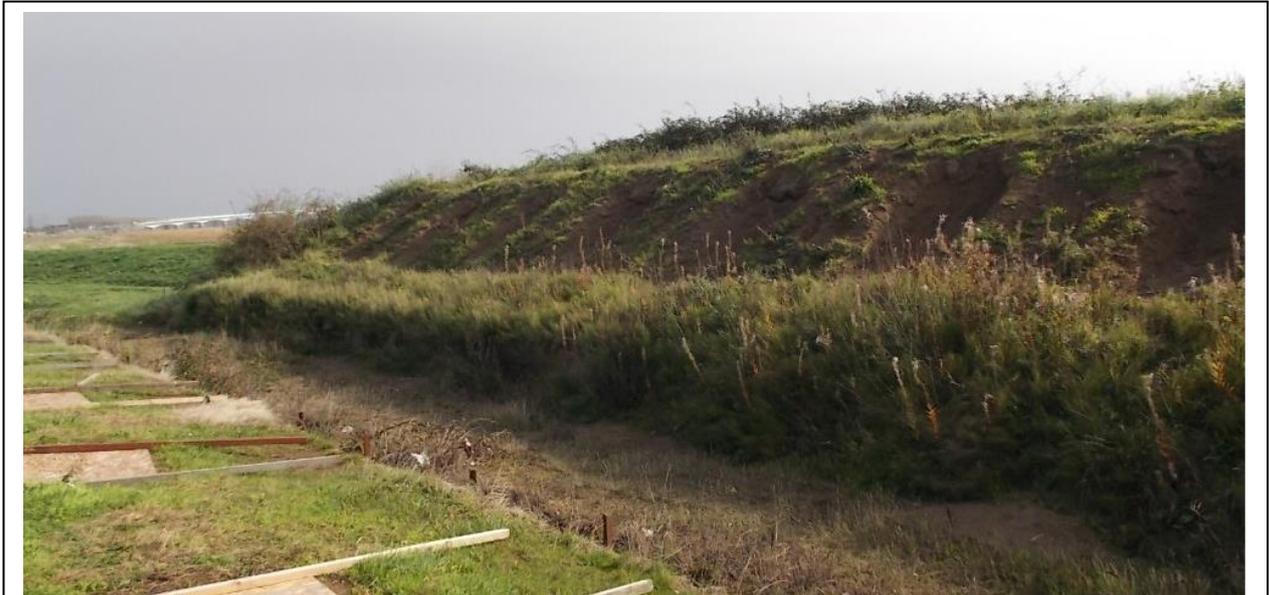
Fig. 9.9: 2017 site photograph showing greater earth mound

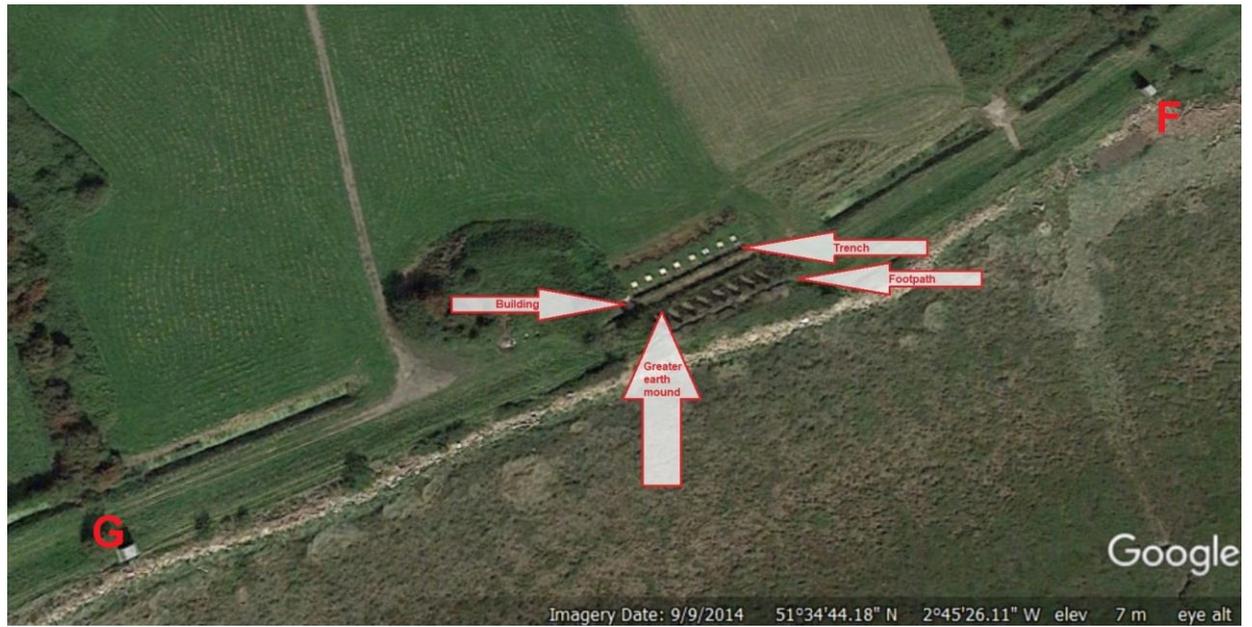
9.23. The 2014 aerial photograph B has been marked up to show a building at the east end of the targets, a trench, the greater earth mound, and the used footpath that on this photograph has a dark line probably caused by the height of the vegetation on the seaward side.

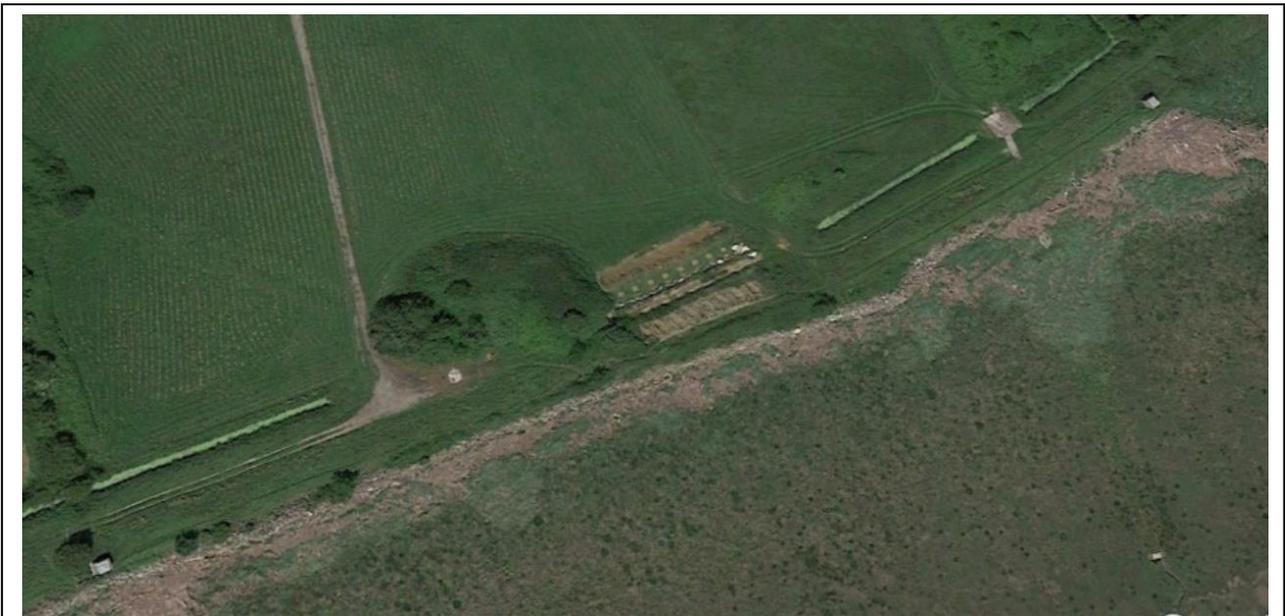
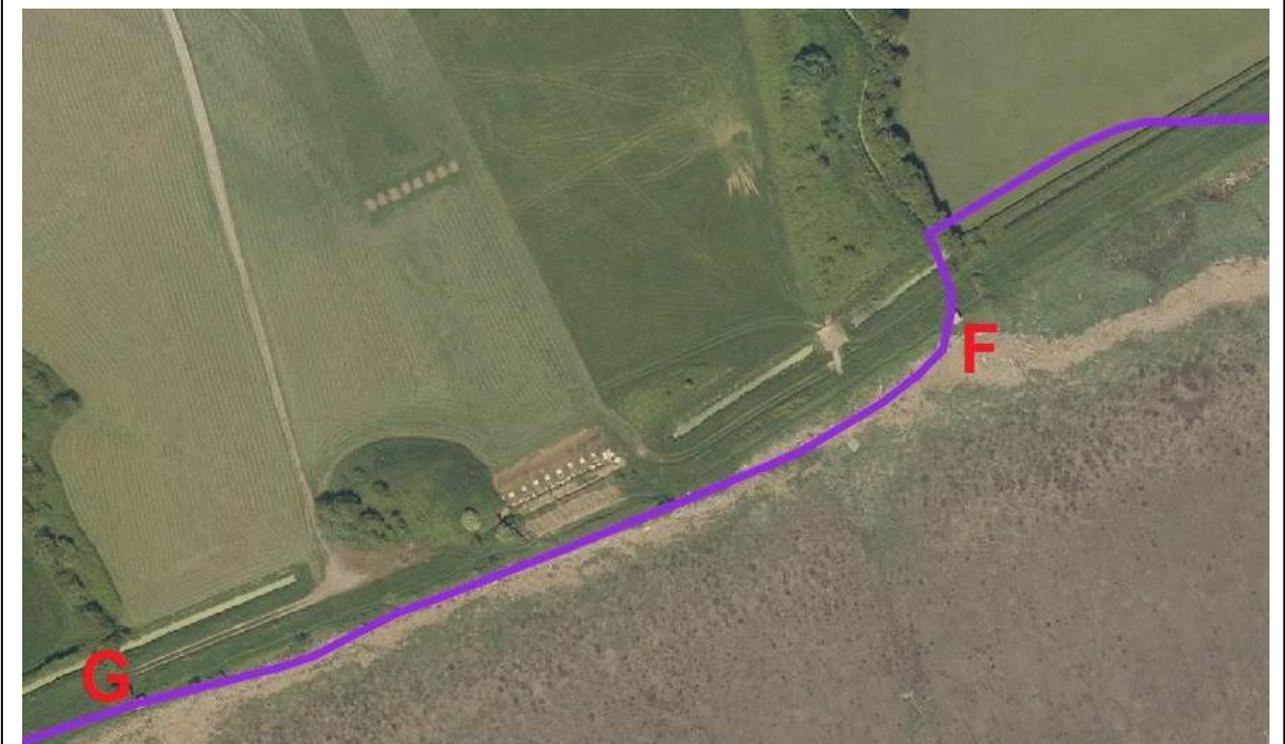
9.24. The 2017 aerial photograph (Fig. 9.13) again has less shadow and although faint there is still a single narrow worn line shown between the sentry boxes.

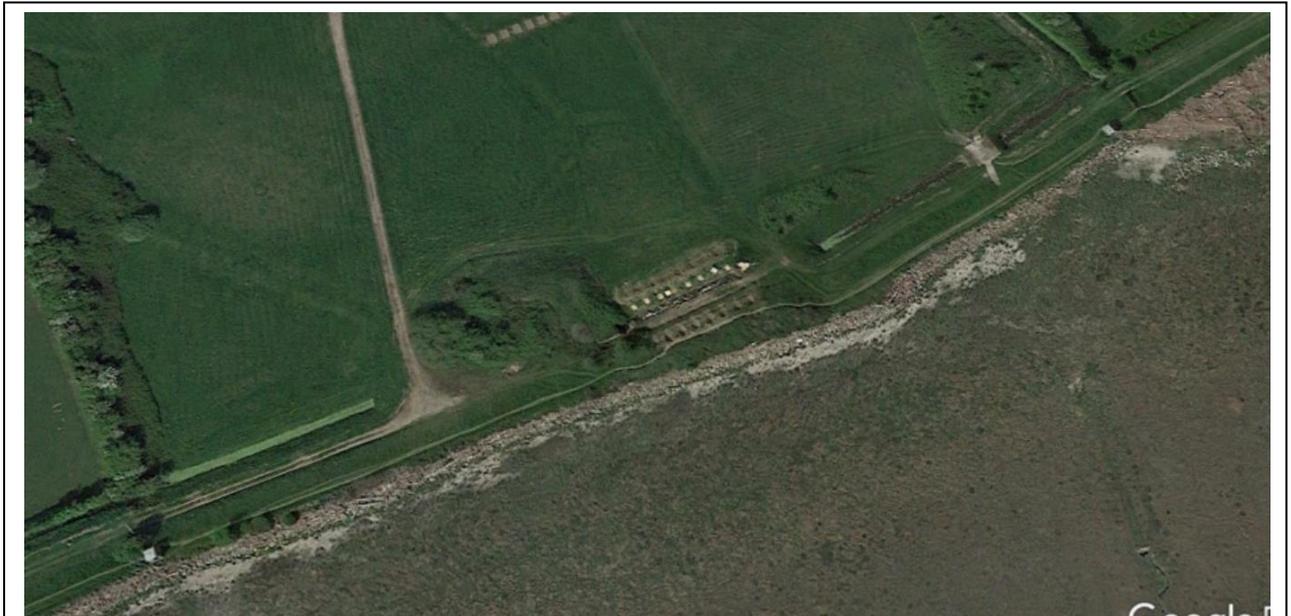
9.26. The 2020 aerial photograph (Fig. 9.14) again has less shadow. This photograph shows the more pronounced and narrow worn lines that indicate the walked alignment of the Route between points F and G the location of the sentry boxes. This worn line is also clearly shown to ascend the greater earth mound.

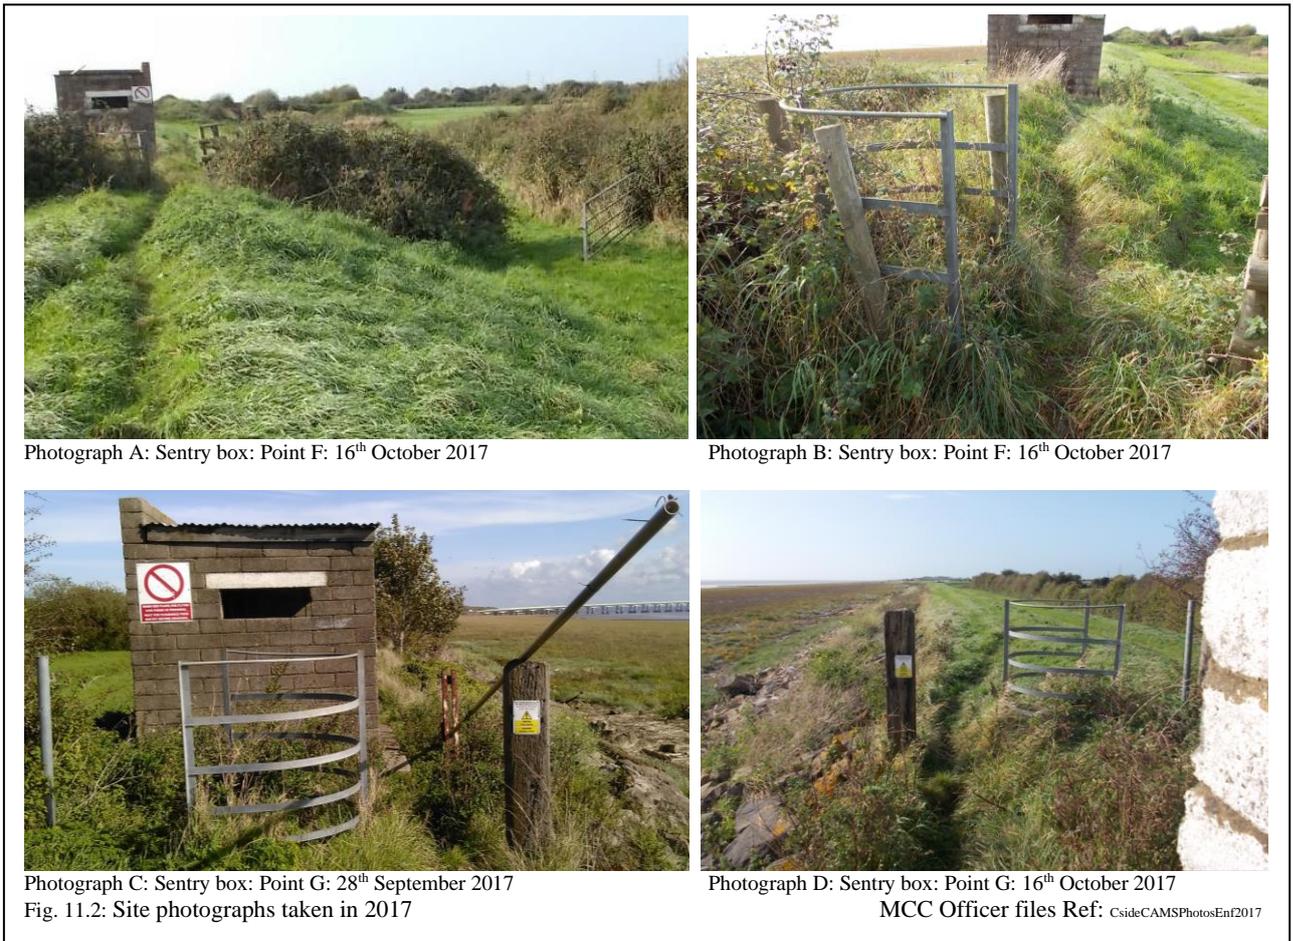
- d. The site photographs taken in 2017 (Fig.11.2), show broken kissing gates and a partially open field gate at point F, photograph A (Fig. 11.2).

- e. The damaged caused to the kissing gates and field gate, show that some are attempting to gain access illegally with either bikes, motorbikes, or vehicles. This is further supported by the damaged caused to other kissing gates that are nearby. Therefore, it is suspected that this behaviour is not associated with walkers and their reasonable use of the kissing gates.

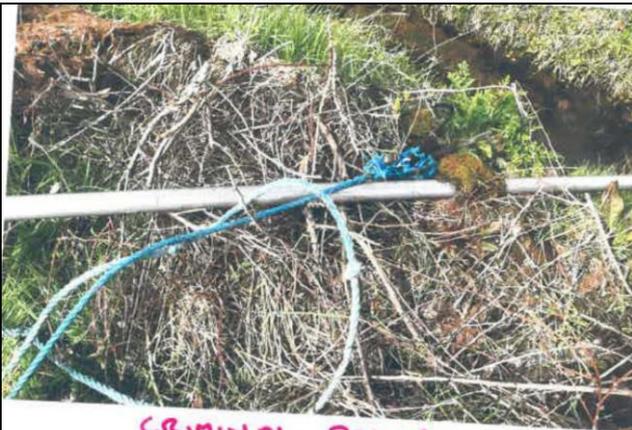
CRIMINAL DAMAGE
WARNING FLAG POLES
CONTINUOUSLY
CUT DOWN

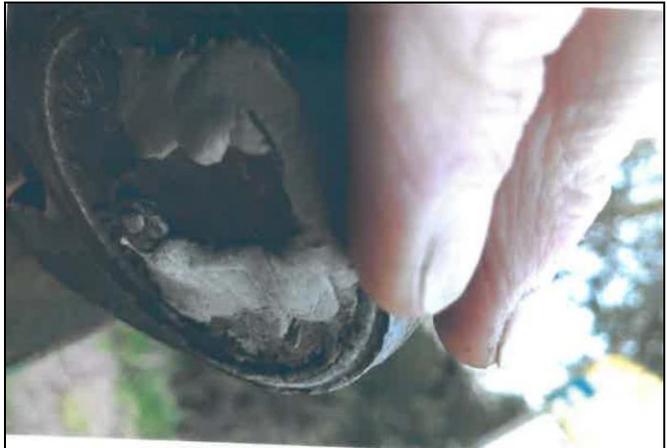
CRIMINAL DAMAGE
LOCK GLUED AND CUT UP
CONTINUOUSLY

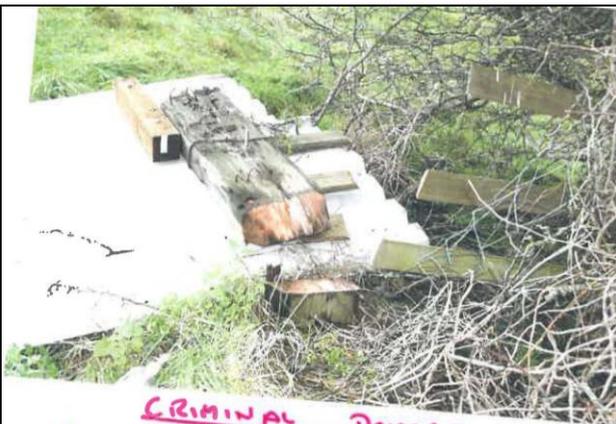
CRIMINAL DAMAGE
FENCE POSTS CUT DOWN
ALLOWING CATTLE AND SHEEP
TO ACCESS TO MOTORWAY
AND RAILWAY
WEST SIDE OF SEVERN RANGE

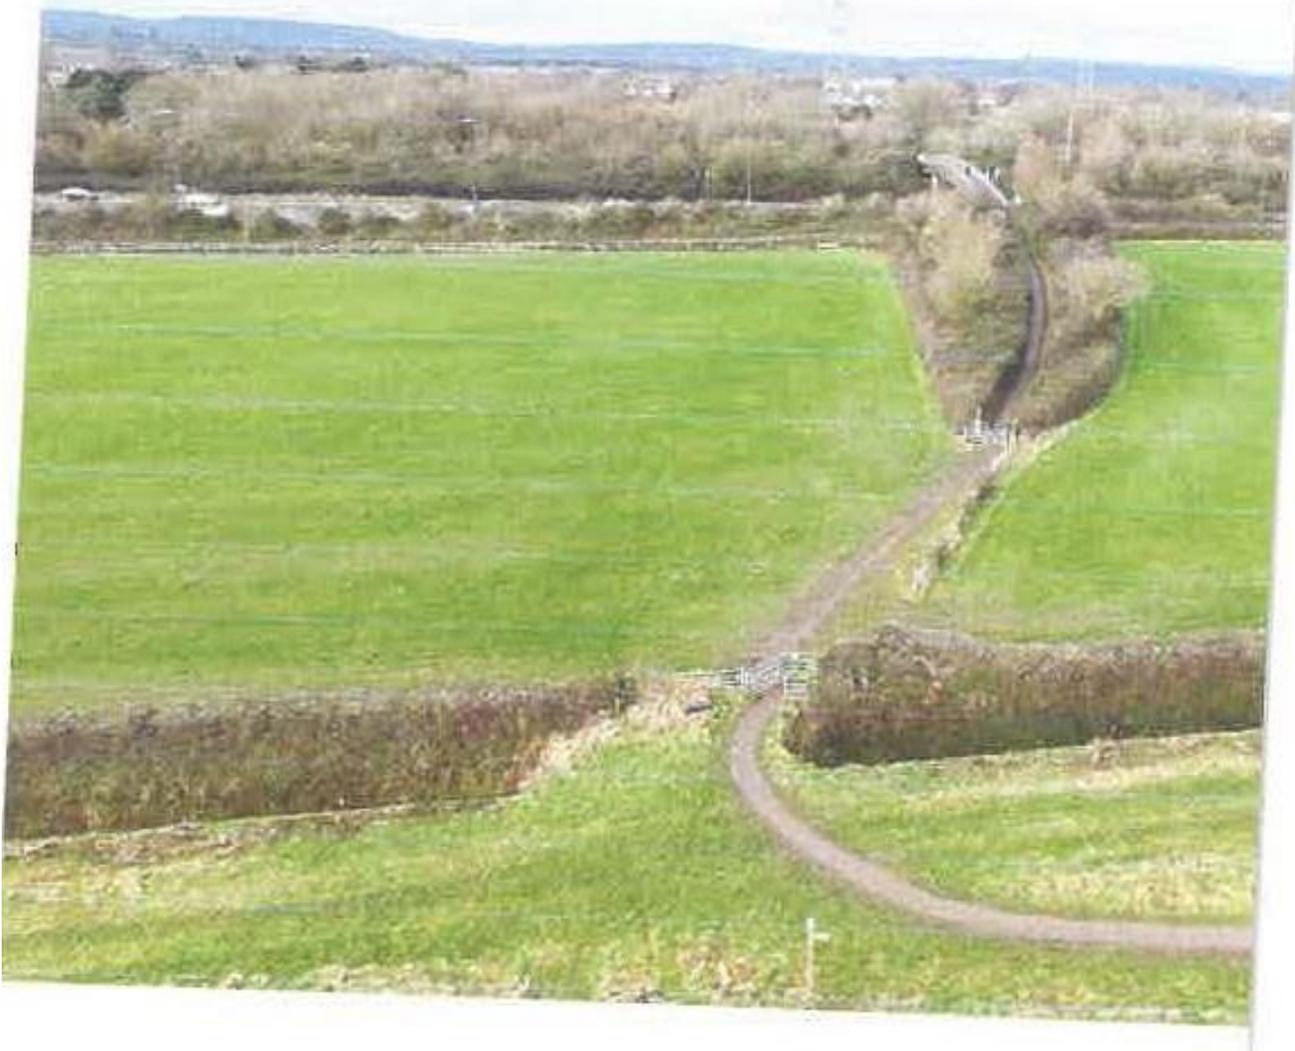
PHOTO OF COASTAL FOOT PATH TO THE NORTH-EAST SIDE OF SEVERNSIDE RANGE WHICH DEMONSTRATES IS WELL USED BY WALKERS AND NO EVIDENCE OF WALKERS TURNING TO THE WEST TO CROSS SEVERNSIDE RANGE
