### **Licensing and Regulatory Committee Rights of Way Panel**

Item No	Item	Pages
1.	Apologies for Absence.	1 - 148
2.	Declarations of Interest.	
3.	Wildlife and Countryside Act 1981 - Section 53 Definitive Map Modification Order Route, A To G, Footpaths 83 and 84 Caldicot – The Seawall.

**DATE: 15<sup>th</sup> SEPTEMBER 2022**

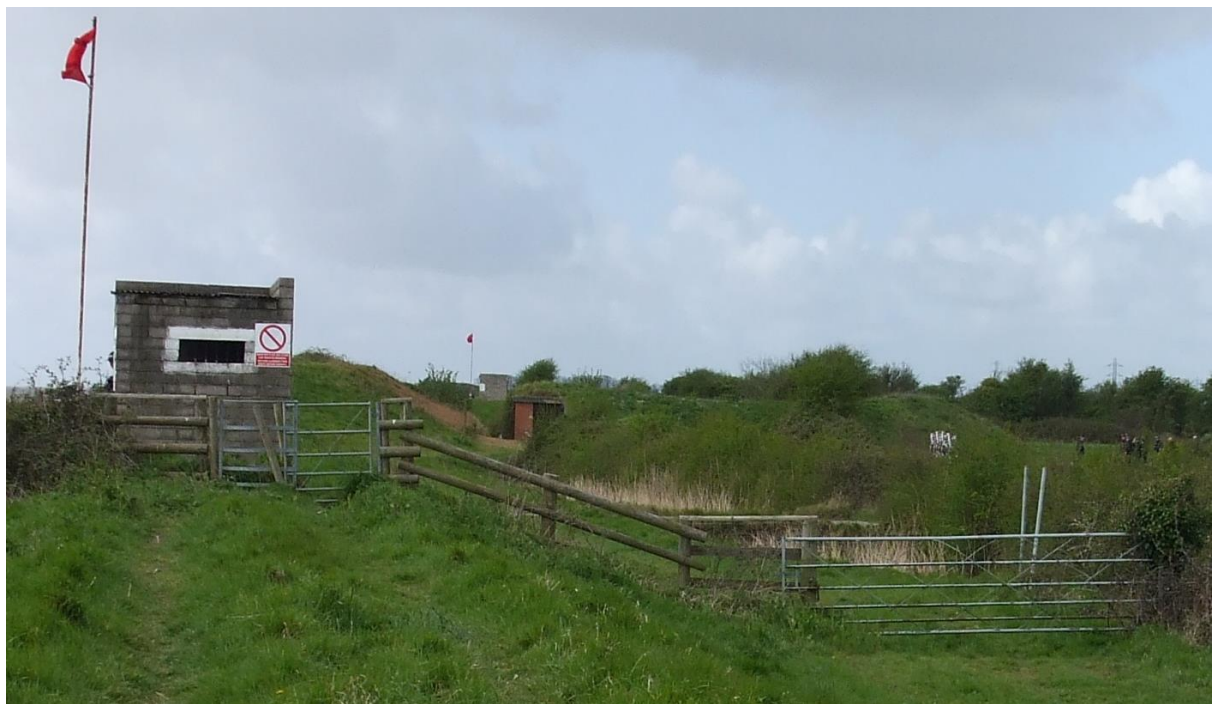
Photo A: Sentry box: Point F: 2008

- i) It is noted that sentry boxes are situated at the east and west boundaries of both Rifle Ranges. In connection with this section of the Route, A to G, the sentry boxes for Severnside Rifle Range have lookouts both directed seawards and overlooking the alignment of the Route that is along the crest of the sea wall. (Fig. 5.1). Furthermore, the sign directed to the walking public is on the wall of the sentry box that is facing any on-coming walkers beyond a kissing gate. Alternatively, the sign is not on the wall that is facing out to sea (Fig. 5.1: Photograph A).

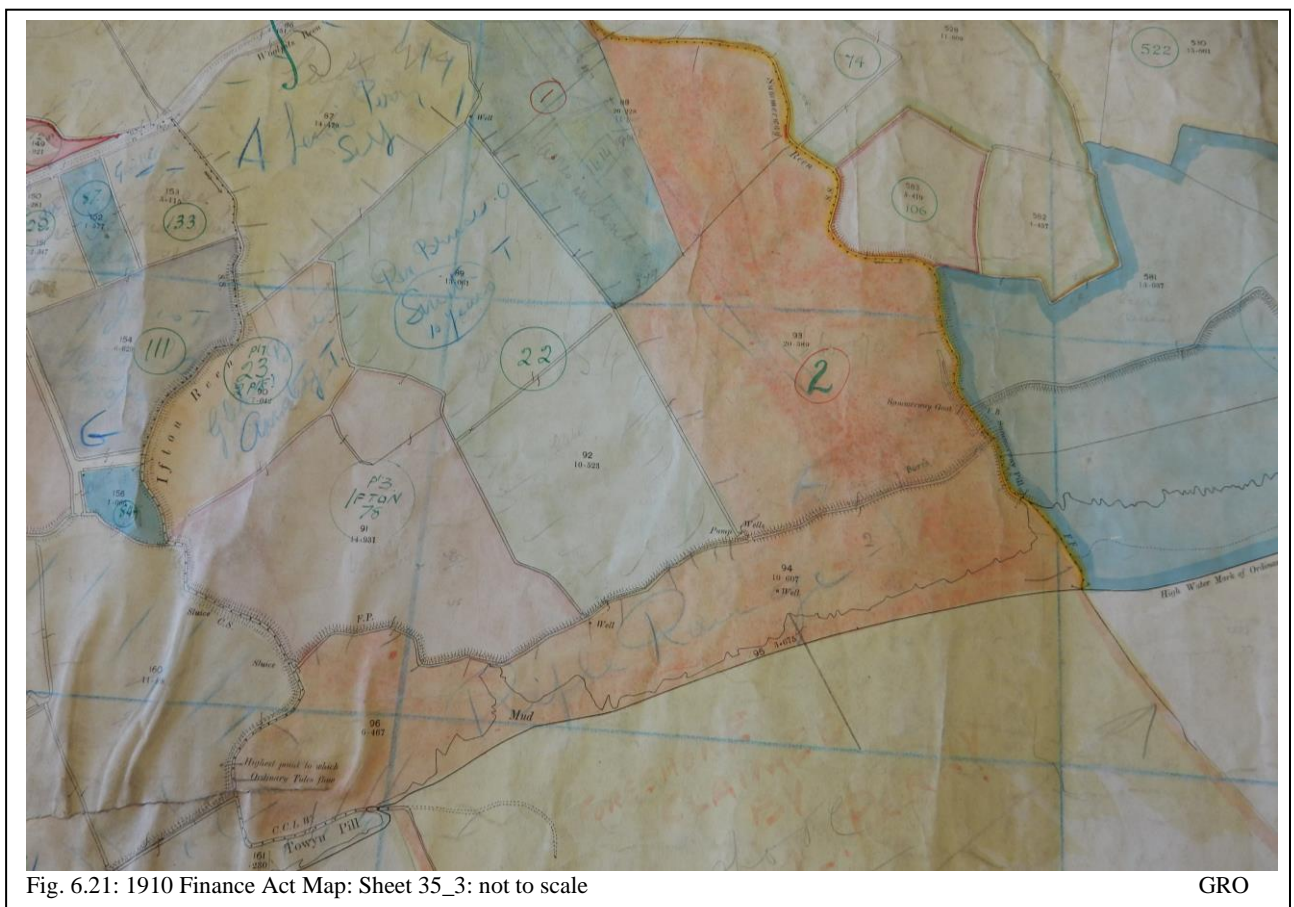
- 6.32. The 1910 Finance Act Map, working sheet 35.3 (Fig. 6.21) does not show the route in question as 'uncoloured' or 'white out'. This means that when this map is taken together with all the historical information investigated it is reasonable to determine that there are no public vehicular or equestrian rights.

- 6.33. The 1910 Finance Act map working sheet 35.3 has the words “Butts” and “Rifle Range” marked in pencil across the plot numbered 2. This indicates the location of the Rifle Range in 1909-1910 which precedes the start of the First World War in 1914.
- 6.34. The base map for the 1910 Finance Act map is the 1901 Ordnance Survey Map (Fig. 6.12) and this shows the alignment of a footpath along with the symbols for footpaths “F.P.” and footbridge “F.B.”.
- 6.35. The Finance Act Register that references the plot numbers on the accompanying map has not been retained by Gwent Record Office for the community of “St Brides - Ifton Parish” or “Ifton Rogiet”.

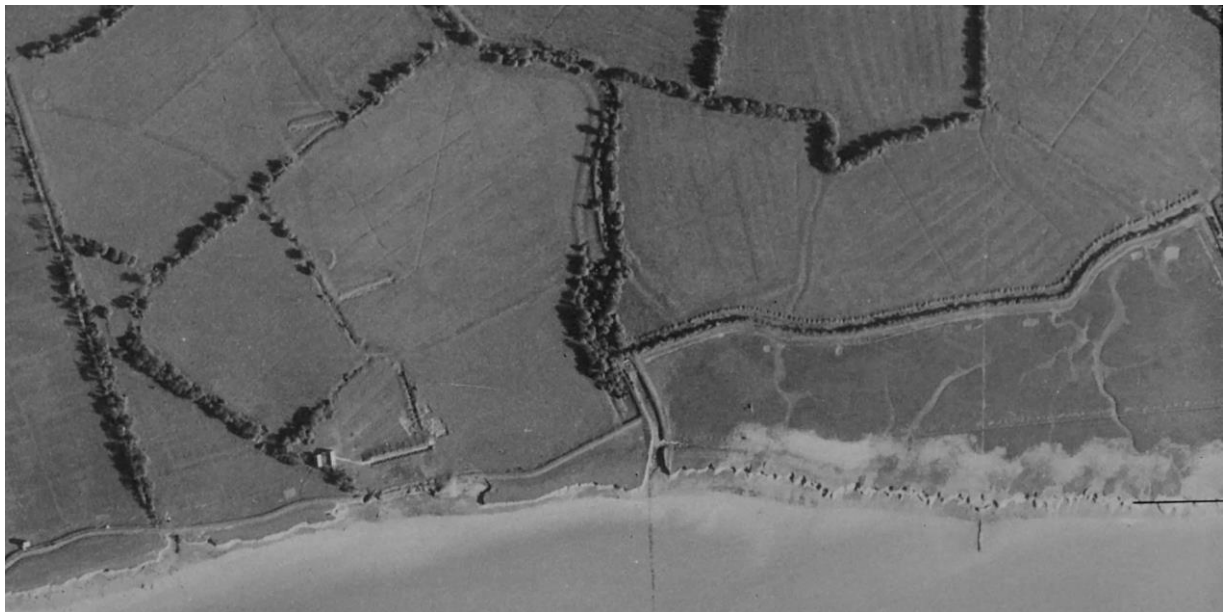
9.2. The 1947 aerial photograph (Fig. 9.1) shows the old alignment of the seawall.

9.3. The photograph (Fig. 9.1B) with labels shows a footbridge that is in the same location as the footbridge marked on many of the OS map 1900 - 1949 (Fig. 6.13). The same footbridge is also noted on the Definitive Map and Statement (Fig. 7.6).

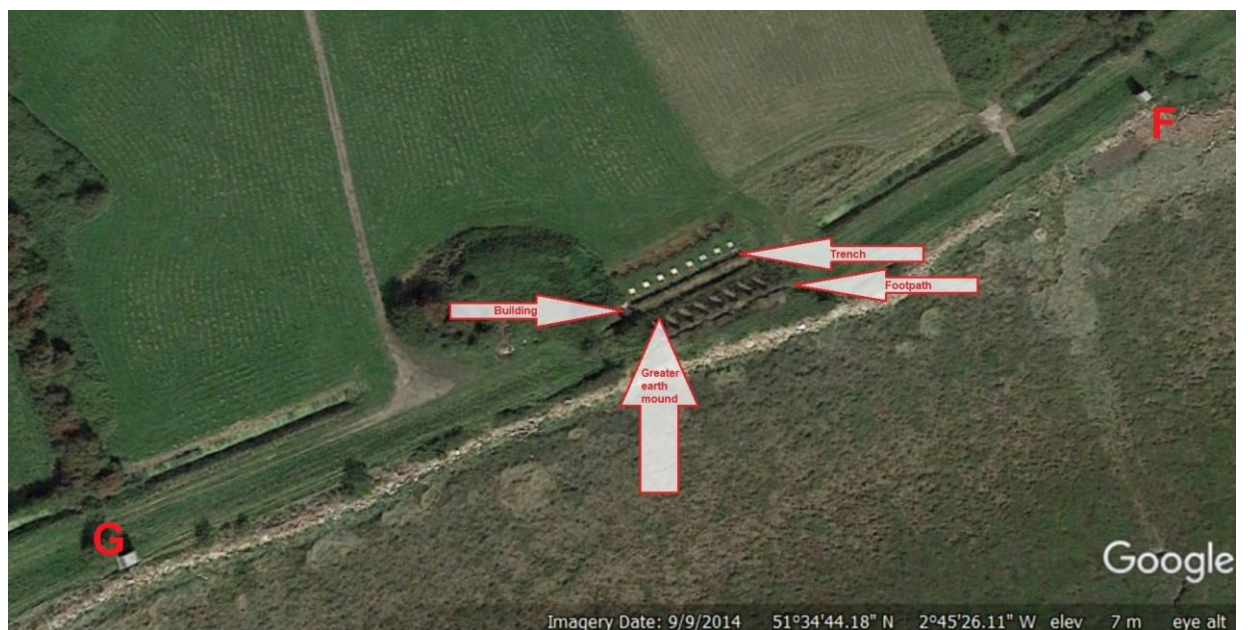
Photograph B:

9.24. The 2014 aerial photograph B has been marked up to show a building at the east end of the targets, a trench, the greater earth mound and the used footpath that on this photograph has a dark line probably caused by the height of the vegetation on the seaward side.

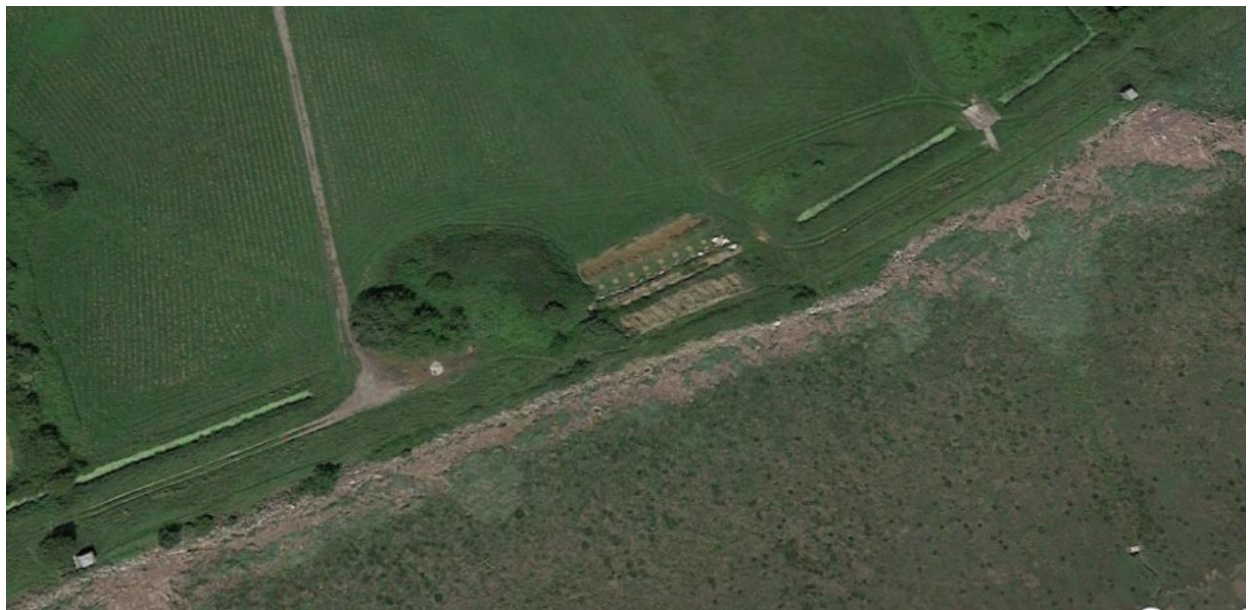
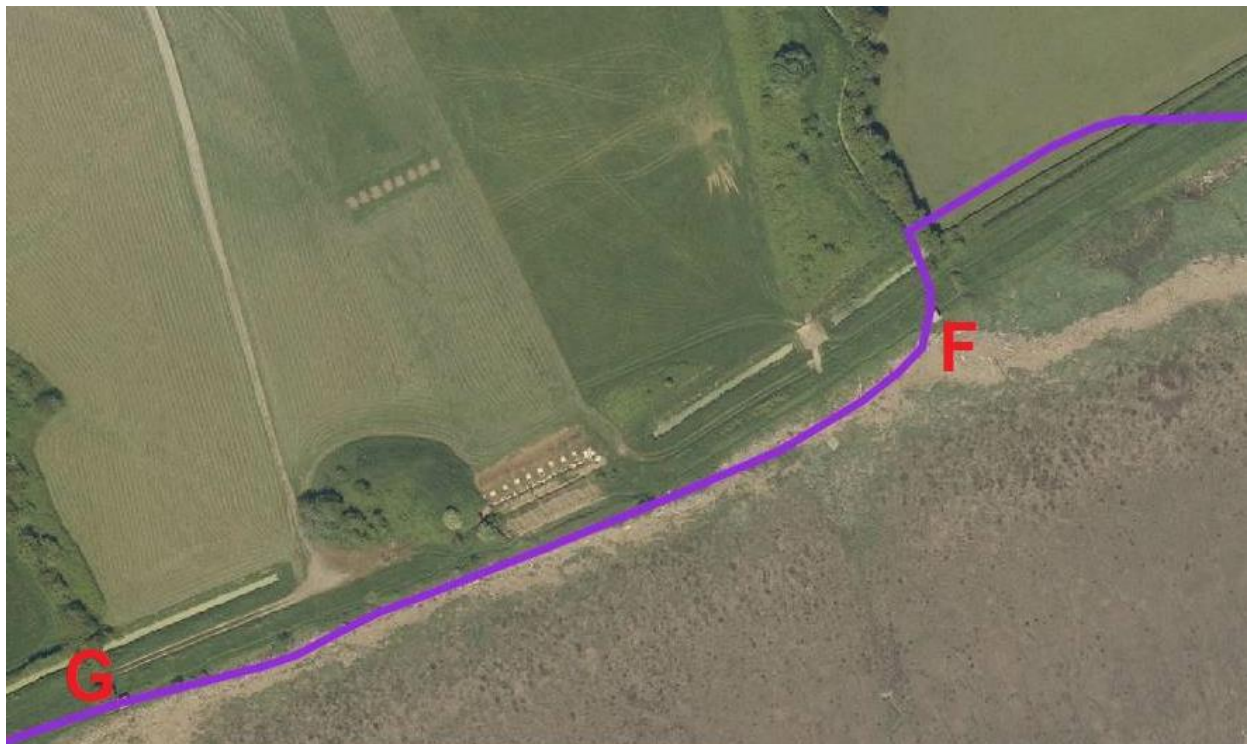
9.25. The 2017 aerial photograph (Fig. 9.13) again has less shadow and although faint there is still a single narrow worn line shown between the sentry boxes.

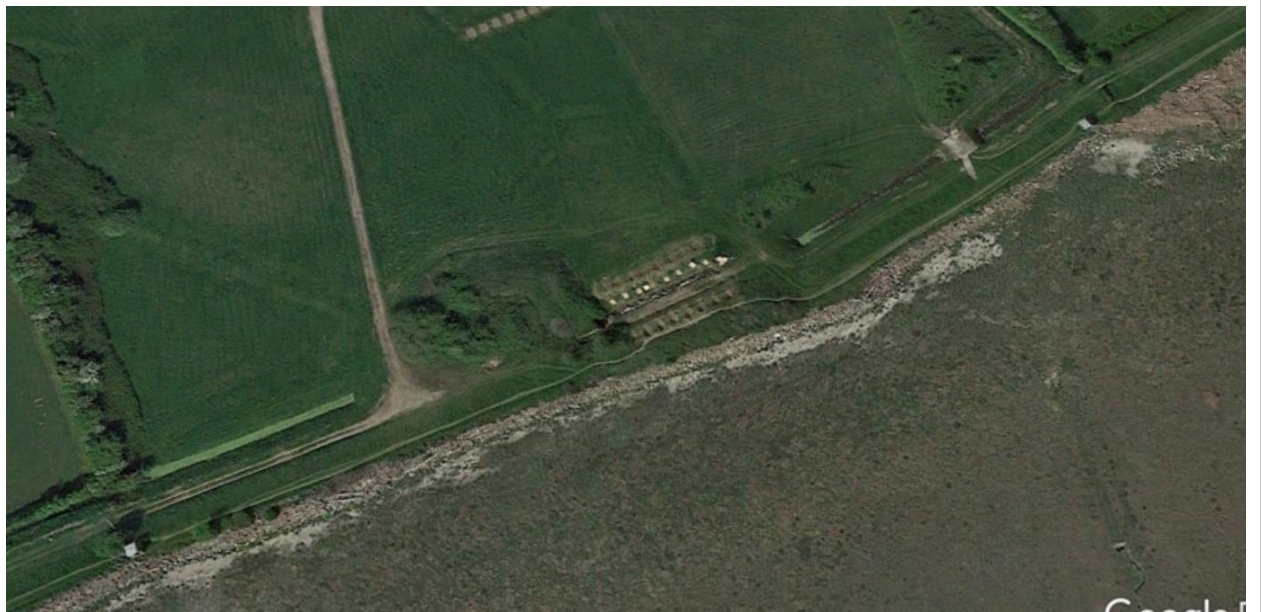
9.27. The 2020 aerial photograph (Fig. 9.14) again has less shadow. This photograph shows the more pronounced and narrow worn lines that indicate the walked alignment of the Route between points F and G the location of the sentry boxes. This worn line is also clearly shown to ascend the greater earth mound.

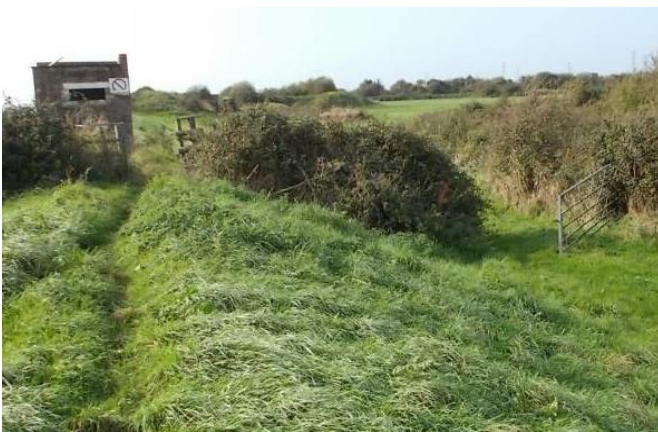
Photograph A: Sentry box: Point F: 16<sup>th</sup> October 2017

- d. The site photographs taken in 2017 (Fig.11.2), show broken kissing gates and a partially open field gate at point F, photograph A (Fig. 11.2).
