Usk

Conservation Area Appraisal & Management Proposals

Report Title: Usk Conservation Area Appraisal & Management Proposals
Client: Monmouthshire County Council
Project Number: 2009/089

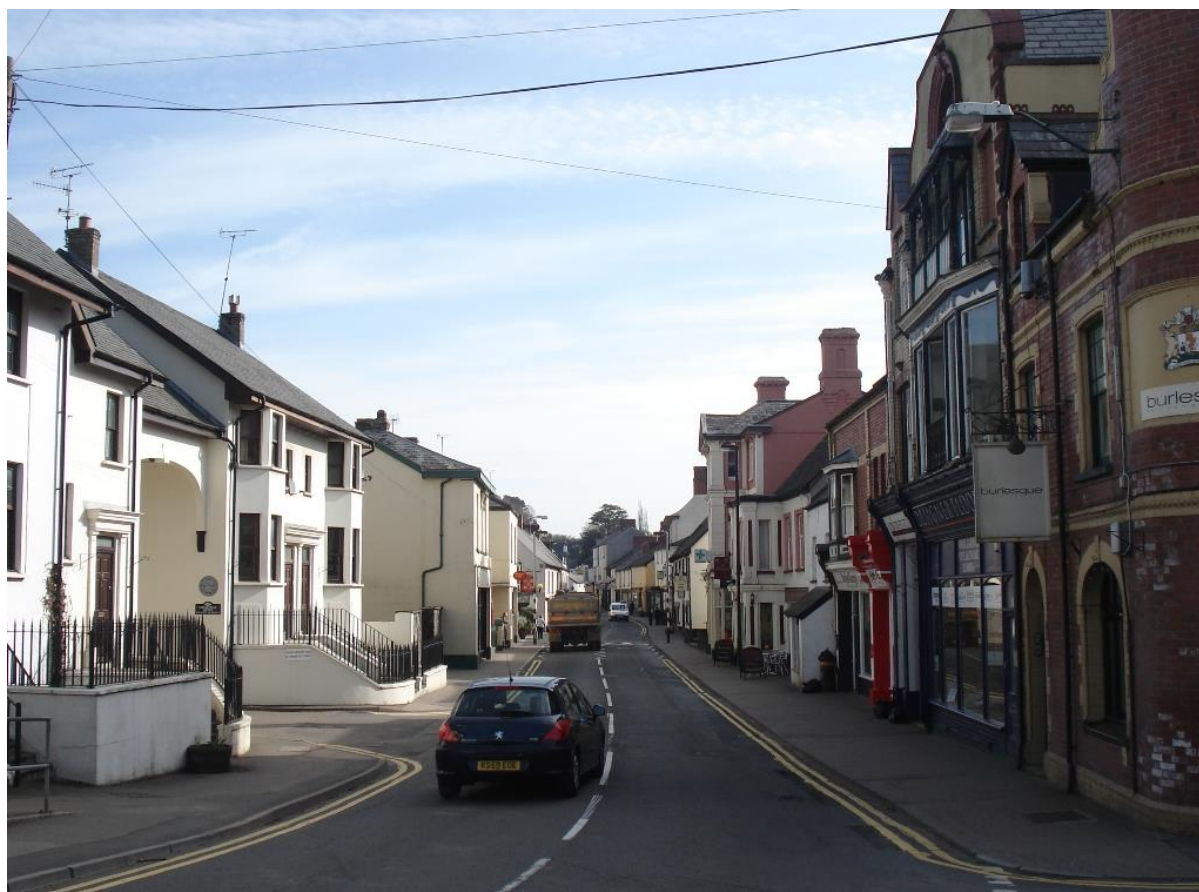
Fig.13 View looking north-east along Bridge Street – note the narrow section of the road and narrow pavement throughout

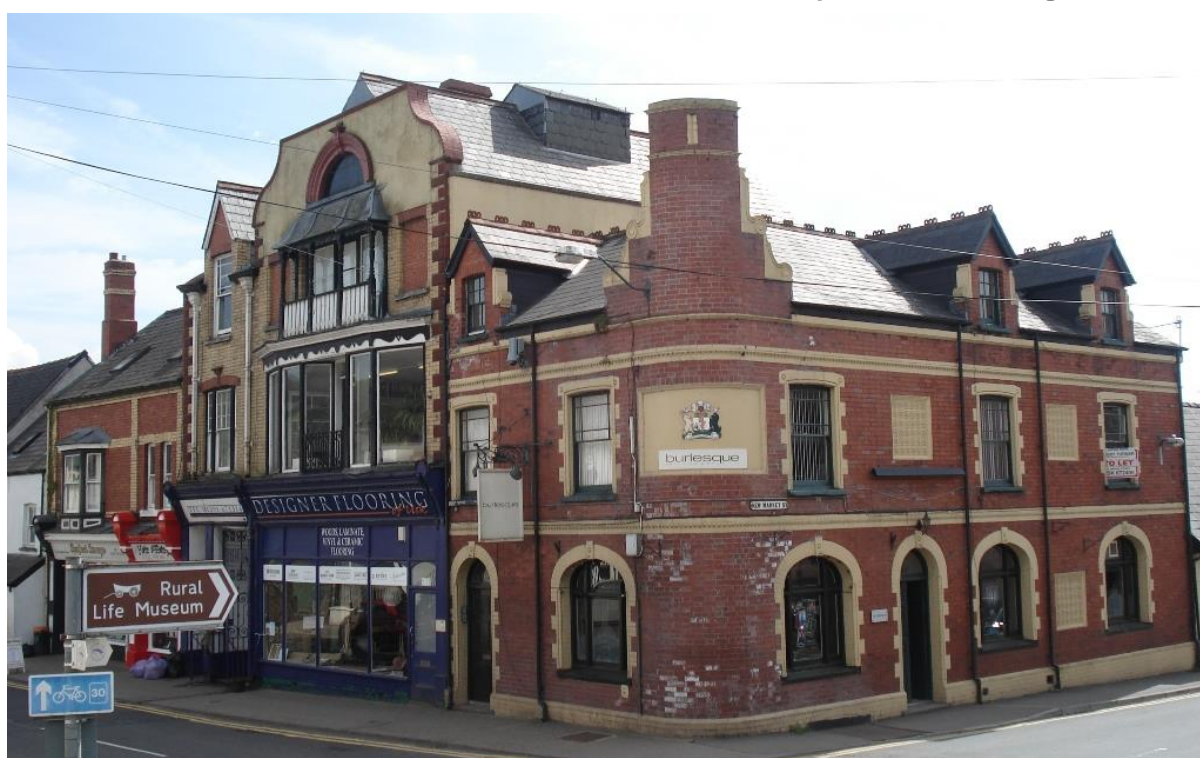
Fig.20 The distinctive use of red and buff brickwork on prominent buildings in the street scene – pictured No.69 Bridge Street

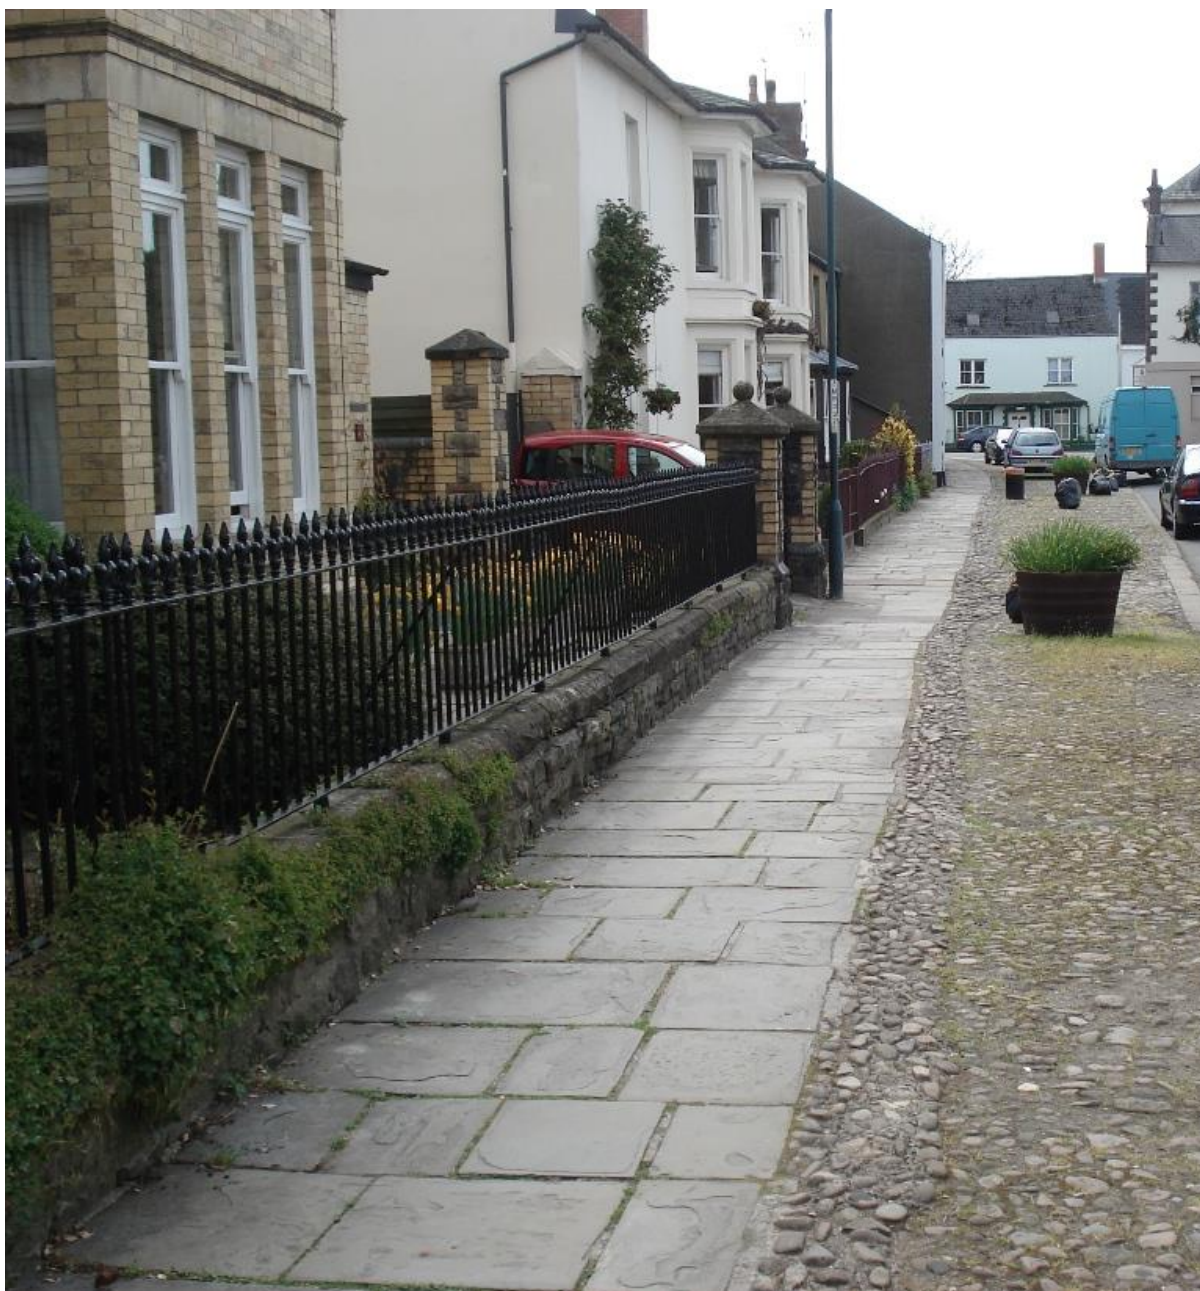
Fig.30 Cast iron railings are a common feature to this part of the conservation area and maintain a strong line to the street at the back of the pavement

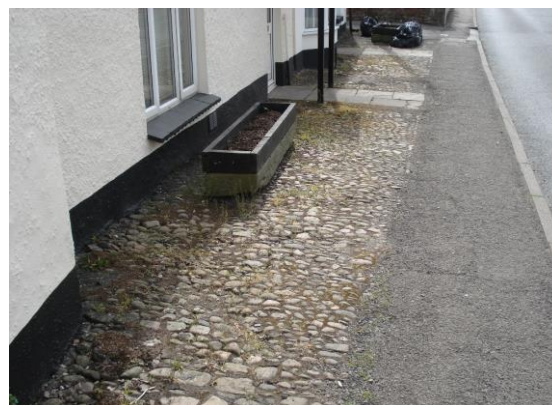
Fig.39 The historic use of cobbles for pavement finishes is an increasingly rare survival and significantly adds to the quality of the public realm within the conservation area

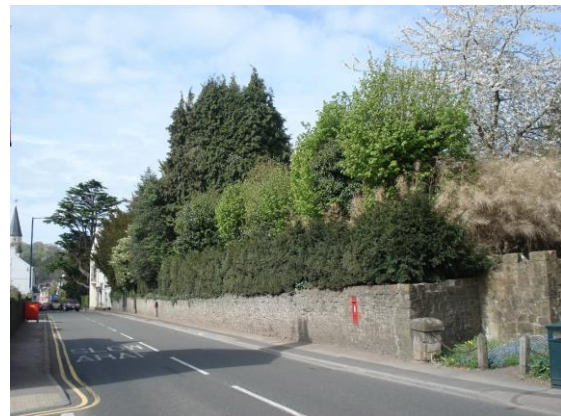
Fig.59 The long stretch of rubble stone boundary wall to the north-west side of Castle Parade is Grade II listed and forms an important historic element giving structure and definition to the street scene

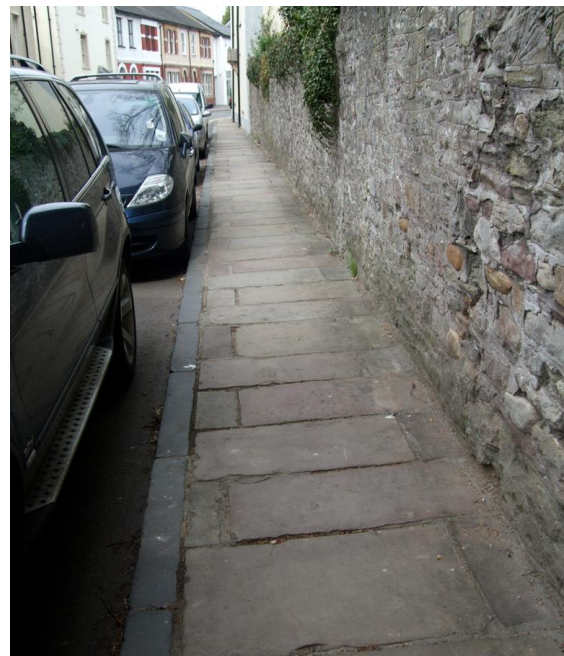
Fig.73 Section of historic stone boundary wall to the north-east side of Priory Street. The combination of stone boundary wall and traditional paving make up part of the general high quality of the public realm to this part of the conservation area

7.3.45 Boundary walls throughout this character area are invariably stone rubble with varied capping details. Some are very early (possibly forming part of the monastic complex which sat to the southern extent of the character area). They consistently make a particularly positive contribution towards the character and appearance of the conservation area where found (**Fig.73**).

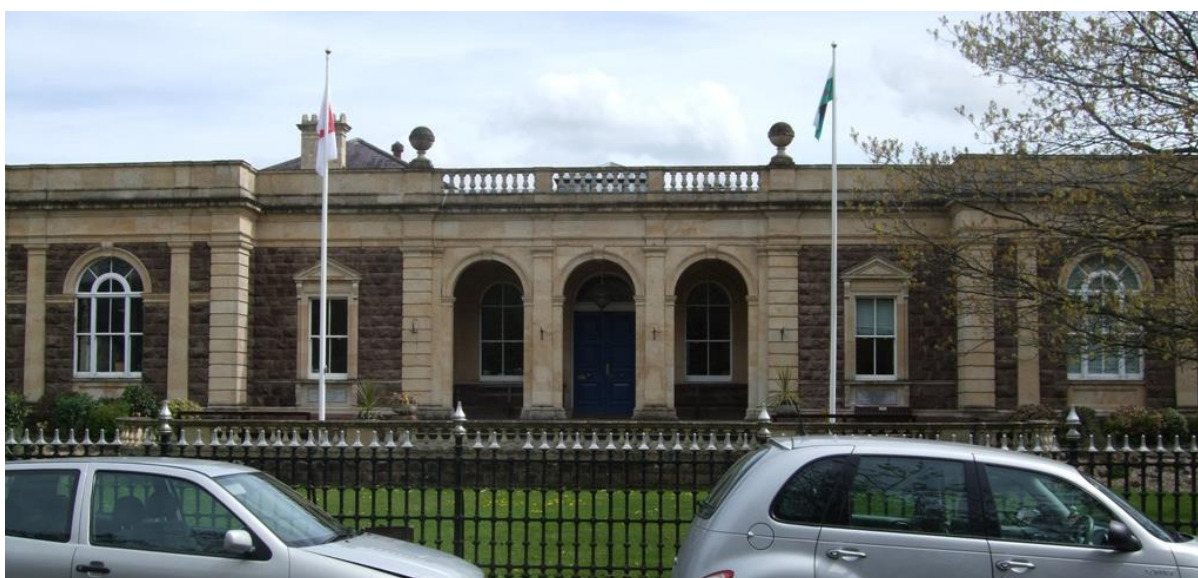
Fig.80 The central bays with colonnade to the Sessions House, an unusual design and vaguely colonial in character

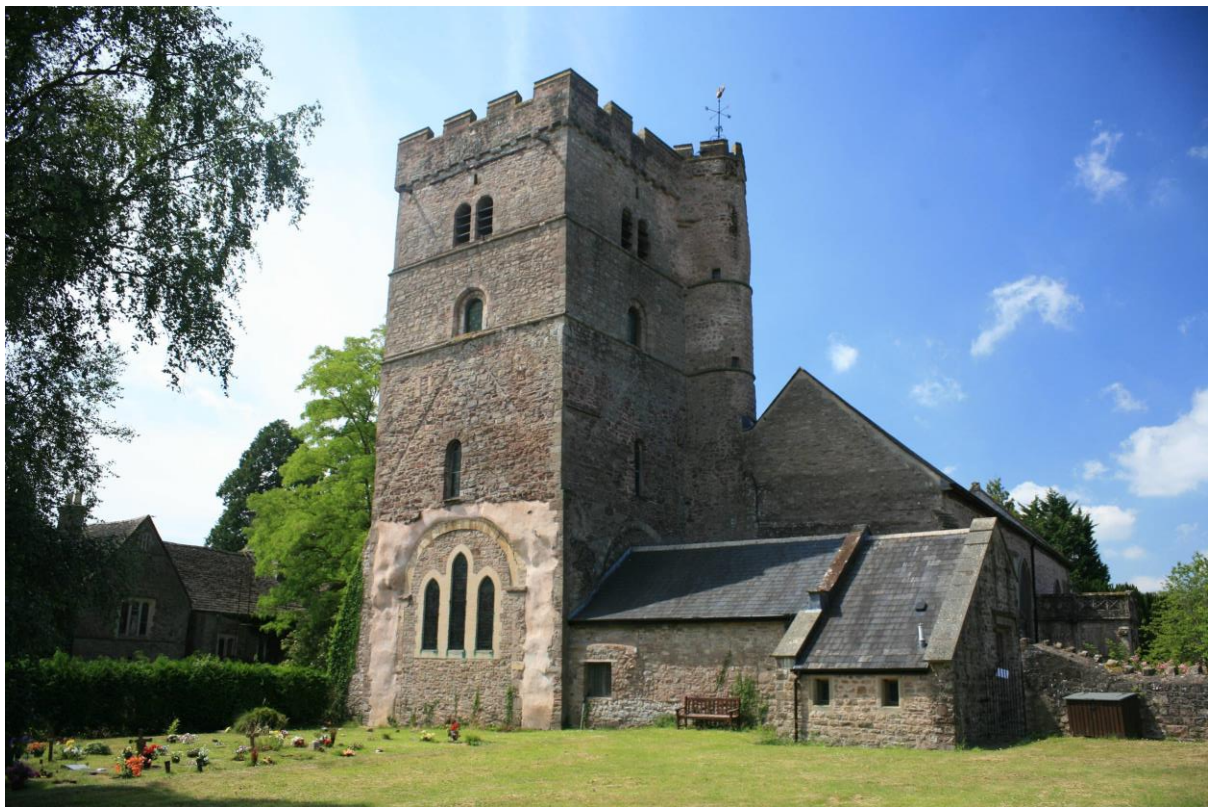
Fig.92 The Priory Church. The massive Norman tower and the later north aisle

7.4.6 The Priory Church of St Mary (Grade I Listed, **Fig.92**) was founded at approximately the same time as the castle, between 1154 and 1170. The stonework of the nave and the massive crossing tower date from this period, and their Norman origins can be seen in the round headed arches in the tower. The Norman east end including its probably semi-circular apse, and its transepts were demolished, leaving the tower as the east end of the church.

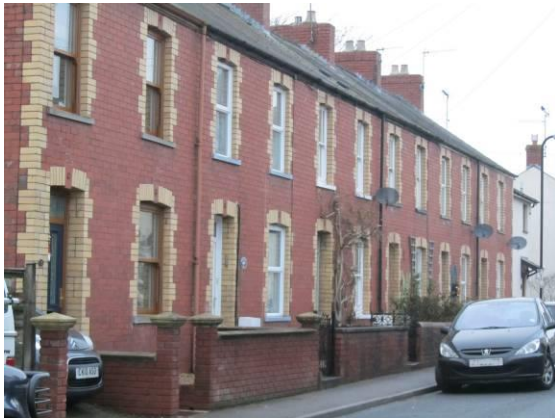
Fig.117 Late 19th century red brick terrace in Mill Street.

7.4.24 A much later artisan terrace is found in Mill Street (unlisted, **Fig.117**). The red semi-engineering brick and buff brick dressings are untypical of Usk. The brickwork detailing, especially the canted arches over windows and doors is well executed. Whilst few original windows survive, the terrace demonstrates the continuity and scale of this type of terrace throughout the town.

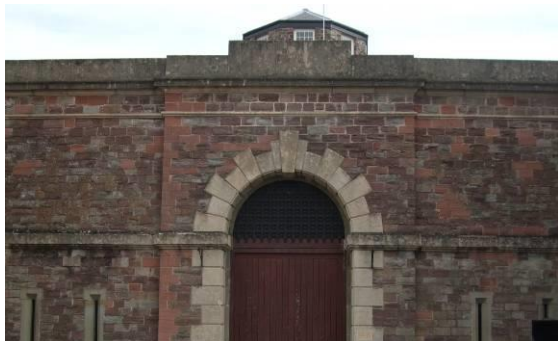
Fig.158 Squared stone to Usk Gaol
