Whitebrook

*Conservation Area
Appraisal &
Management Proposals*

Report Title: Whitebrook Conservation Area Appraisal & Management Proposals
Client: Monmouthshire County Council
Project Number: 2009/09

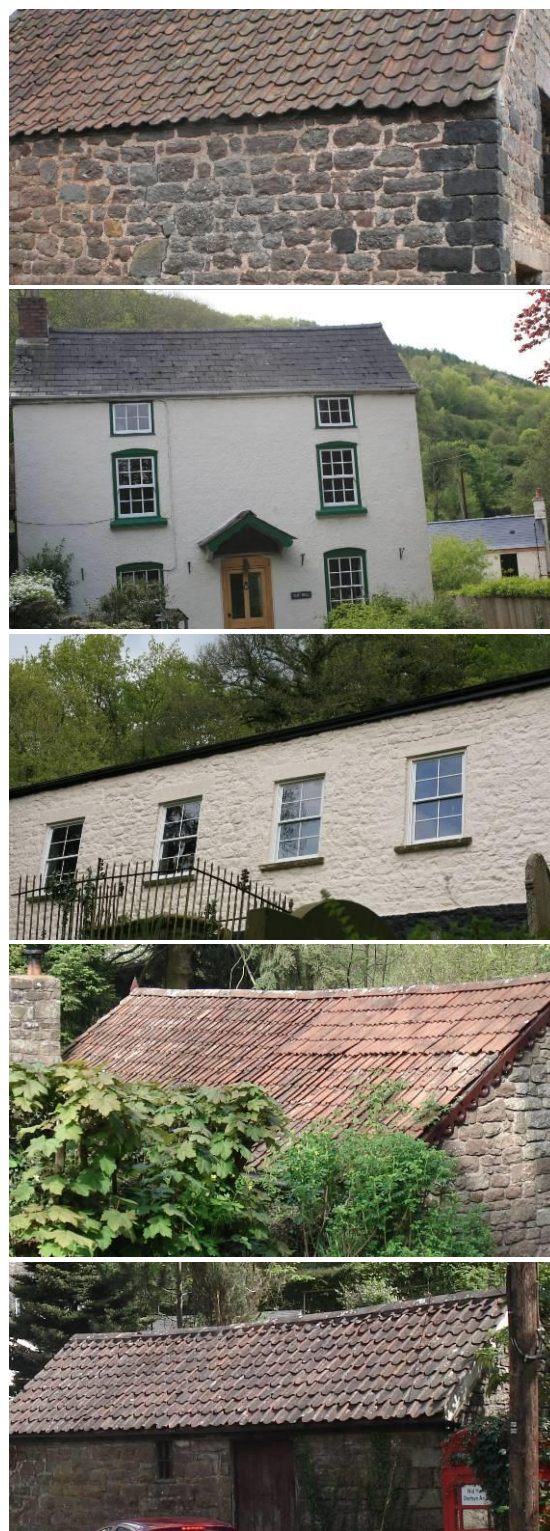
Fig.17 Materials found in the character area. From top: Slag blocks used in conjunction with quartz conglomerate rubblestone, smooth render and natural slate roofs, white-washed rubblestone, Bridgewater tiles, pantiles

7.3.6 The character area, in line with the entire conservation area, has a strong palette of building materials which create a well-defined and recognisable coordinated ensemble (**Fig.17**). Cottages and outbuildings are coursed quartz conglomerate rubblestone, sometimes white-washed. Of particular local interest is the use of slag blocks (a by-product of manufacture upstream at Redbrook) for quoins and door openings to barns at Tump Farm. Higher-status buildings are frequently smooth rendered and painted white or cream. Roofs are natural slate or replacement cement-fibre slate to most houses. Concrete tiles to Folly Cottage are an exception. Outbuildings utilise a combination of clay pantiles (of various designs) and terra-cotta and blue clay double Roman tiles with corrugated iron to some sheds. Chimney stacks are red brick or stone. Windows are multi-pane timber vertical sliding sashes with simple casements to some cottages. Rubblestone boundary walls are a feature often seen with historic iron entrance gates.

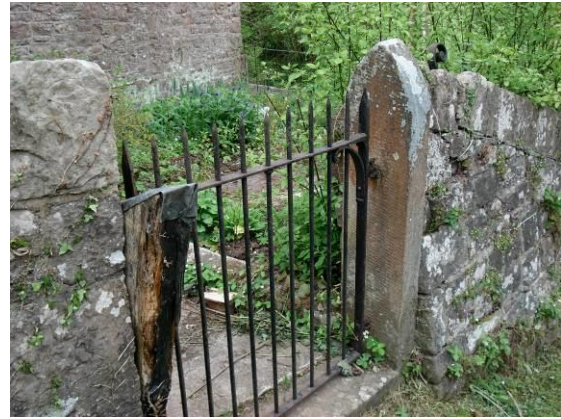
Fig.19 Stone gate piers and iron gate to Old Trinity Church

7.3.8 Features of note include stone gate piers to Wye Valley House, the former Baptist Chapel, Old Trinity Church and garden (**Fig.19**). This garden, dedicated to Edward Conner Lysaght 1902-1997, is an interesting drystone walled pound (in need of repair and maintenance) (**Fig.20**). Drystone walls topped with historic iron railings to Old Trinity Church continue on a footpath south. The Baptist chapel graveyard contains an interesting survival of 19th century headstones of Whitebrook paper makers and the Pick family who ran the Post Office. Other significant features comprise industrial archaeology including a sluice at Manor Brook Cottage, the outbuilding west of the Bell over the Manor Brook, possibly a former smithy and the substantial ruins of the Wye Valley paper mill (**Fig.21**). In addition where the White Brook joins the Wye are traces of a quay and the ruins and footings of the riverside paper warehouses demolished in the 1960s.

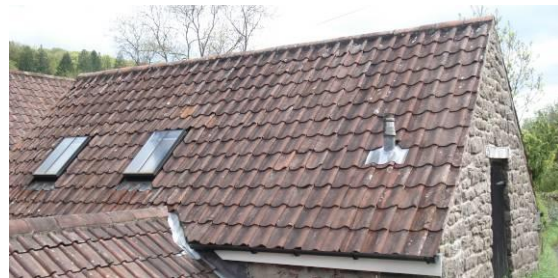
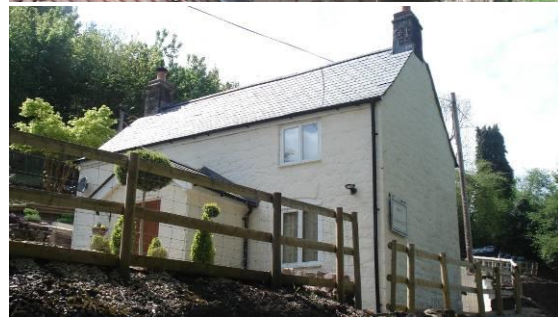
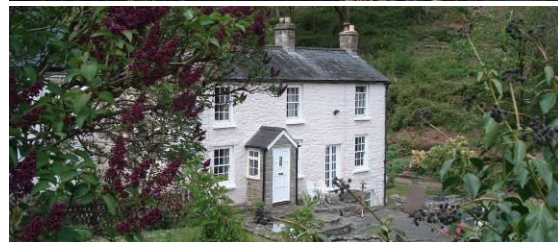
Fig.26 (right) Materials found in the character area. From top: Clay pantiles, white-washed rubblestone with natural slate and stone stacks, quartz conglomerate rubblestone with Bridgewater tiles.

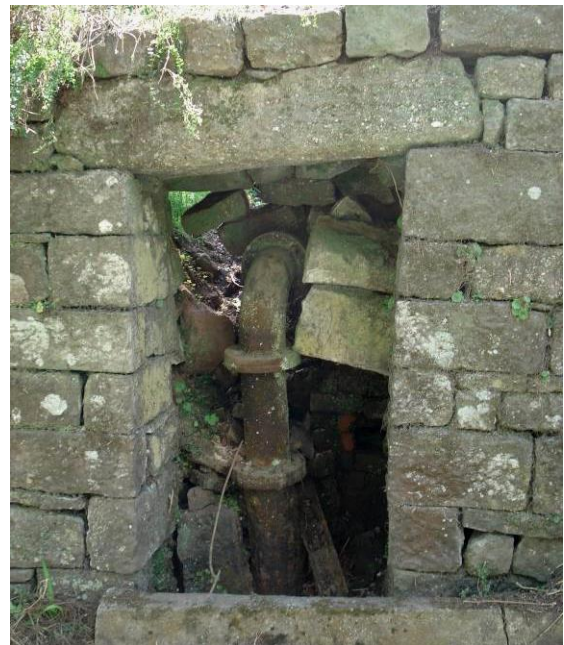
Fig.31 Historic iron pipe taking water from Manor Brook under the road to Clearwater Mill

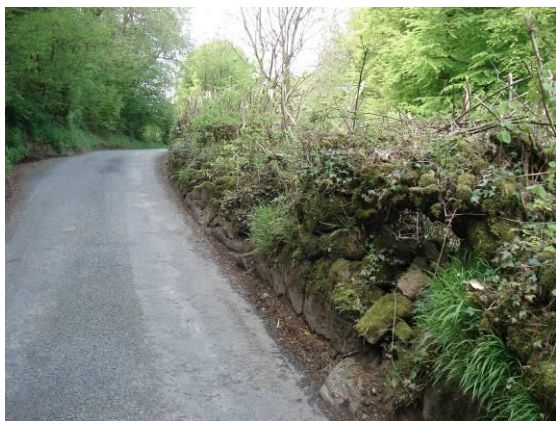
Fig.43 Low tumbledown drystone walls

7.3.23 New Mills House is a smooth rendered building with slate roof and clay ridge tiles, end stacks and timber vertical sliding sashes. There are many drystone boundary walls in the character area constructed from the local quartz conglomerate rubblestone (**Fig.43**).

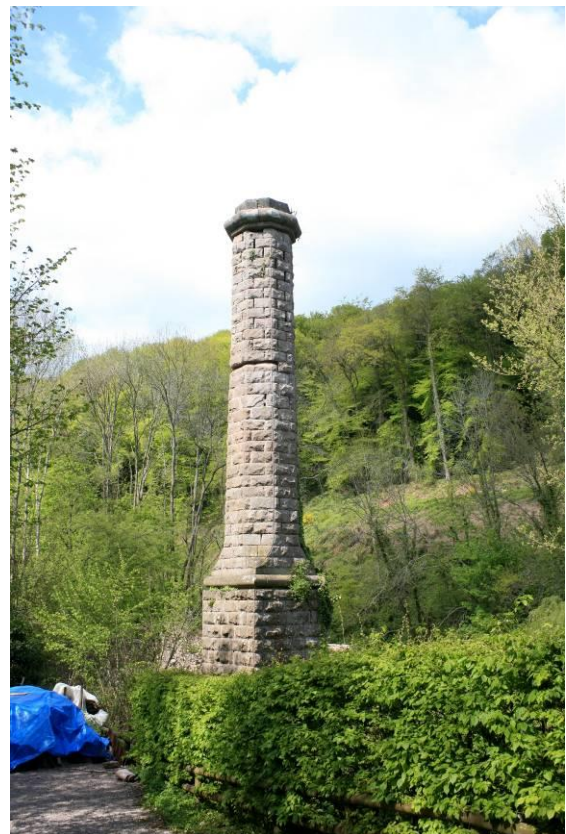
Fig.48 The 1860s chimney at Clearwater Mill

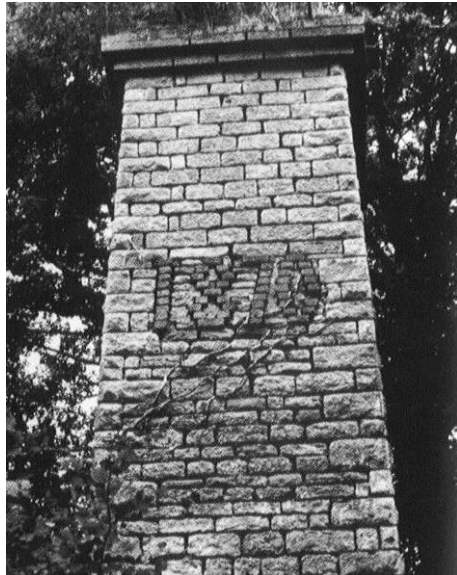
Fig.49 An historic photograph of the 1870 chimney which served Sunnyside Mill (now believed to have been demolished)

7.4.11 Sunnyside Mill only remains as fragments of stone walls in the garden of Traligael (former manager's house). This once large mechanised paper mill was served by three engines. On the south side of the valley was a stone chimney dated 1870 (**Fig.49**). Its stone-lined flue leads under the road to the mill site. Its two supply ponds remain.

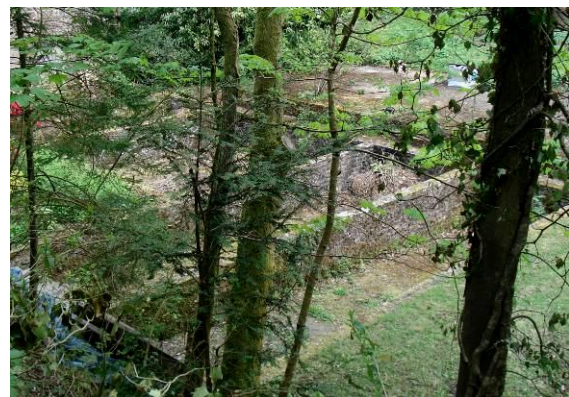
Fig.52 The tanks used for the fishery

for 10 horses remains (**Fig.51**) (converted into a private dwelling house, Coach House) as do the stone and concrete rectangular shaped tanks immediately downstream of the mill which was the site of a 1920s trout farm of the Wye Valley Fishery (**Fig.52**).

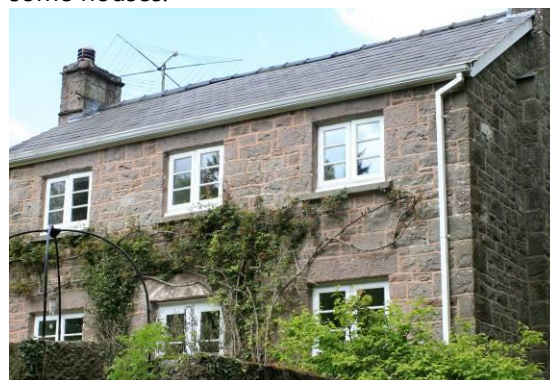
Fig.75 Local rubblestone laid to courses at Mount Pleasant

7.7.2 Stone is a mix of local limestone and sandstone with distinctive sandstone quartz conglomerate which is found locally in rocky outcrops and used extensively for millstones. Walling is predominantly rubblestone but laid to courses (**Fig.75** & **Fig.76**). Occasionally it is white-washed (**Fig.77**). High status mill managers' houses and the c.18th century Tump Farmhouse are rendered and painted in shades of white and cream. Very occasionally cottages are rendered, but this is usually a later remodeling of exposed stone buildings (**Fig.78**). Stone-work to houses, mill buildings and outbuildings often has red or yellow brick dressings. Slag blocks, a by-product of the furnaces upstream at Redbrook and often used as ballast in river vessels, are found at Tump Farm where they are used on farm buildings as quoins and around windows and door openings. Occasional outbuildings and mill buildings feature weatherboarding. The village hall is corrugated iron. Many 18th and 19th century cottages have small window openings with timber casement windows. Higher status houses have larger openings with Georgian timber sliding sashes. Window surrounds are sometimes painted black forming a strong colour contrast with white rendered walls.

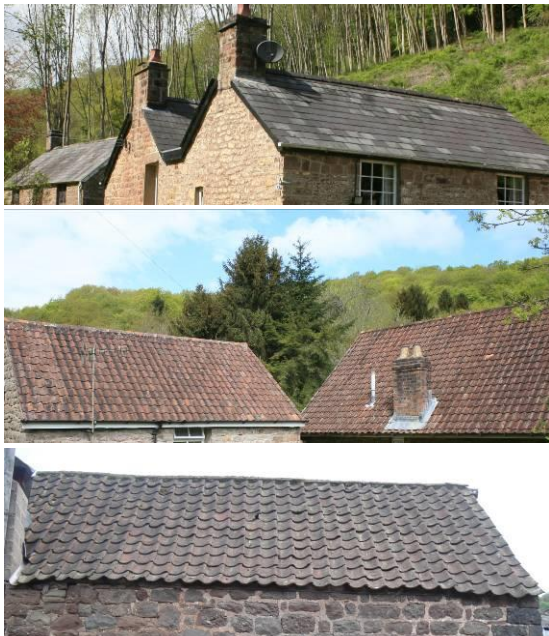
Fig.79 Characteristic roofing materials: Natural slate and clay pantiles

7.7.3 Most traditional houses still retain natural slate or clay pantile roofs (**Fig.79**) although some have seen these materials replaced with cement fibre slates. This is generally seen at medium to low pitches to simple gabled roofs with brick or stone ridge stacks. Outbuildings largely feature clay pantiles or double roll clay tiles. Some historic properties and 20th century housing have concrete interlocking tiles. Late 20th century housing and 21st century housing have natural slate or cement fibre slate roofs.

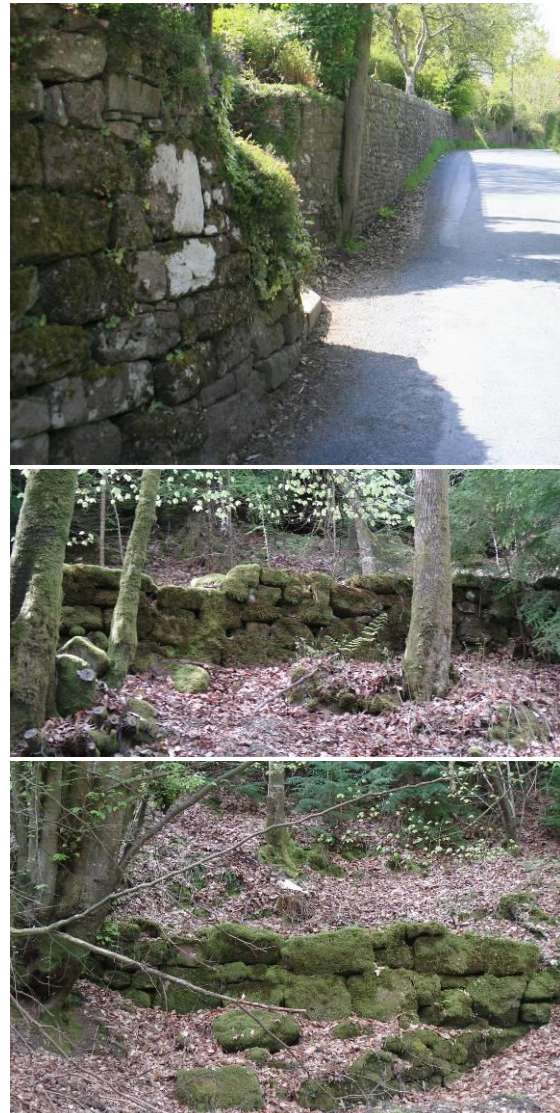
Fig.80 Typical stretches of boundary walls

7.7.4 Historic dry rubblestone walls are a feature of the conservation area, often found in long stretches alongside the through road or forest tracks (**Fig.80**). There are frequent low stone walls with cams and rustic stone gate piers to houses. Low stone walls are sometimes topped by earth banks, covered in ferns and moss with trees growing through the walls.
